Report No. NED/EQD/SR-17/01

Shaking Table Test of BRB Strengthened RC Frame

May 2017

DEPARTMENT OF EARTHQUAKE ENGINEERING
NED UNIVERSITY OF ENGINEERING AND TECHNOLOGY

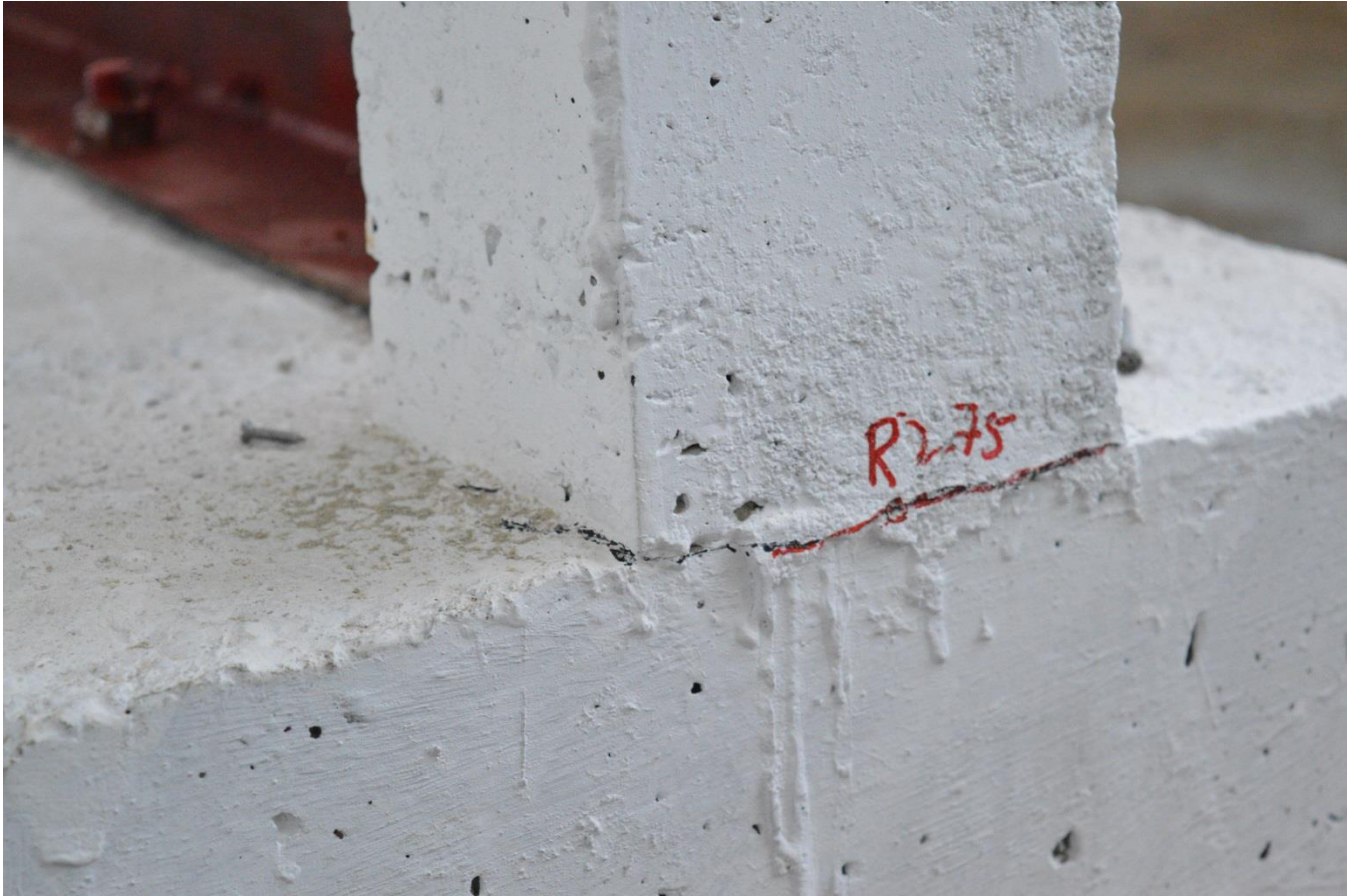
- 1) No damage occurred to the frames up to 250% level of earthquake and both frames were intact.
- 2) First crack in the columns appeared at 275% level of earthquake excitation. For the control frame, the flexural crack appeared at the connection of column with the base beam (Fig. 10). A shear crack also appeared in one of the columns of the BRB strengthened frame above the plate of clevis used to connect the BRB end with the column (Fig. 11).

Fig. 10 First level crack in the column of control frame

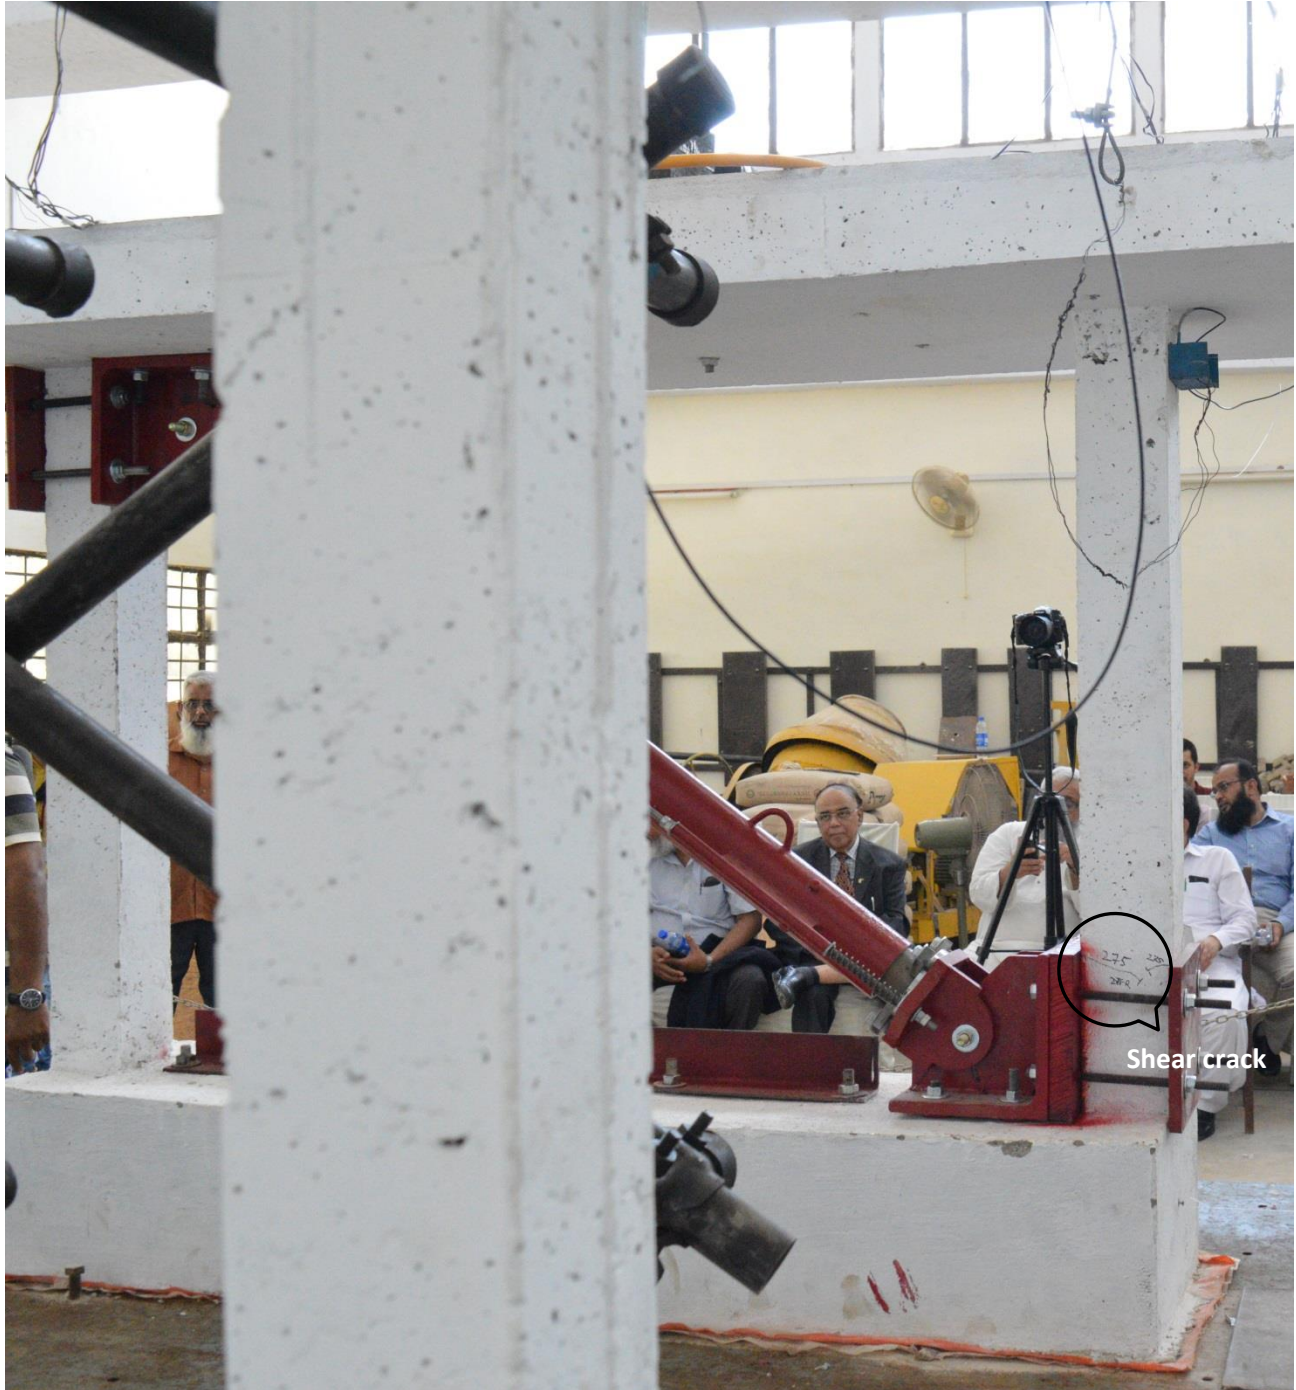
Fig. 11 Shear crack in the column of BRB strengthened frame at top of end plate

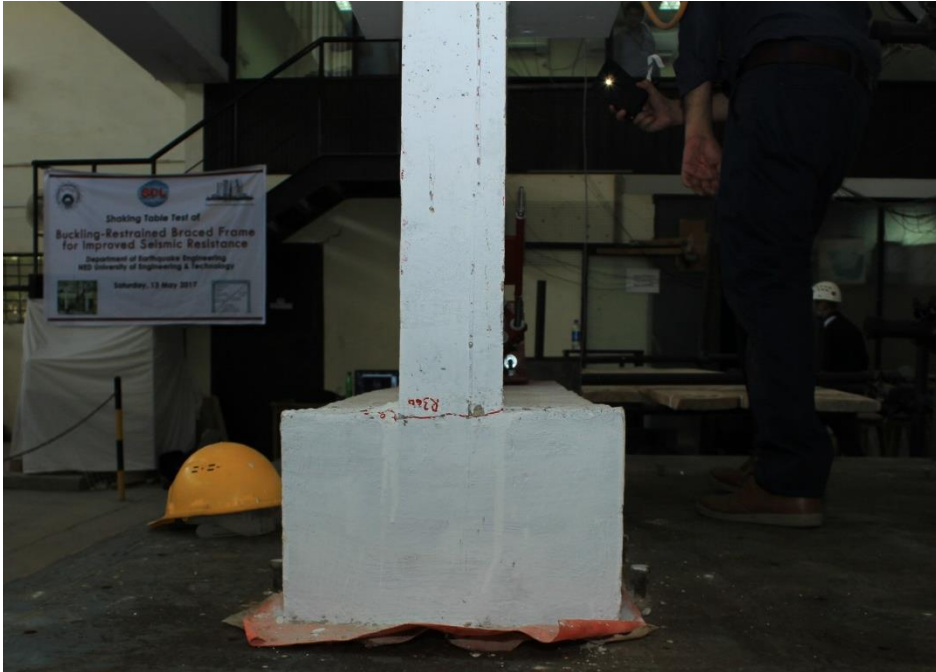
- 2) A crack in the junction of column and base beam appeared in the BRB strengthened frame in the column where BRB was connected in the top of the column (Fig. 12).

Fig. 12 Crack at the column-base beam junction in BRB strengthened frame

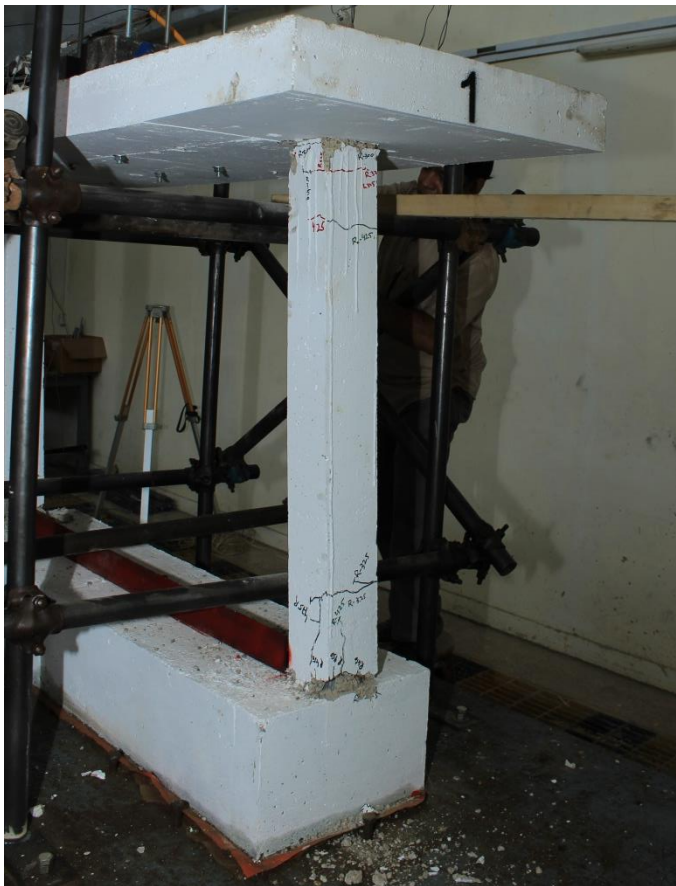
- 3) The cracks in the columns of the control frame increased with the increase in PGAs of the calibrated records. These cracks concentrated the top and bottom regions of the columns (Fig. 13).

Fig. 13 Damage zones in column of control frame

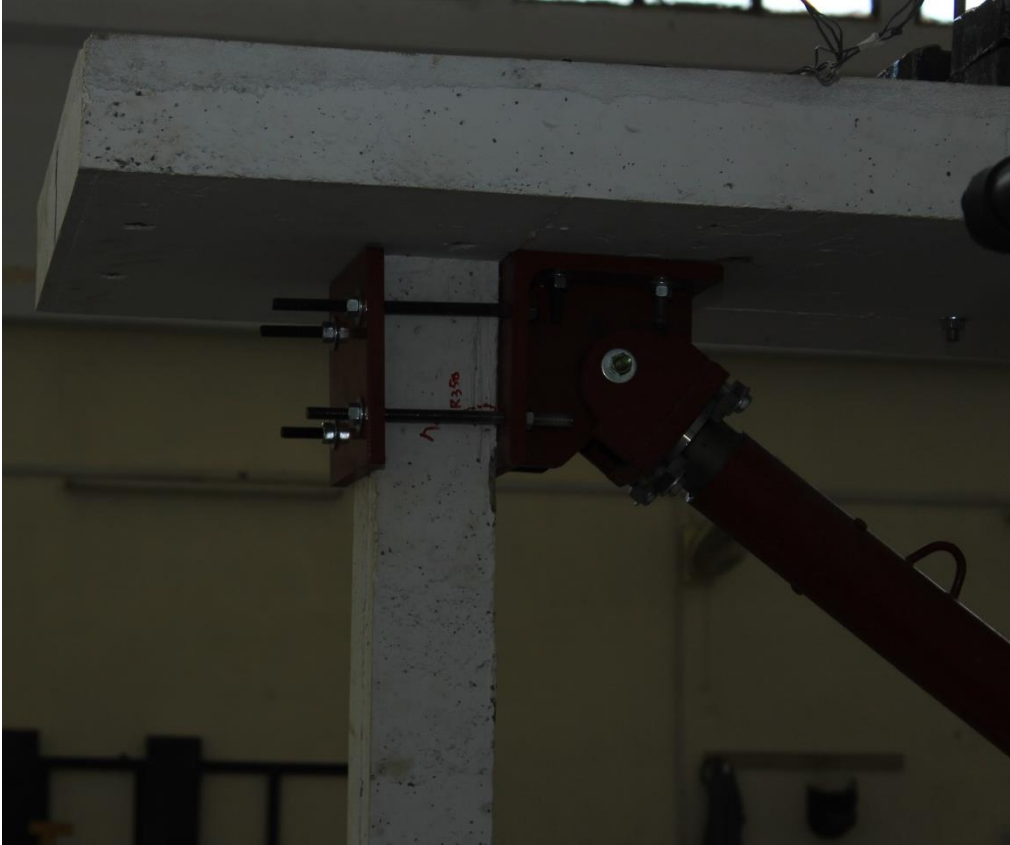
- 4) The shear crack in the BRB strengthened column opened up with the application of higher PGAs. New cracks, however, were not seen in this frame until 350% level of earthquake excitation when a crack appeared in the column top region where BRB end was connected (Fig. 14). This was the column opposite the column with the shear crack. Another crack in the same column appeared on its opposite face at 375% level of earthquake (Fig. 15).

Fig. 14 Crack in the column of BRB strengthened frame at 350% earthquake excitation

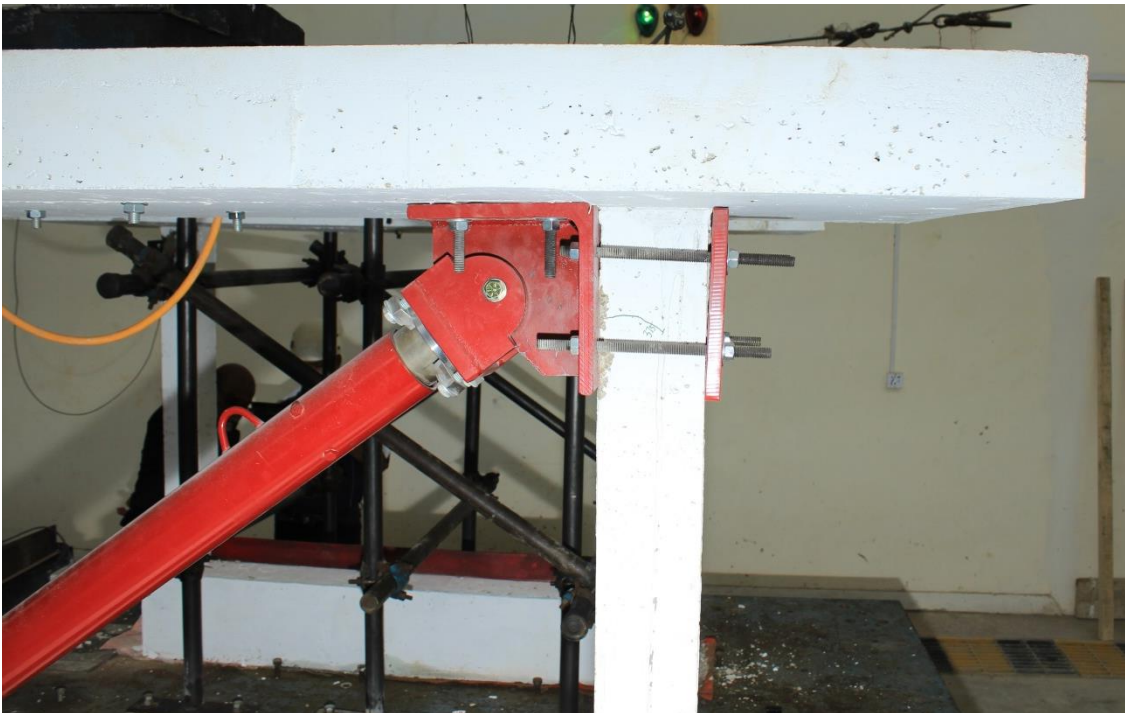
Fig. 15 Crack in the column of BRB strengthened frame at 375% level of test run

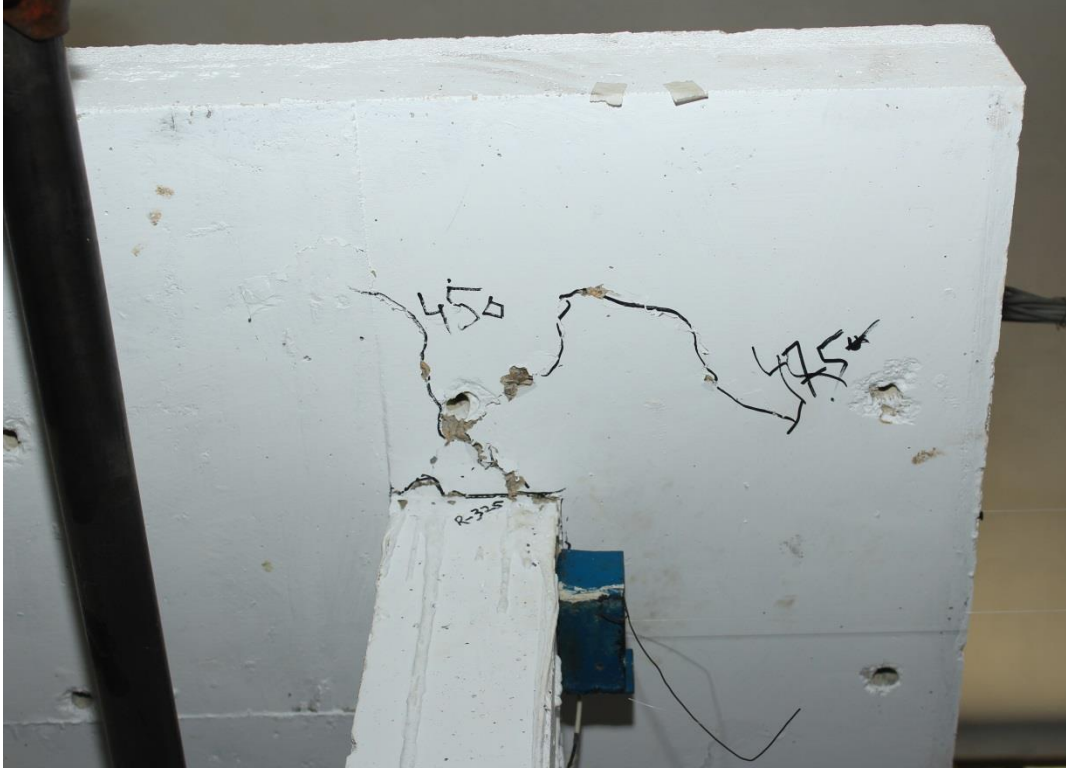
- 7) Another crack appeared with the application of 475% level of dynamic excitation (Fig. 16).
A large piece of concrete in the bottom of the overhanging part of the slab of the control frame broke at 475% level of earthquake (Fig. 17).

Fig. 16 Cracks in the overhanging part of top slab in control frame

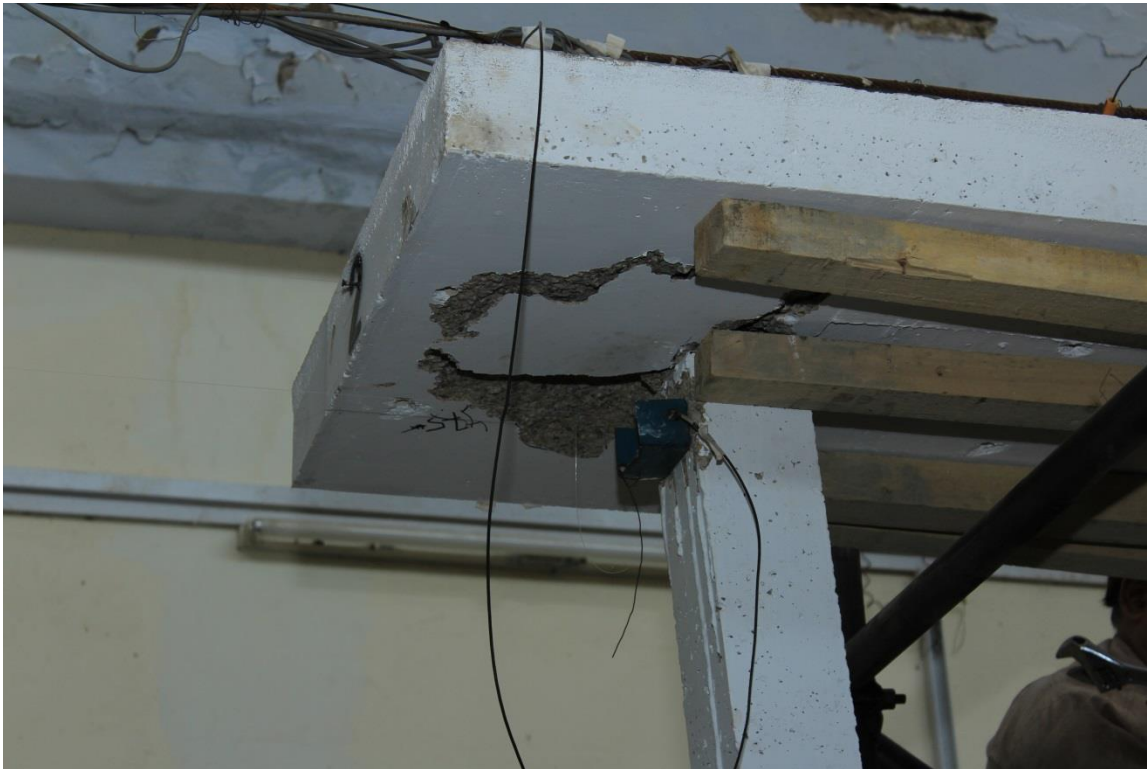
Fig. 17 Damaged portion of top slab for control frame
