3-Storey Library Building in Karachi

A Case Study of Seismic Assessment and Retrofit Design

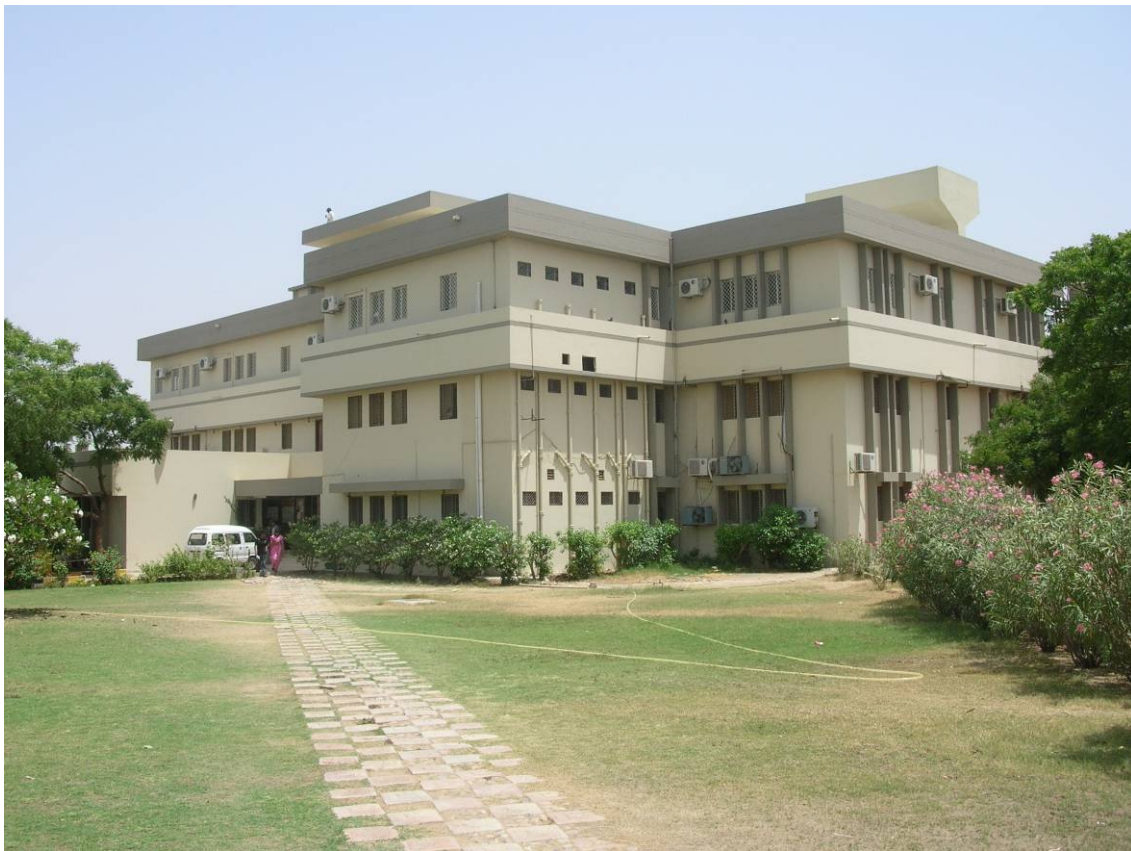
Figure 1. Front elevation view of the building

The building, shown in Figure 1, is a three storey (ground plus two) library building. The building's overall dimensions are 109'-6" by 141'-0", and it is approximately 42 feet tall. The building has a reinforced concrete moment frame structural system with unreinforced concrete block infill walls. The concrete block infill walls are 6 inches thick and located primarily at the periphery. The foundations are reinforced concrete spread footings. The building is relatively new and is in reasonably good condition. No condition assessments or repairs have been made.

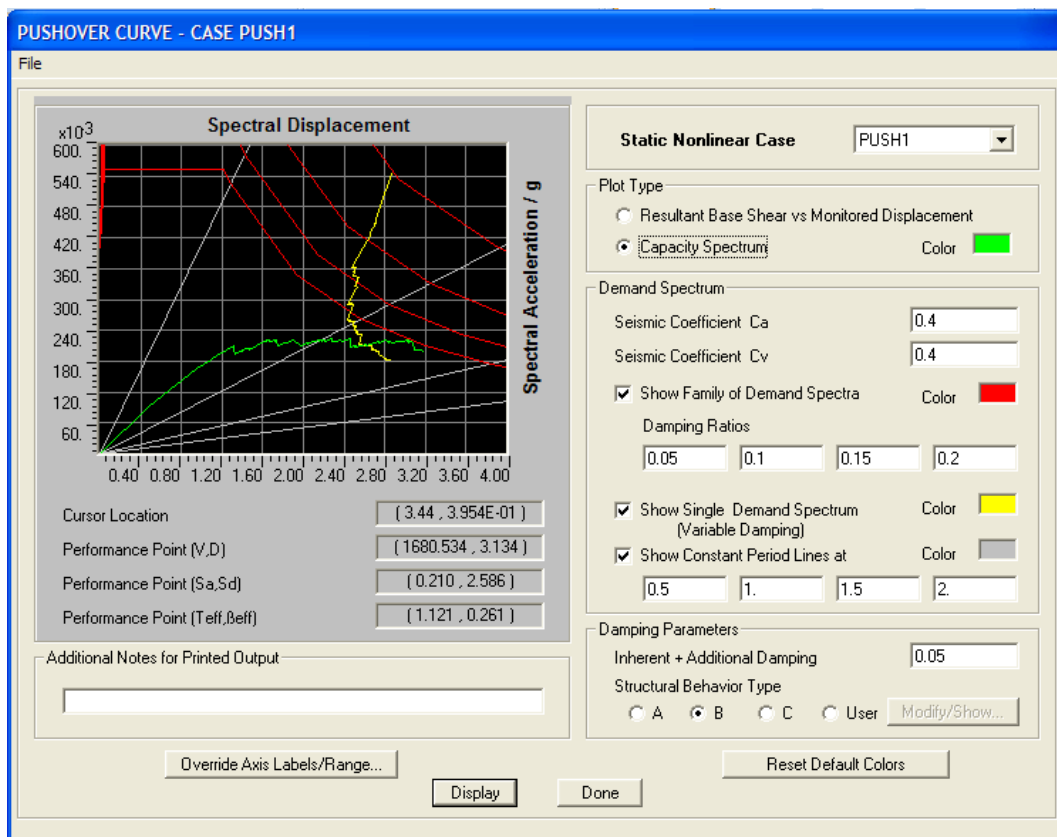
Figure 7. Performance level

Figure 6 shows the pushover load-deformation curve. The curve bends and becomes jagged as the various structural members begin to yield and undergo plastic deformation. In Figure 7, the pushover curve, a measure of the building's capacity, is converted into a capacity spectrum and compared with the estimated demand using the capacity spectrum method. This figure shows the performance level where demand and capacity spectra intersect each other at that point where it is necessary to see the condition of the structure, and whether it is fulfilling the demand or not. This point is called the *performance point*.

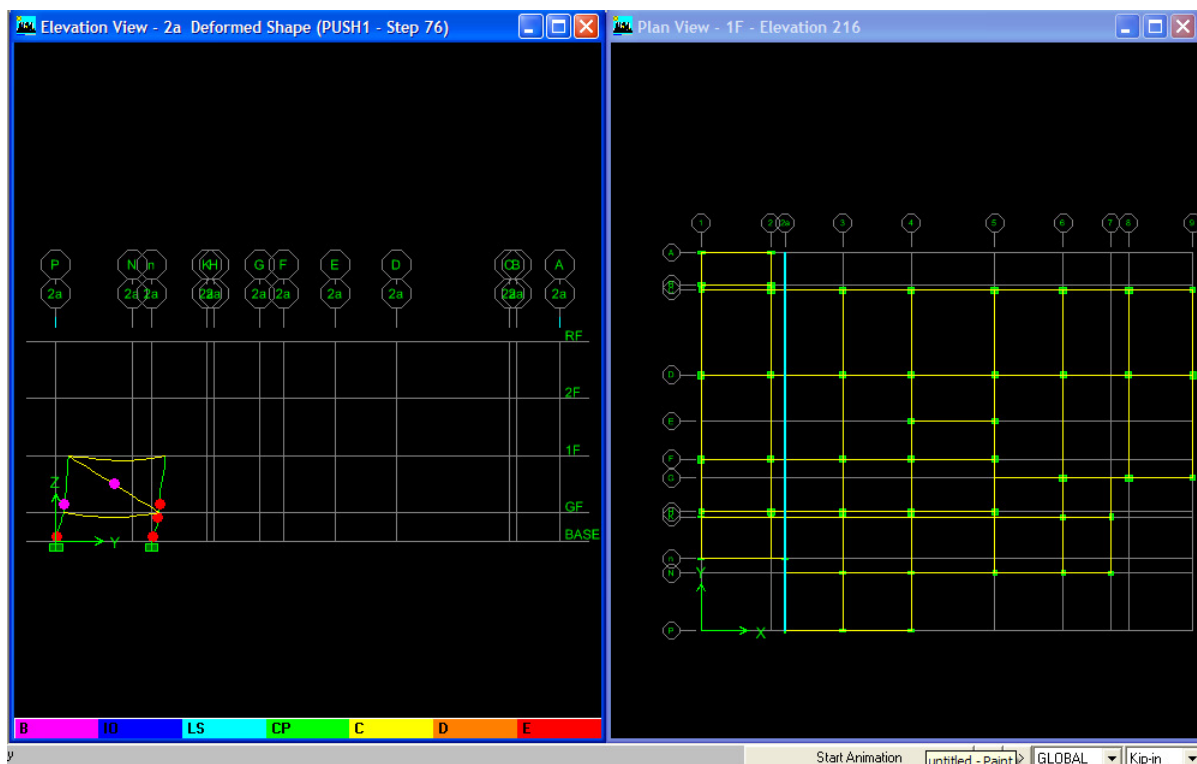
Figure 9. Hinge deformation vs. acceptance criteria

The columns in the small single storey addition at the front of the library are failing, as indicated by the red circles in Figure 9. This shows that retrofitting is needed to achieve stability and to achieve the desired life safety performance level.

In order to prevent column failure in the small additional block and to prevent pounding with the main building, the case study team decided to stitch the small additional block and the emergency exit stair to the main building. They also considered reinforced two options for adding deformation capacity and strength in the ground storey: infill panels reinforced by a shotcrete to create a shear wall, and a combination of reinforced infill panels and wrapped columns. The team determined that a walls-only solution was preferable, and then investigated two configurations of reinforced infill panels. The first option had reinforced panels in the ground storey only, and not below ground. The second and preferred option, shown in Figure 10, placed panels in more optimal locations for constructability and also provided panels below the ground level, in between the base and ground floor at the outer periphery.

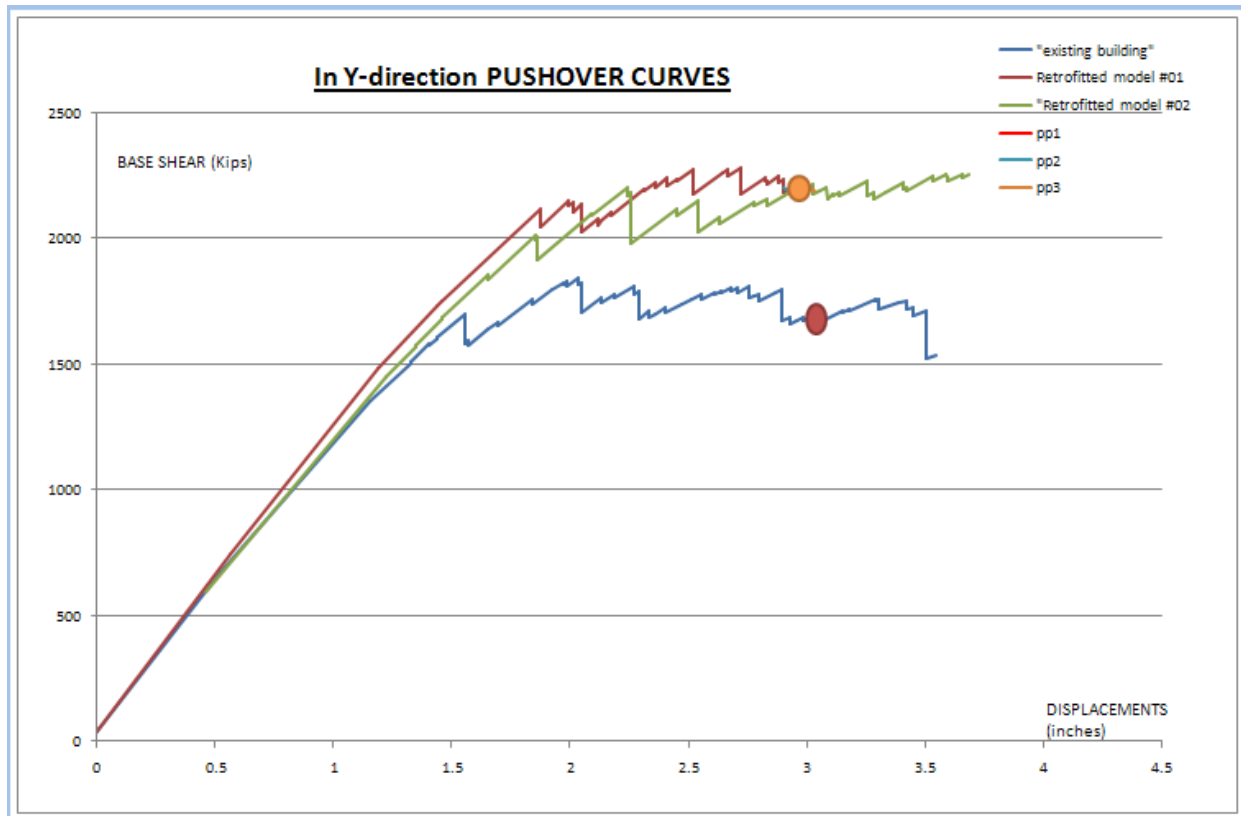
Figure 11. Comparison of pushover curves; Retrofitted model #01 is Option 1, Retrofitted model #02 is Option 2

Figure 11 shows a comparison of pushover analysis results for the two retrofit options versus the existing building. The capacity and demand spectra for retrofit option 2 are shown in Figure 12. Retrofit option 2 provides better performance than option 1, and rectifies the column failures experienced by the existing building, as Figure 13 shows.
