8-Storey Mixed Use Building in Karachi

A Case Study of Seismic Assessment and Retrofit Design

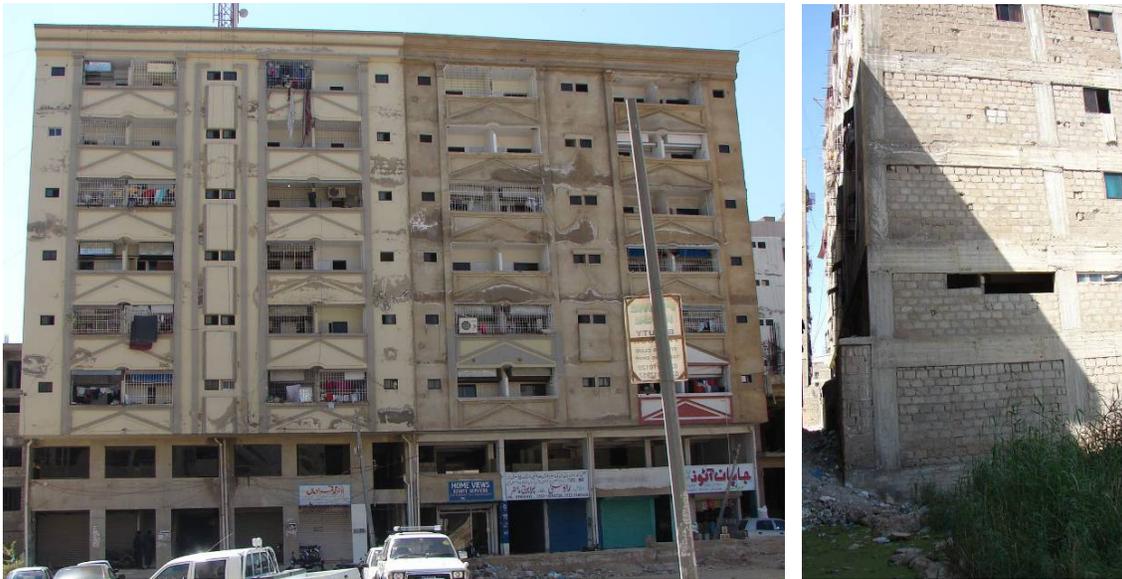
Figure 1. Front elevation view (left) – the case study building is on the left; side elevation view (right)

The building, shown in Figure 1, is an eight storey (ground plus seven) mixed use apartment building with shops at the ground floor and offices at the mezzanine level. The building's overall dimensions are 55'-0" by 75'-0", and it is approximately 90 feet tall. The building has a reinforced concrete moment frame structural system with unreinforced concrete block infill walls. The concrete block infill walls are 4 inches thick. The foundations are reinforced concrete spread footings. The building is relatively new but some water damage is visible from the exterior. Some repairs have been made, but no condition assessments have been made.

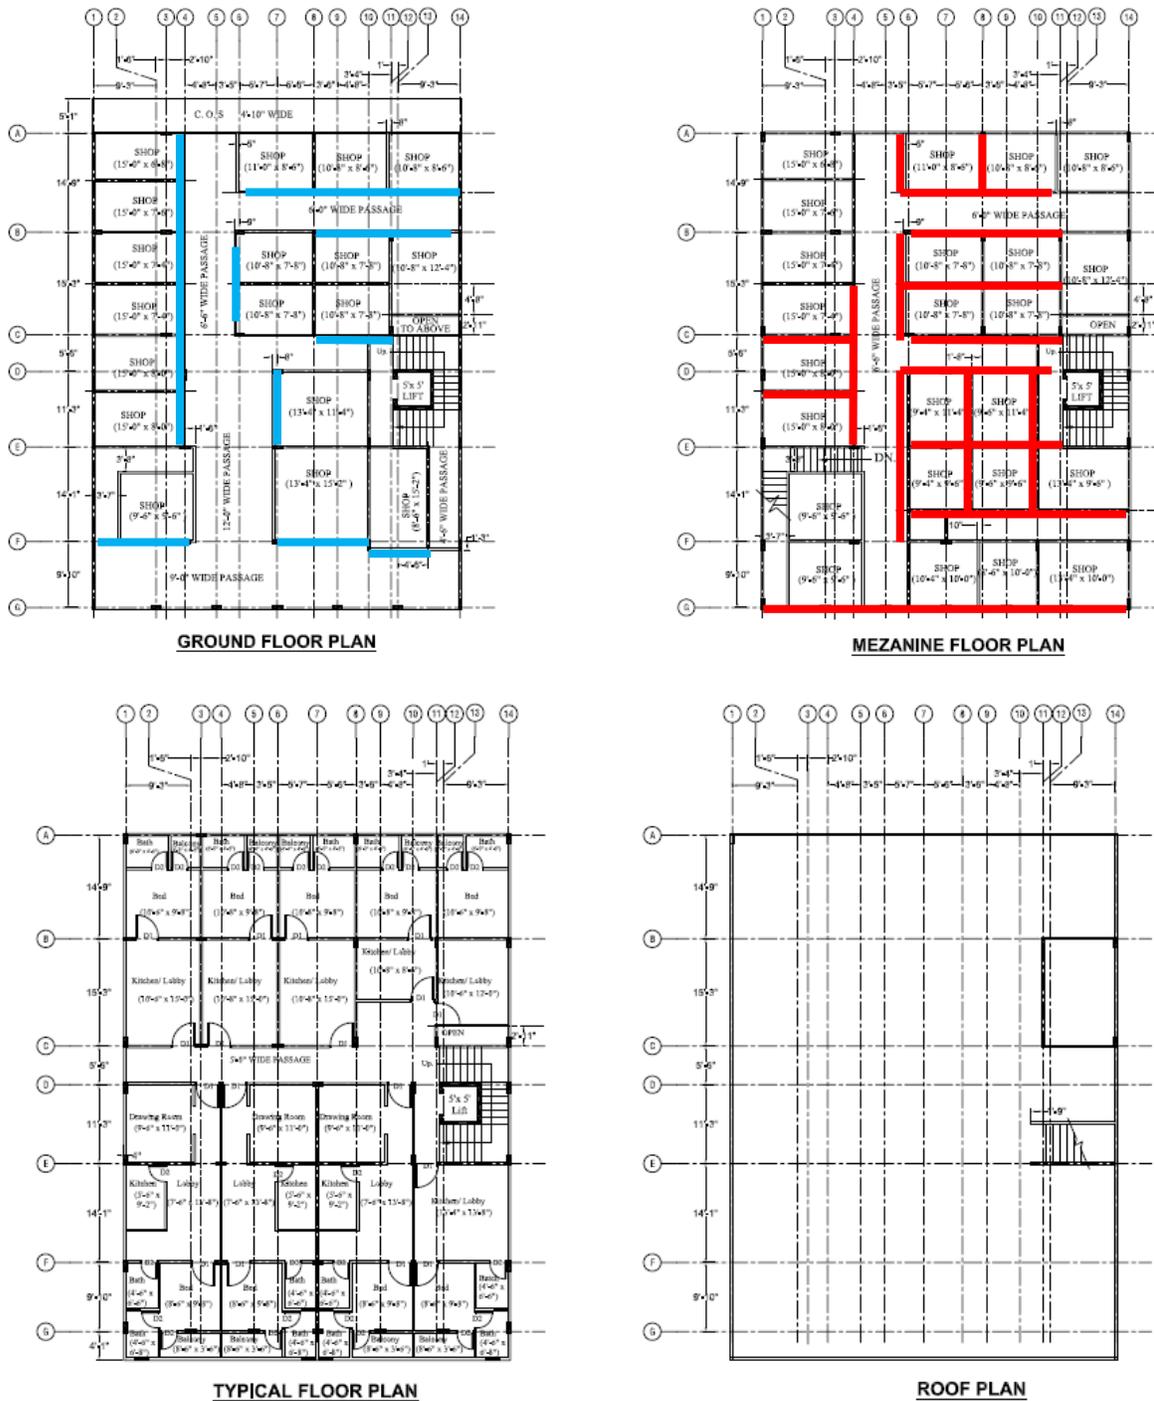
Figure 2. Architectural plans of ground floor, mezzanine, typical upper residential floor, and roof. Blue and red lines indicate locations where unreinforced masonry infill walls have been removed in commercial areas.

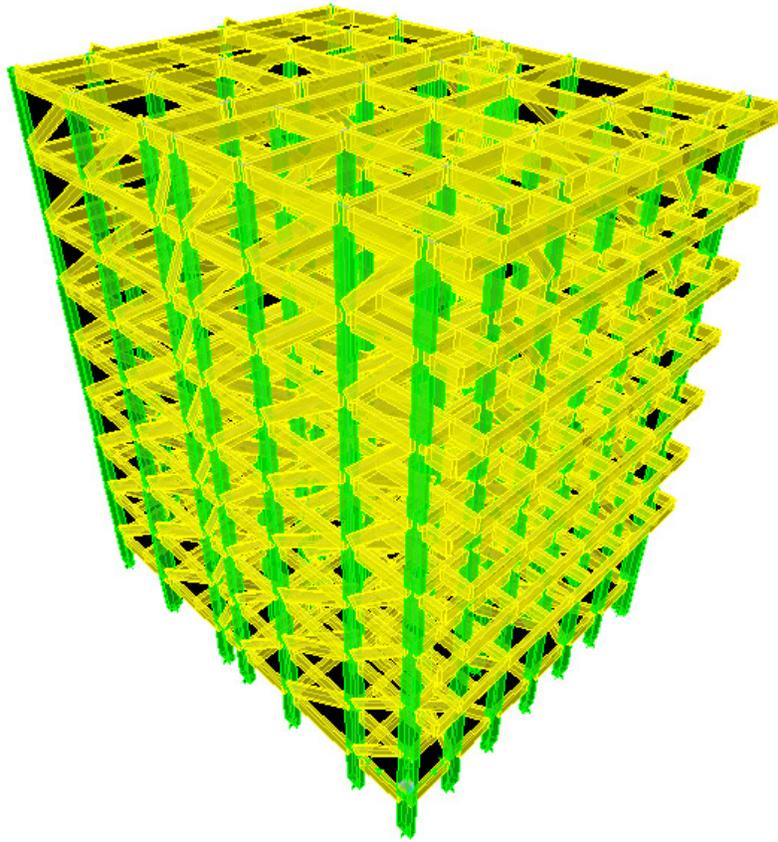
Figure 8. Rendering of linear ETABS model of the building

Figure 8 shows the 3-D model of the building generated in ETABS Nonlinear version 9.7.0. The beams and columns were modeled with linear beam-column elements, and the infill walls were modeled with single linear compression struts. The linear static analysis shows that there are a number of columns with demand/capacity ratios (DCRs) greater than one and even exceed global ductility of two, so the building is expected to respond in the nonlinear range. Please see Appendix B for linear analysis and Appendix C for non linear analysis results.

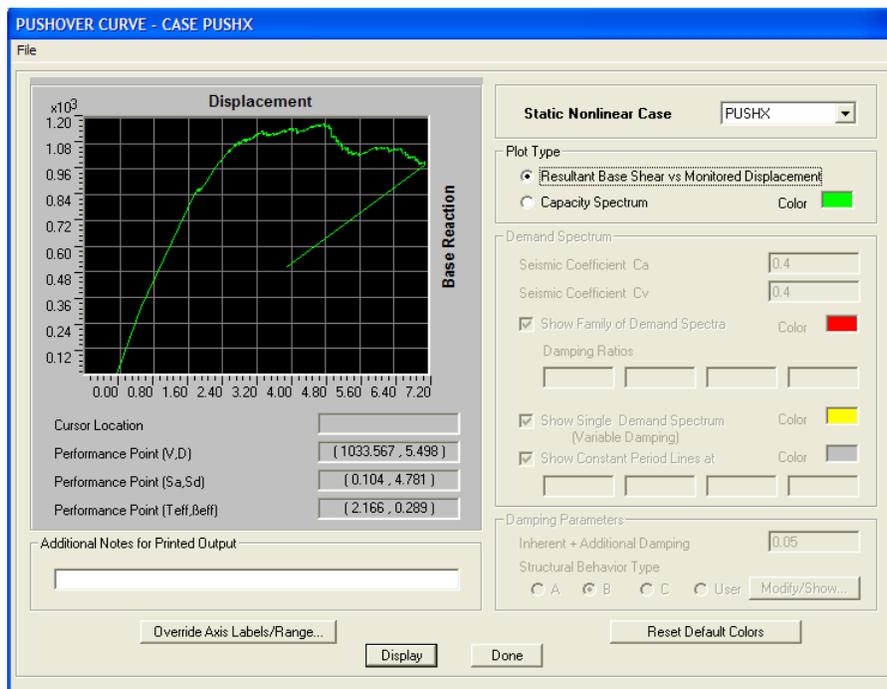
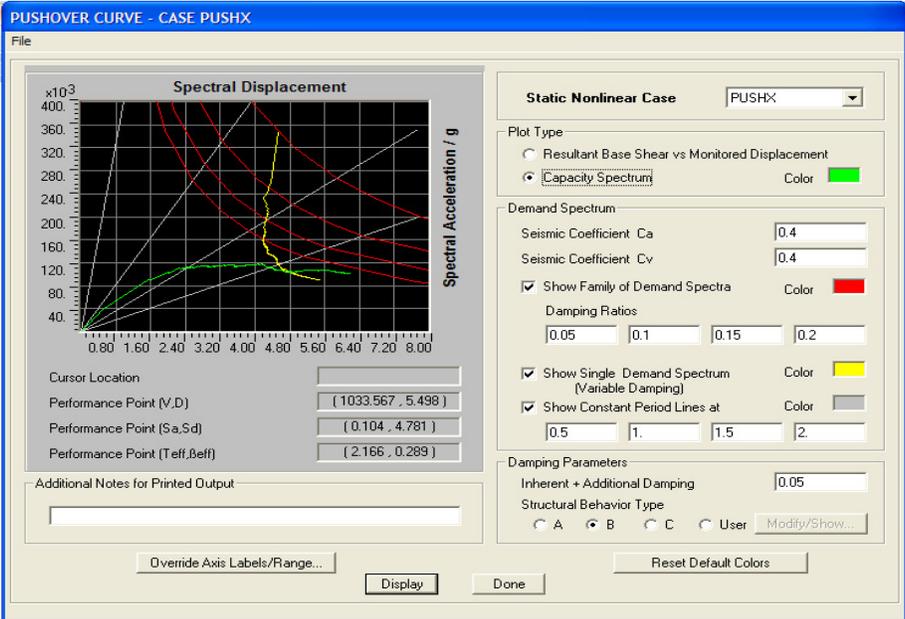
Figure 9. Pushover curve (top) and performance level (bottom) for seismic forces in X-direction

Figure 9 shows the load-deformation curve, or *pushover* curve as well as the *performance point*, the point at which the demand spectra and capacity spectra intersect each other and where it is

necessary to see the condition of the structure, and whether it is fulfilling the demand or not. The deformed shapes and state of the nonlinear hinges at the performance point show that the building will be heavily damaged during the maximum considered earthquake, but that it is not likely to collapse. While the beams and infill panels have been pushed far into the nonlinear range and have lost most of their strength, the columns suffer minimal damage. This is a desirable seismic mechanism. Therefore the building as a whole can be considered to attain the collapse prevention performance level, despite individual members exceeding the collapse prevention acceptance criteria in ASCE 41-06. The deformed shape for the frame at the front of the building is shown in Figure 10, with the deformed shapes for the remaining frames shown in Appendix C.

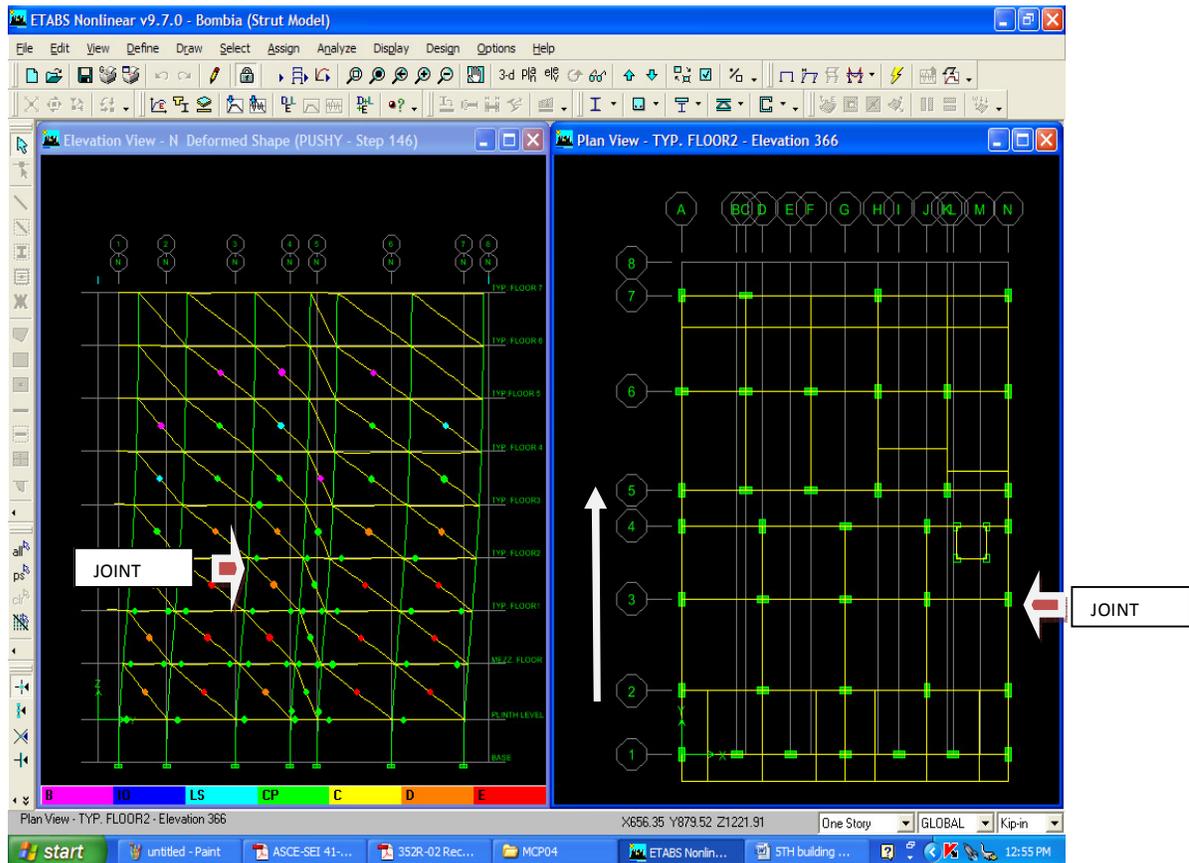
Figure 13. Location of the column joint

Joints have no reinforcing because although the column ties are closely spaced at the ends, they do not continue through the joint. In addition, the struts, columns, and beams are connected at the same node in the 3-D model. Therefore one critical joint was checked by hand using the American Concrete Institute (ACI) procedure outlined in ACI 352-02, such that the horizontal strut force is added to the shear force at the performance point and compared to the shear capacity of column, to see whether there will be a problem with the struts failing the columns or the joints failing in shear. The following equations from ACI 352-02 were applied to the joint shown in Figure 13, using the value of γ from ACI 352-02 Table 6-10, shown in Figure 14.

In all the cases above, the joint shear capacity at the ground, first to fourth, and fourth to roof columns (88.5 kips, 70 kips and 62 kips respectively) is less than the demand, so a joint retrofit would normally be recommended. However, because this is a residential building, joint retrofits would be highly disruptive and therefore impractical. Also, because the demand-capacity ratios for the joints are less than 2, it is unlikely that the joints would be damaged enough to cause the building to collapse. Because the building is being evaluated for the Maximum Considered Earthquake, collapse prevention performance is acceptable and retrofit of the joints is not required.
