Five Storey Residential Apartment Building Near Murree

A Case Study of Seismic Assessment

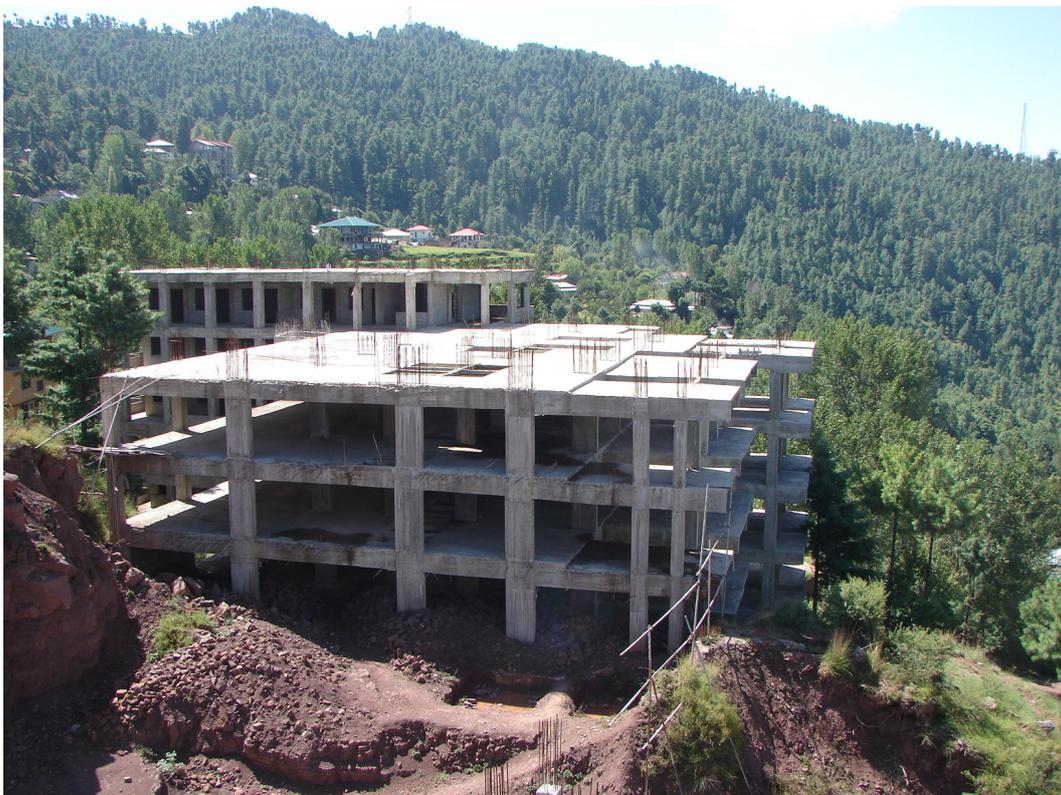
Figure 1. The building during construction

Figure 1 shows the five storey apartment building under construction (ground plus four). Car parking is located at the ground floor while the above floors are residential apartments. The building's overall dimensions are 81'-0" by 102'-0", and it is approximately 50 feet tall. The building has a reinforced concrete moment frame structural system with unreinforced concrete block infill walls. The concrete block infill walls are 9" thick. The foundations are reinforced concrete spread footings. The building is relatively new built therefore; no condition assessment or repairs are needed.

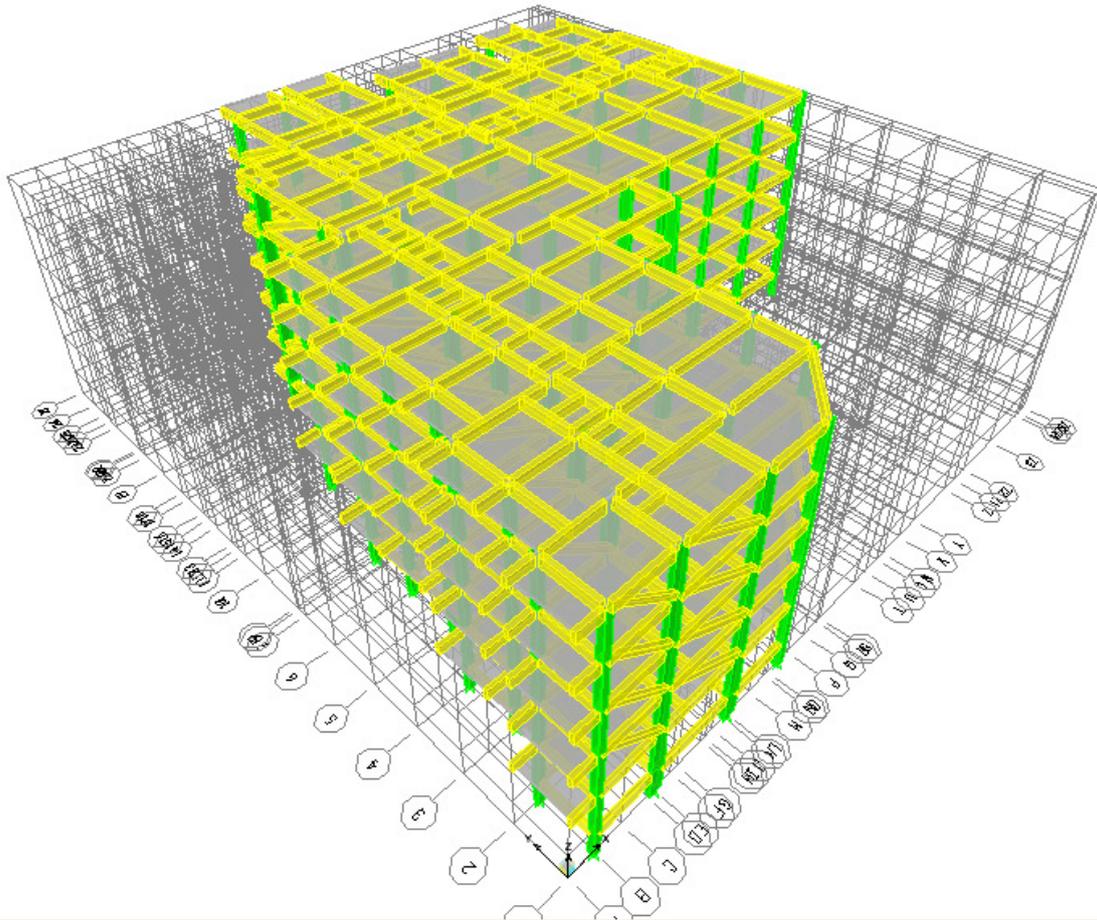
Figure 7. Rendering of linear ETABS model of the building

For Tier-2 Analysis, a linear static analysis was performed for the building in ETABS Nonlinear version 9.7.0. Figure 7 shows the developed 3-D model of the building. In the 3-D model of the building, the beams and columns were modeled with linear beam-column elements, and the infill walls were modeled with single linear compression struts. The results of the linear analysis showed that there were no columns with demand/capacity ratios (DCRs) greater than one, but showed two beams had DCRs higher than one due to combined shear and torsion effects. However, these two local failures will not affect building stability and the nearby beams, which are not overstressed, are able to support the slab and prevent it from collapsing. Therefore the building was accepted as adequately designed and no nonlinear static analysis was needed. Please see Appendix B for linear analysis results.
