# Five Storey Mixed Use Building in Karachi

## A Case Study of Seismic Assessment and Retrofit Design

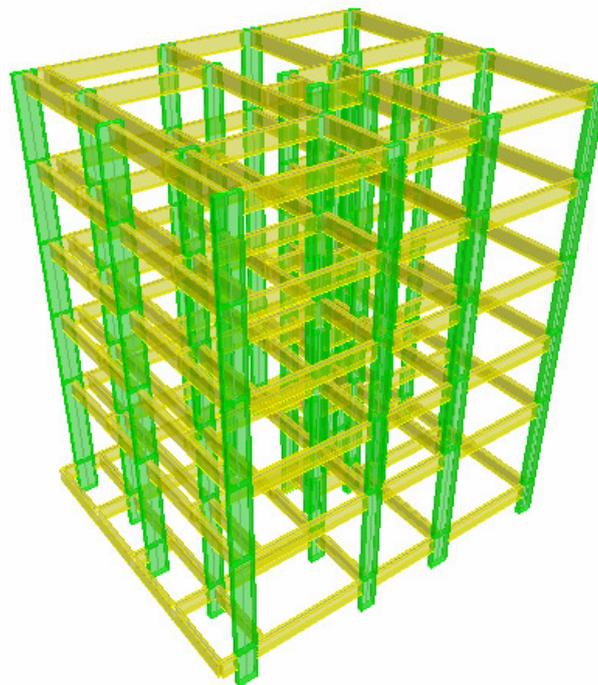
Figure 5. Rendering of linear ETABS model of the building

Figure 5 shows the 3-D model of the building generated in ETABS Nonlinear version 9.7.0. The beams and columns were modeled with linear beam-column elements, and the infill walls were modeled with single linear compression struts. The linear static analysis shows that there are a number of columns with demand/capacity ratios (DCRs) greater than one and greater than two, so the building is expected to respond in the nonlinear range. Please see Appendix B for linear analysis results.

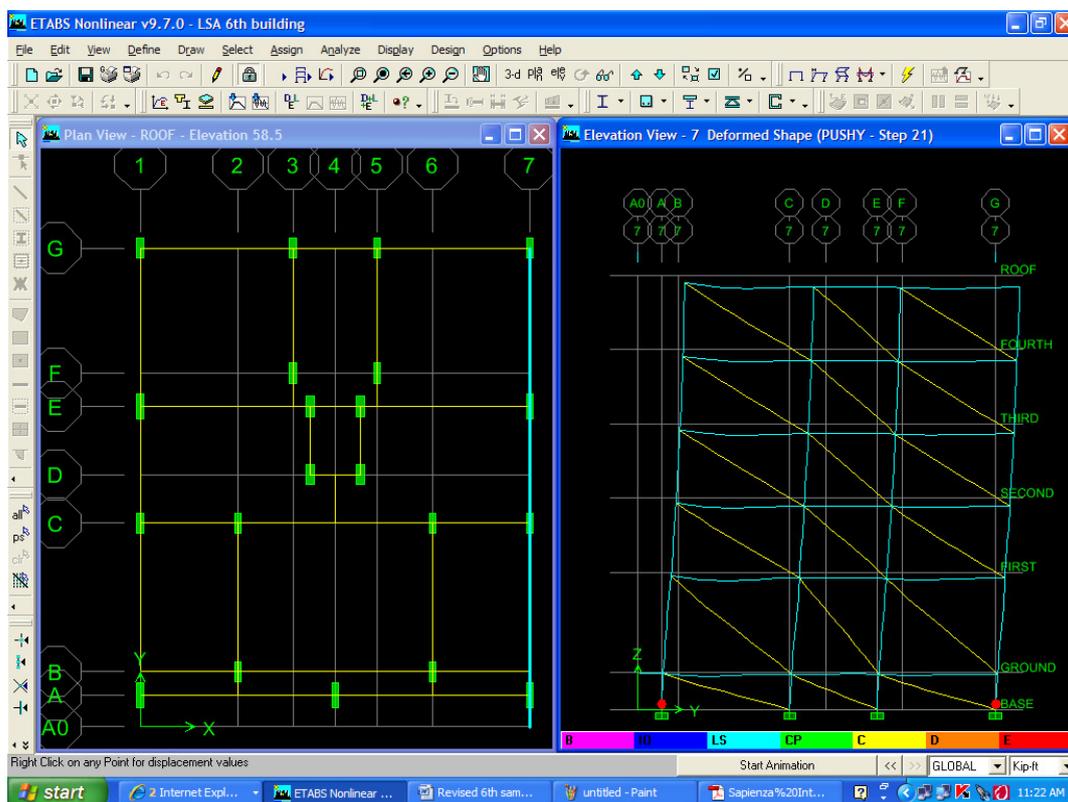
Figure 8. Hinge deformation vs. acceptance criteria

Figure 8 shows the state of the nonlinear hinges at the performance point for Y-direction analysis. Note the failure of the ground storey columns.

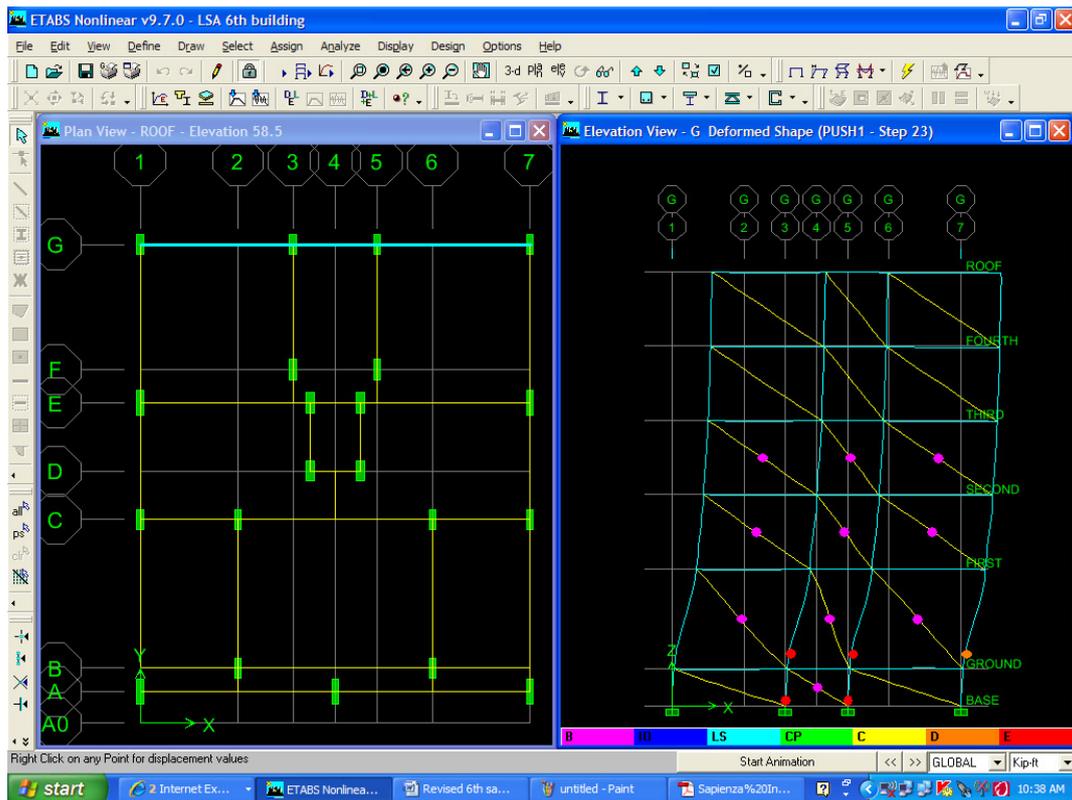
Figure 11. Hinge deformation vs. acceptance criteria for x-direction analysis

Figure 11 shows the state of the nonlinear hinges at the performance point. Columns at the ground storey and base have failed, and the building is forming a single-storey collapse mechanism at the ground storey. This shows that retrofitting is needed to achieve stability and to prevent collapse.
