10-Storey Office Building in Karachi

A Case Study of Seismic Assessment

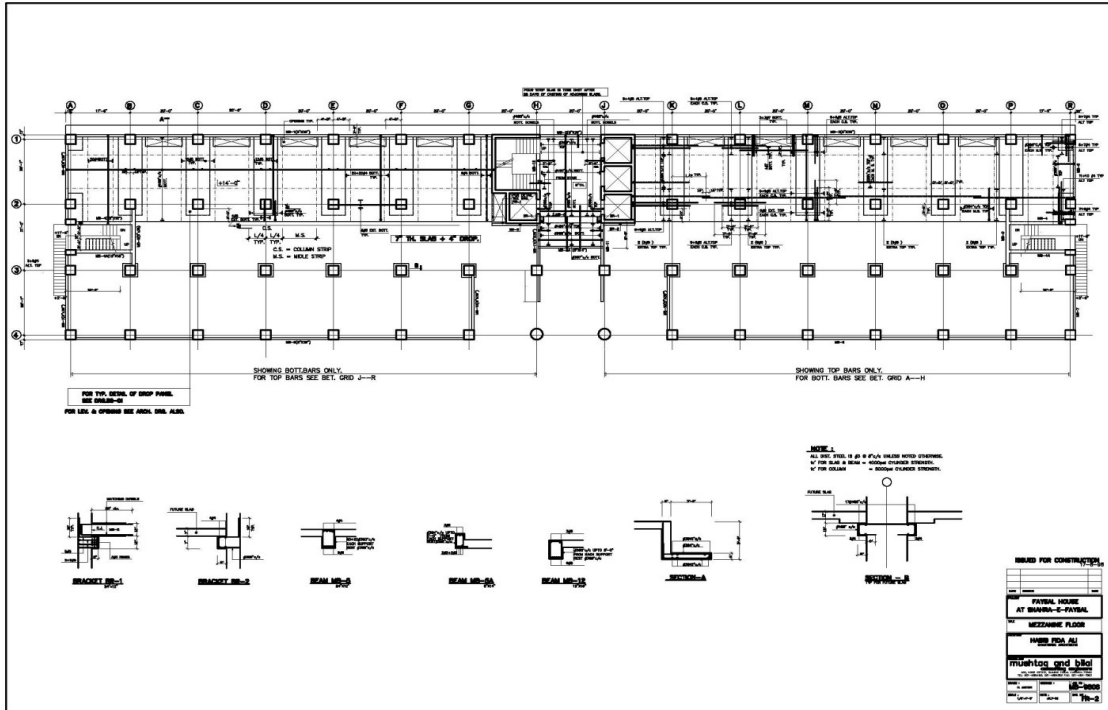
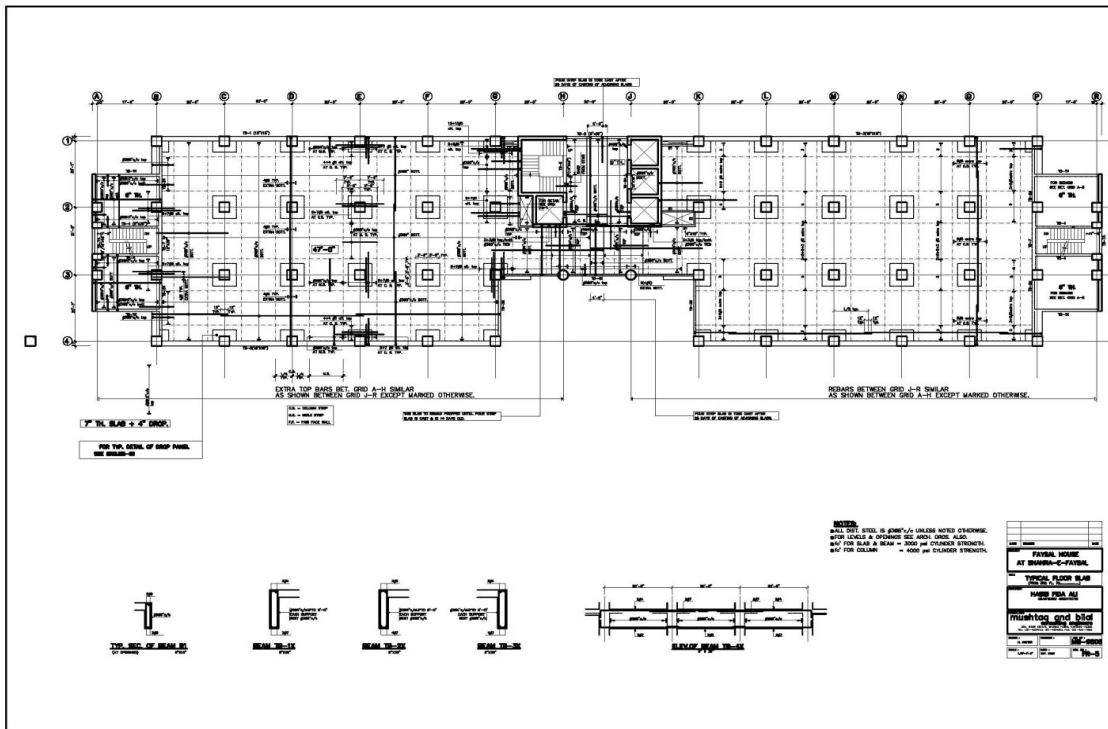
Figure 5. Structural framing plans: mezzanine (top) and typical floor (bottom)

3. According to the framing drawings, the bottom flexural bars in slabs are not passing through the columns and are extended up to the center of the column; however top reinforcement is passing through the column up to a length of $L/4$ on either side to avoid punching.

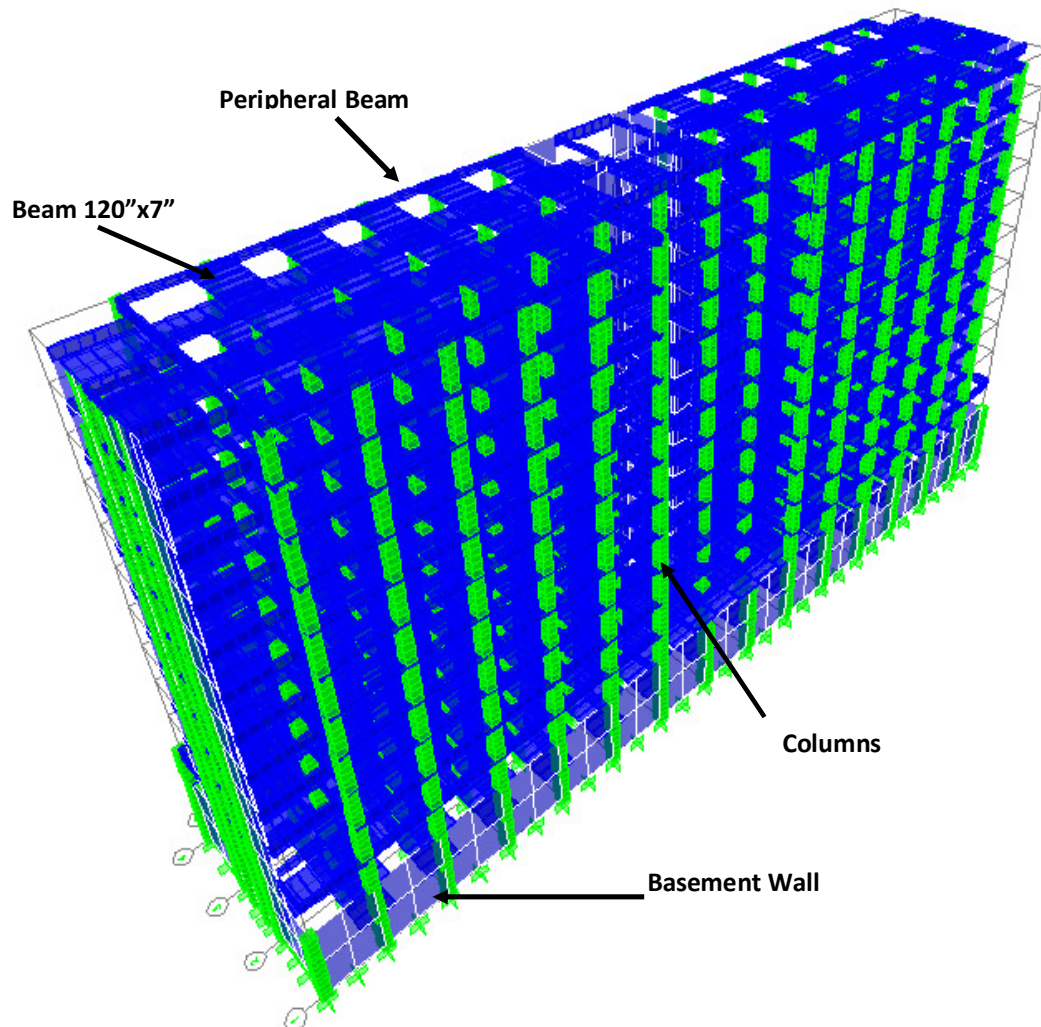
Figure 7. Rendering of linear ETABS model of the building

Figure 7 shows the 3-D model of the building generated in ETABS Nonlinear version 9.7.0. The peripheral beams and columns were modeled with linear beam-column elements, and the infill walls were modeled with single linear compression struts. The reinforced concrete walls were modeled as membrane area elements. The column strip approach was used to model typical floor beams (120"x7"). The 7 inch thick slab was modeled as membrane area element. An over strength factor (R) of 5.5 (for concrete building frame system having shear wall) was used for seismic analysis. The

analysis results show that there are a number of columns with demand/capacity ratios (DCRs) greater than one, so the building is expected to respond in the nonlinear range. Please see Appendix B for linear analysis results.

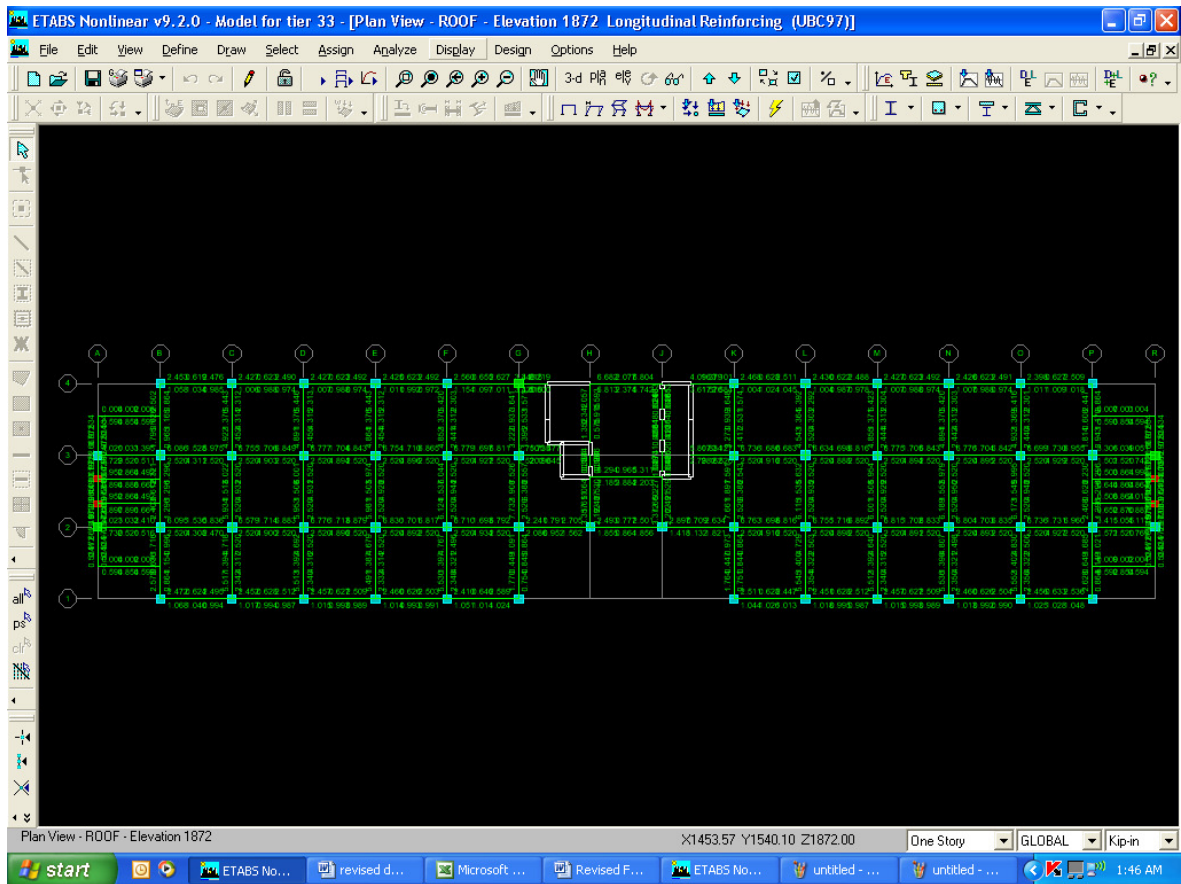
Demand/Capacity Ratios for Beams

Required Maximum reinforcement has been observed at @ Roof Level:

Required maximum reinforcement at top of beam = 6.682 in²

Required maximum reinforcement at bottom of beam = 5.813 in²

Provided reinforcement at support (4+4 #8) = 6.284 in²

Provided reinforcement at mid span (4+4 #8) = 6.284 in²

Demand capacity ratio at top of the beam = 6.682/6.284 = 1.0633 which is slightly greater than 1

Demand capacity ratio at bottom of the beam = 5.813/ 6.284 = 0.925 which is less than 1

6. Beams seem okay - demand capacity ratios are just over 1 at the roof.
7. Building seems okay except for columns at ends. The low level of nonlinear behavior means that there is unlikely to be a problem for building stability.

Maximum beam reinforcement is required at roof level as shown in the Plan View above.

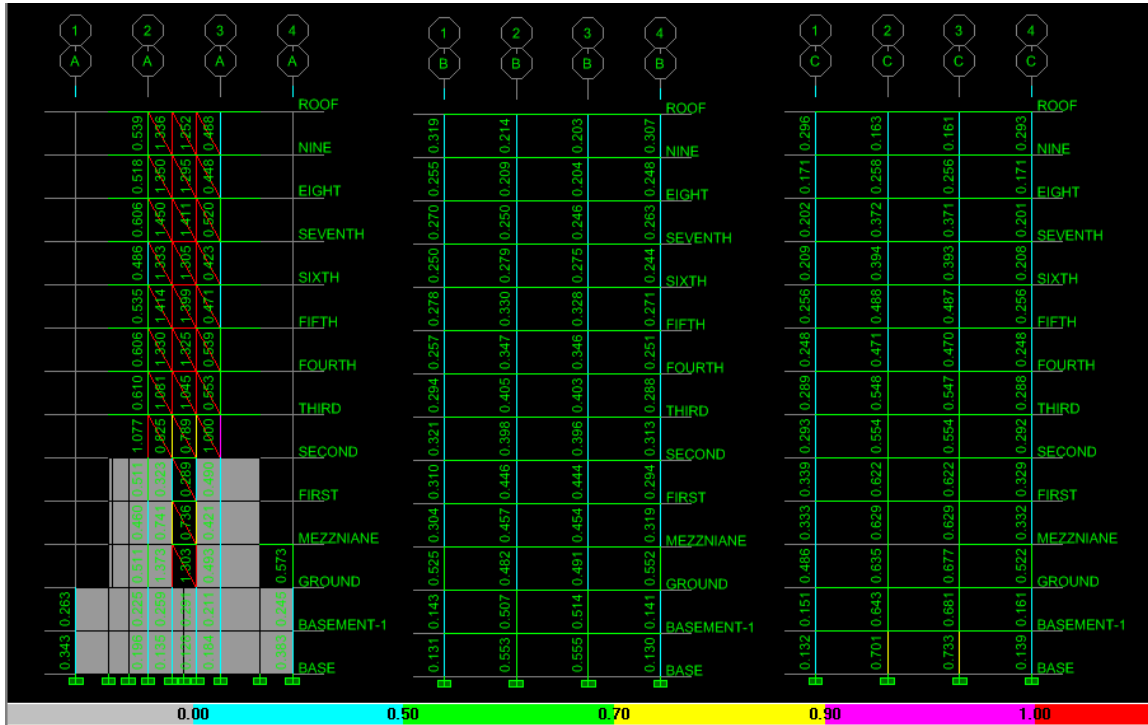
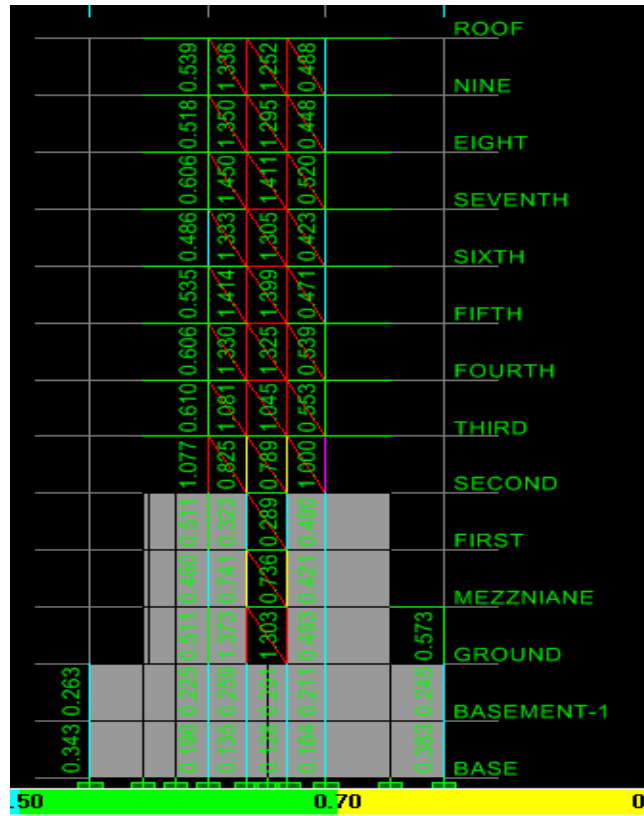
Demand/Capacity Ratios for columns at Grid-A,B and C

5. Demand capacity ratios are slightly greater than 1 for a small number of exterior columns at second floor level where a shear wall terminates. This shear wall extends from ground to below 2nd floor. Also many columns on grid A above the shear walls have DCRs greater than 1, but these columns are small. Most other columns are okay.

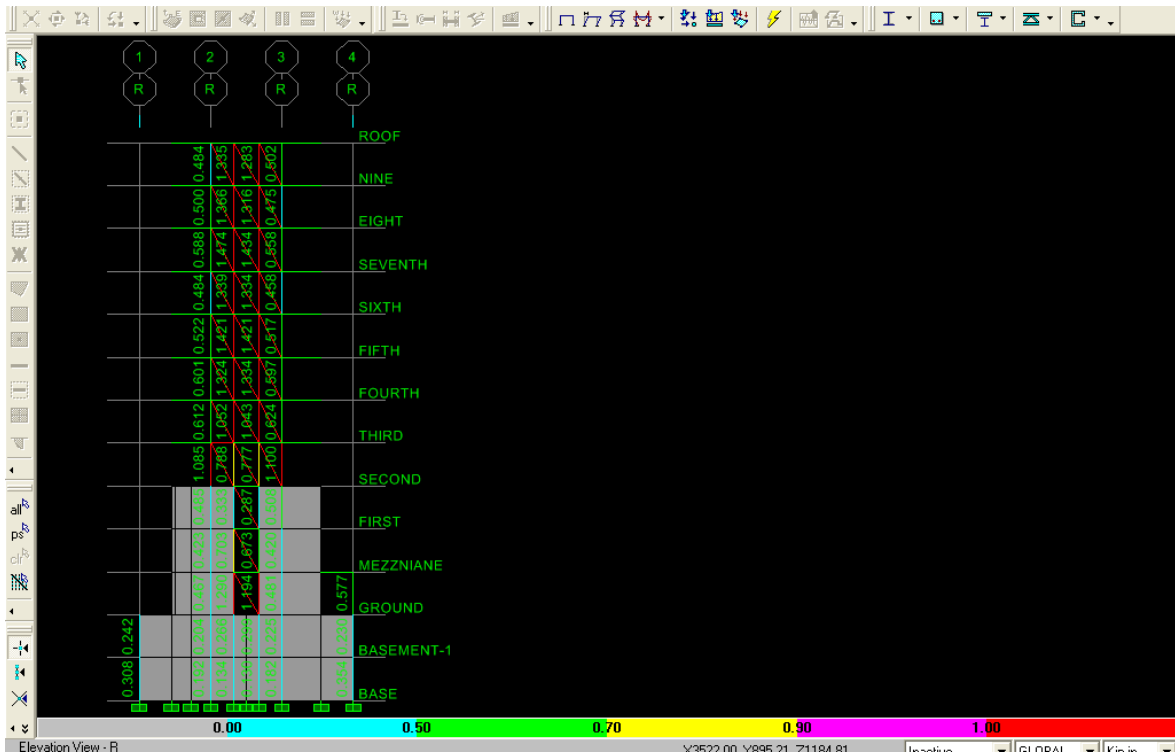
Demand/Capacity Ratios for Frame at Grid-R

4. According to linear static analysis of this sample building, all columns connected to slab directly have demand/capacity ratio (DCR) < 1 . Internal columns in the end framing bents have DCRs greater than 1, but they are connected to stairs and/or peripheral beams (please refer structural drawings) rather than the slab and have DCRs less than 2.

0.484	0.484
			0.500	1.335
			0.588	1.474
			0.484	1.339
			0.522	1.421
			0.601	1.324
			0.612	1.052
			1.085	0.788
			0.485	0.333
			0.423	0.703
			0.467	1.290
			0.287	1.194
			0.508	0.481
			0.420	0.577
			0.502

The damage to columns having $1 < \text{DCR} < 2$ will just be cosmetic and not affect the structural stability since there seems to be sufficient strength/stiffness in other bays to resist the seismic forces. But, some thought should be given to whether the column damage would be acceptable to building occupants. If it would not be acceptable, then some retrofit measures could be considered.
