Stone Masonry School in Abbottabad

A Case Study of Seismic Assessment and Retrofit

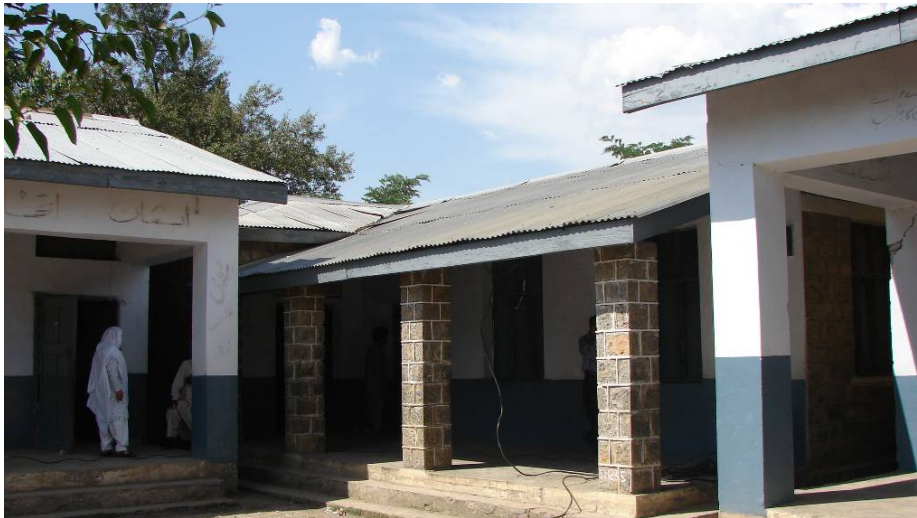
Figure 1. View of the case-study school building before retrofitting.

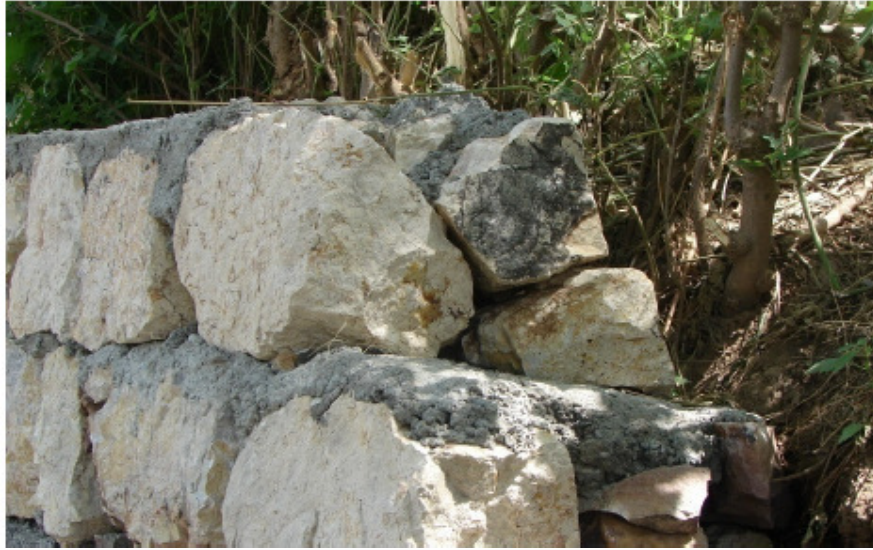
The structural system of the building consists of load bearing walls which have been constructed using double leaf random rubble stone masonry with a cavity in the middle. Figure 3 shows a wall of this type under construction. The cavity is filled with rubble stones blended with mortar. This mortar infill provides a connection between the inner and the outer layers of stonework. These walls provide a strong structural system to resist gravity loads but lack resistance to lateral loads as the walls are not well connected together at their ends or to the roof trusses and act as free standing walls. Because there is no reinforcing, the walls have very limited tensile capacity and fail in a brittle manner. As shown in Figure 1, the columns stand alone with no bracing either at roof level or at plinth level leaving them to behave independently of the other parts of the building.

Figure 3. Typical wall construction

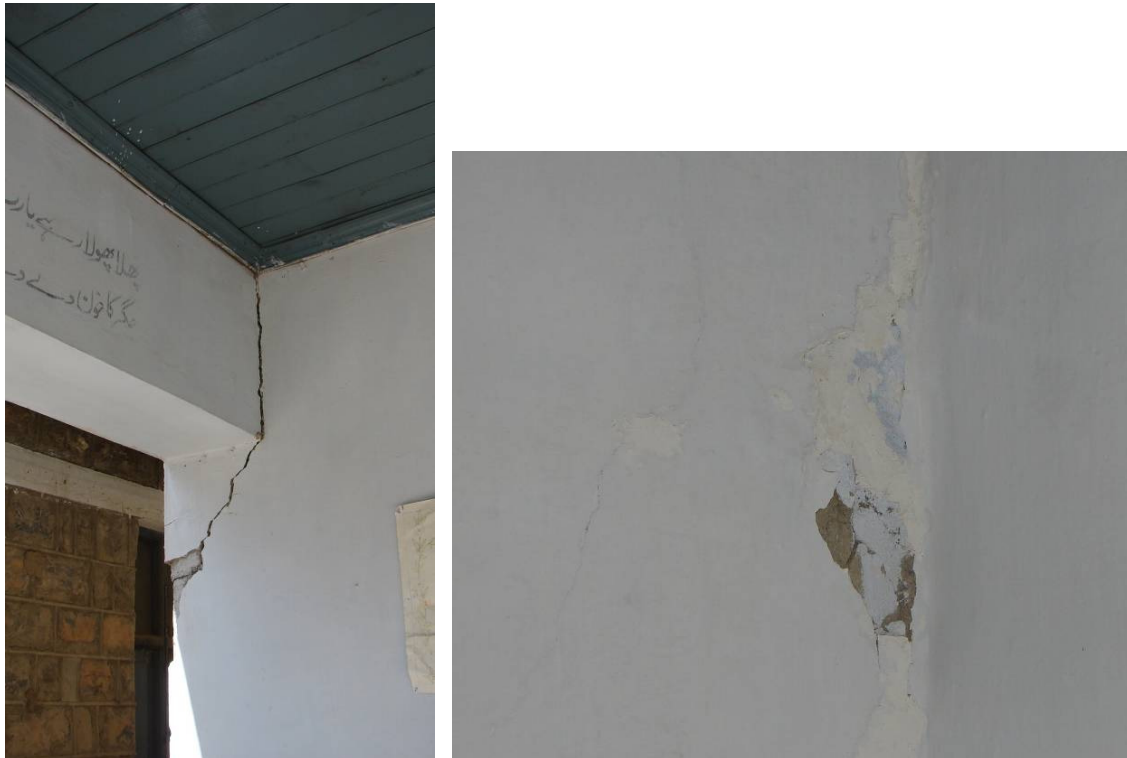
The vulnerability assessment exercise carried out by the team members for the schools in the region showed that no major earthquake damage was apparent in these buildings. The buildings were located some distance from the region of strongest shaking, as Figure 4 shows. However, mortar cracks were visible between stone blocks. Cracks were also visible at the corners of adjacent walls and door and window openings, as Figure 5 shows. These cracks are typical of this type of construction. In addition, the gable wall at a few locations failed out-of-plane near the roof line, as Figure 6 shows. Such failures are common in unreinforced masonry gable walls.

Figure 5. Typical cracks at openings (left) and wall junctions (right)

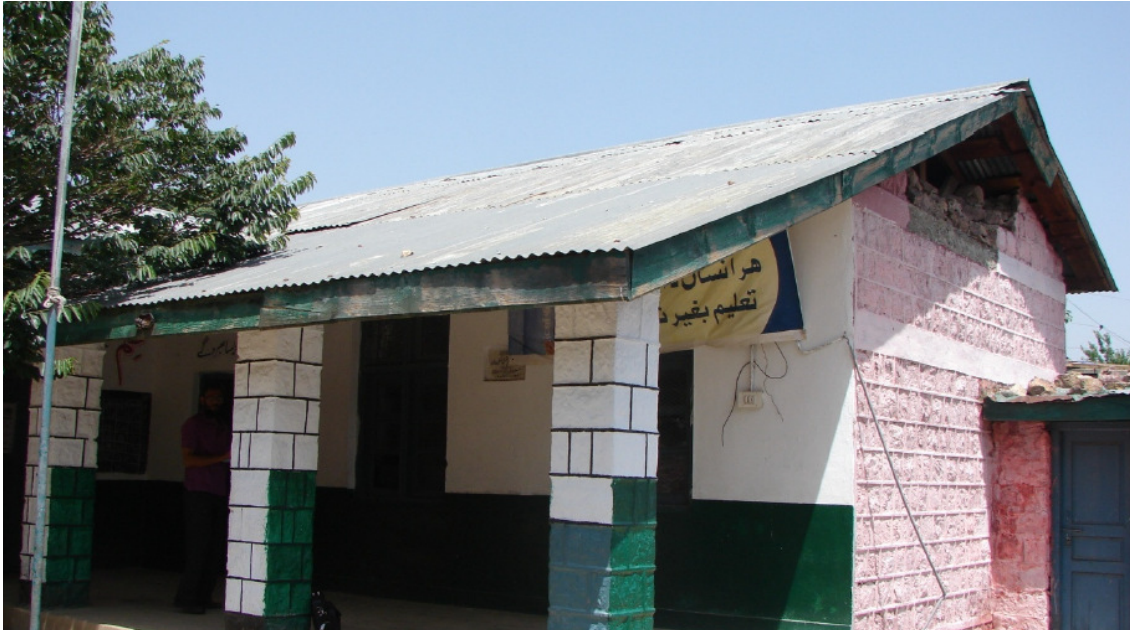
Figure 6. Out of plane failure of the gable wall in a school building
