# Four Storey Office Building in Muzaffarabad

A Case Study of Seismic Assessment and Retrofit Design

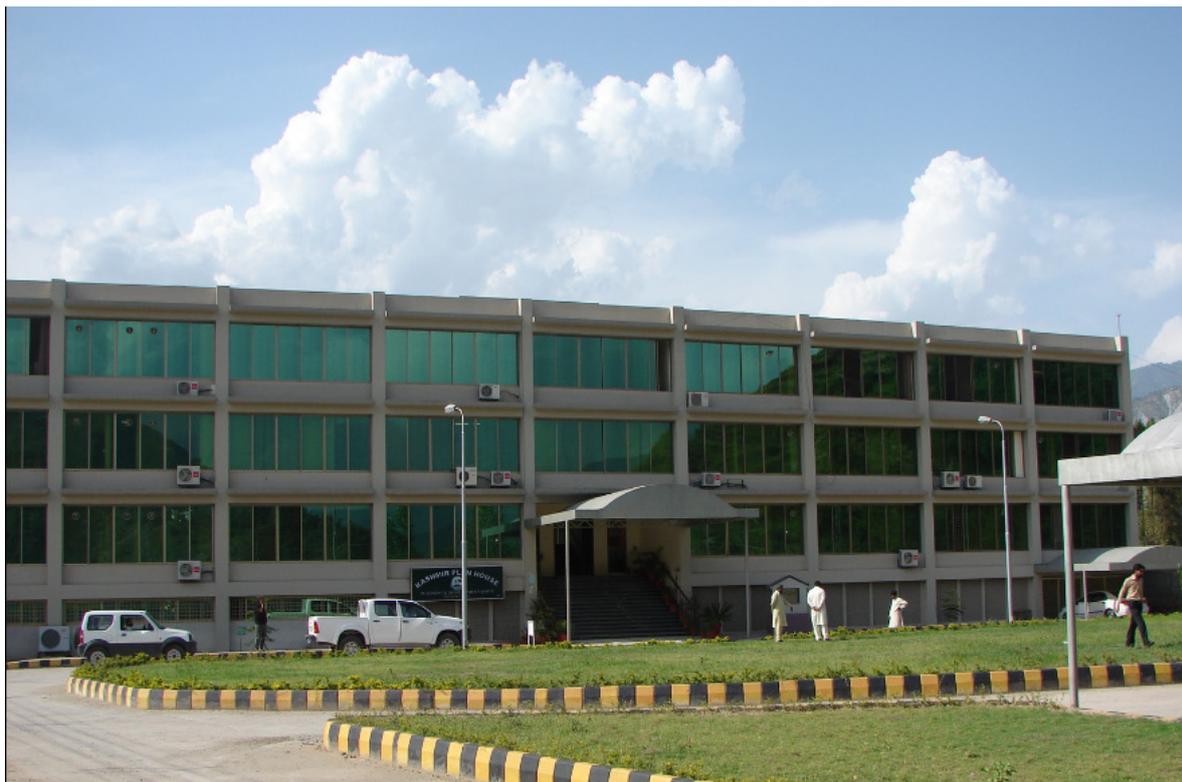
**Figure 1. Front elevation view**

The building, shown in Figure 1, is a four storey (ground plus three) office building with a basement. The building's overall dimensions are 176'-3" by 52'-6" and it is approximately 48 feet tall. The building has a reinforced concrete moment frame structural system with 8 inch thick concrete block infill walls, which are present only in the shorter direction. The building has no infill walls in the long direction. The foundation is a reinforced concrete raft foundation. The building is newly constructed and is in reasonably good condition. No condition assessments or repairs have been made.

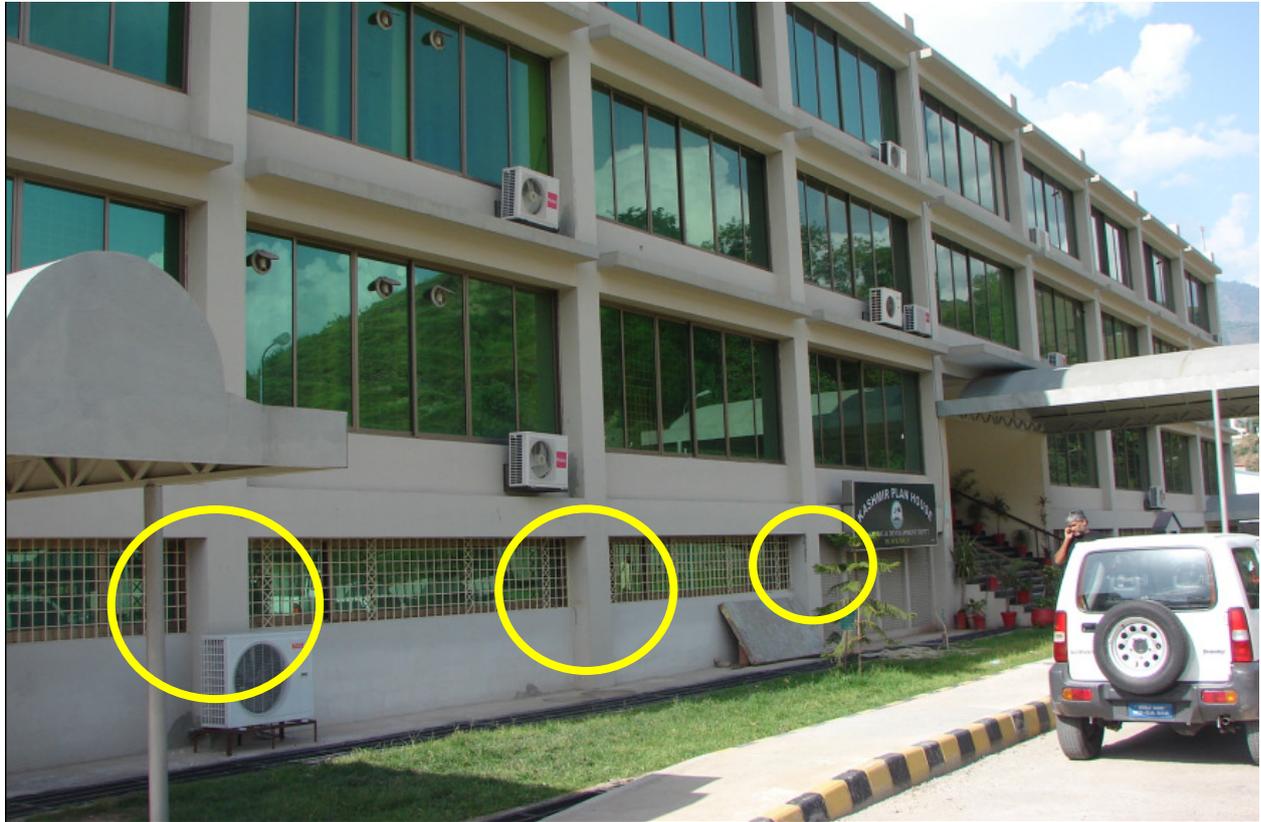
**Figure 12. Captive columns at ground storey**

The case study team assessed the building's potential seismic vulnerabilities using the US Federal Emergency Management Agency (FEMA) Pre-standard 310 Tier 1 Checklist modified for Pakistan conditions, as well as the American Society of Civil Engineers (ASCE) Standard 31 Tier 2 analyses and acceptance and modeling criteria from ASCE 41. The building was found to be adequately designed, but requiring removal of a small number of partial-height infill masonry walls that currently create a captive column condition at the ground storey on one side of the building.

As can be seen in Figure 12, there are captive columns in the bottom left corner of the front elevation of building. This is the only check that remained non-complaint after the Tier 2 analysis. Because the captive columns are created by partial-height masonry infill walls, conceptual solutions include creating a gap between the infill and column, which would be filled with elastomeric material, or replacing the infill walls with the same panels as used on the right side of the building, glazing, or a wire screen.

The case study team recommends that to eliminate the captive columns, the partition walls maybe replaced with a similar configuration used on the right side of the building or having glass windows installed as done in the above floors.

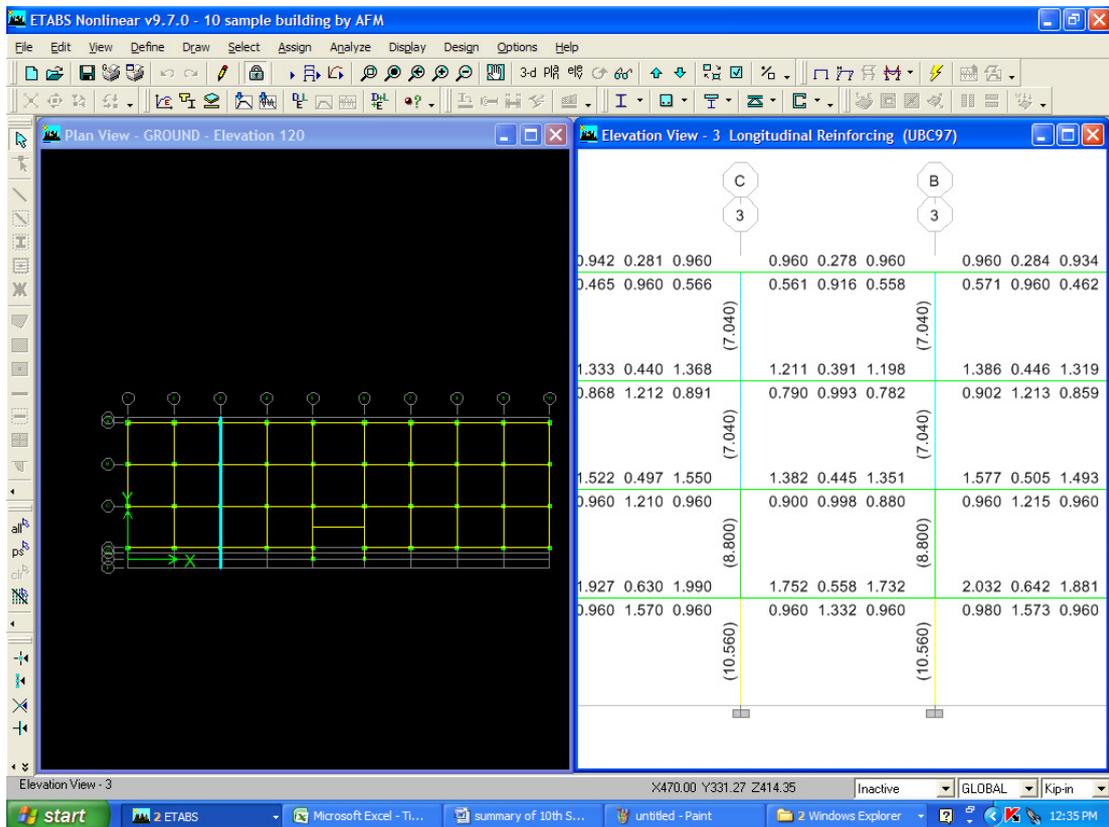
**Required Reinforcement in Beams**

Because ETABS does not automatically calculate demand/capacity ratios for beams from required reinforcement (ETABS performs this calculation for columns), demand/capacity ratios were determined by hand calculations as shown below. Beam demand capacity ratios were less than 1.
