# Four Storey Academic Building in Karachi

## A Case Study of Seismic Assessment

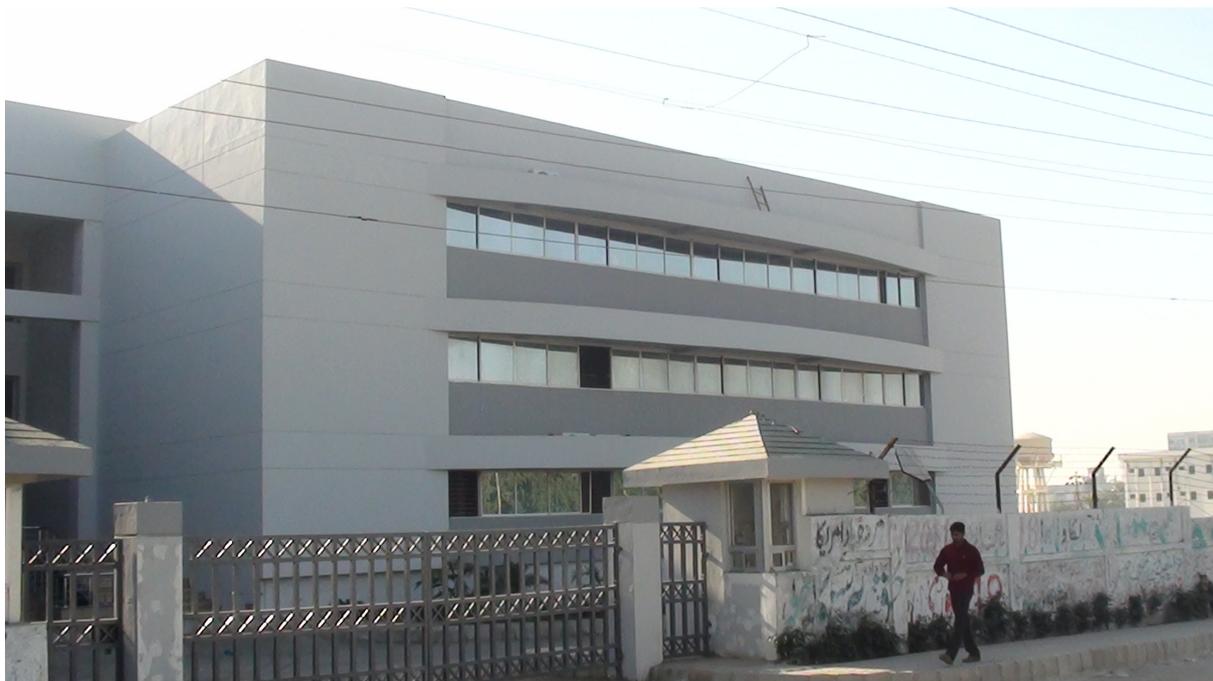
**Figure 1. Front elevation view of the building**

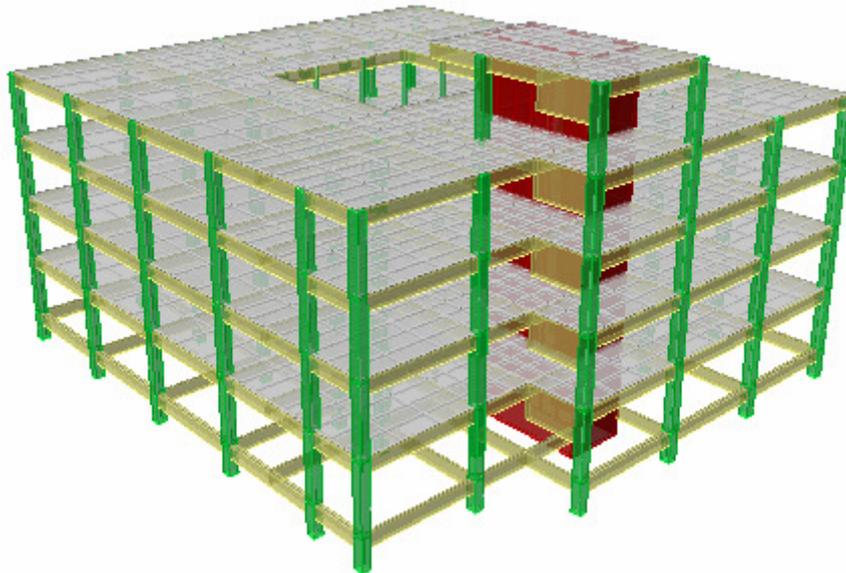
Figure 14. Rendering of linear ETABS model of the building

There is a torsion irregularity at ground, first and second floor levels.

The first storey is the only one which is slightly exceeding the allowable limit.

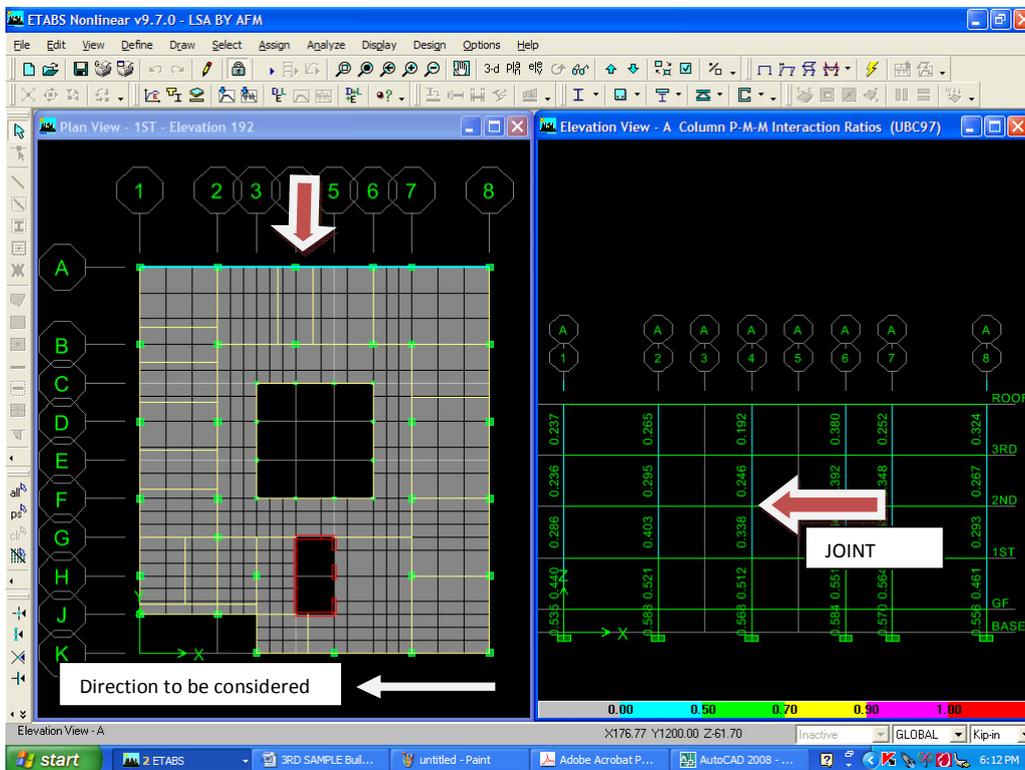
The case study team checked the demand/capacity ratios for floor and plinth beams by hand, and also checked the joint shear capacity with hand calculations based on the methods American Concrete Institute (ACI) Standard 352-02. The check of shear demand versus capacity at critical joints shows that the joints have adequate strength.

Figure 15. Joint checked for shear by hand calculation

**So joint shear strength is greater than the demand, and there is no need to retrofit the joint.**
