6-Storey Mixed Use Building in Karachi

A Case Study of Seismic Assessment and Retrofit Design

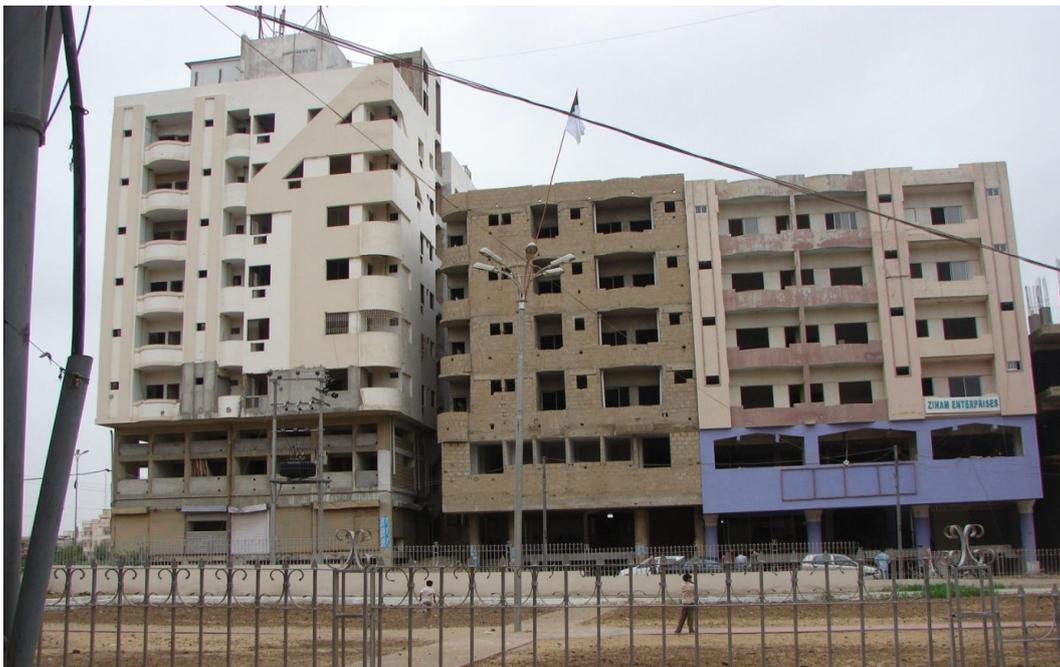
Figure 1. Front view of the building (building in the middle) during construction and its neighbours

Figure 1 shows the case study building (middle building). The building is a six storey (ground and mezzanine plus four typical floors with a basement) mixed use apartment building with shops at the ground and mezzanine floors. The building's overall dimensions 40' wide by 68' long and it is approximately 53 feet tall. The building has a reinforced concrete moment frame structural system with unreinforced concrete block infill walls and an eccentrically located reinforced concrete core. The concrete block infill walls are 6 inch thick. The foundations are reinforced concrete spread footings. The building is recently constructed and no condition assessments have been made.

The retrofitted columns located on grid-8 will have eccentric section, as there is hardly any space on one side of the buildings due to an adjacent building as shown in Figure 1. However, in the retrofitted 3-D non linear analysis model, the sections have been taken as concentric. This may result in some additional forces in the columns, but the overall strength is quite high as can be seen in Figure 15, as hinges have yet to be formed in the retrofitted columns.

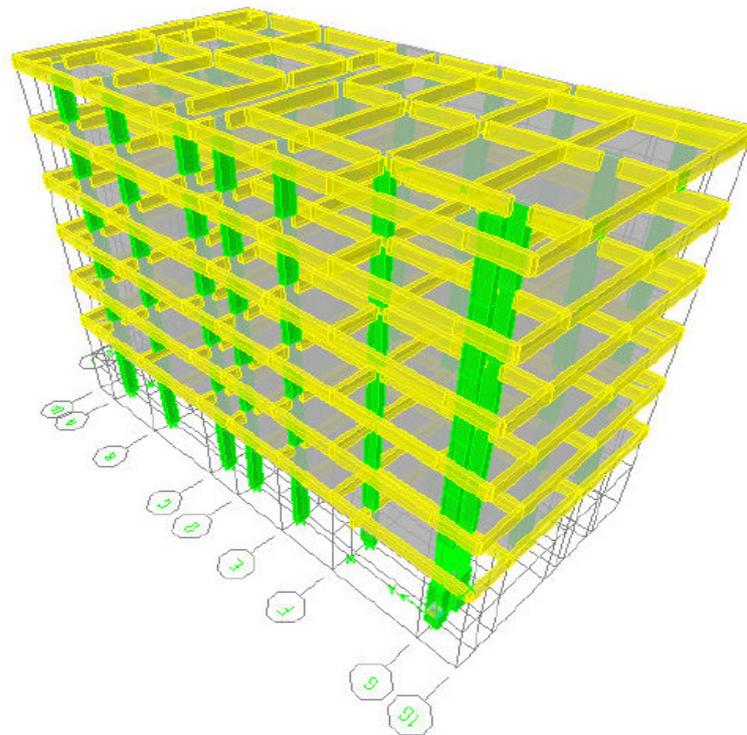
Figure 8. 3-D finite element model in ETABS

Figure 8 shows the 3-D model of the building generated in ETABS Nonlinear version 9.7.0. The beams and columns were modeled with linear beam-column elements, and the infill walls were modeled with single linear compression struts. The linear static analysis shows that there are a number of columns with demand/capacity ratios (DCRs) greater than one and so the building is expected to respond in the nonlinear range. Please see Appendix B for linear analysis and Appendix C for nonlinear analysis results for the existing building.

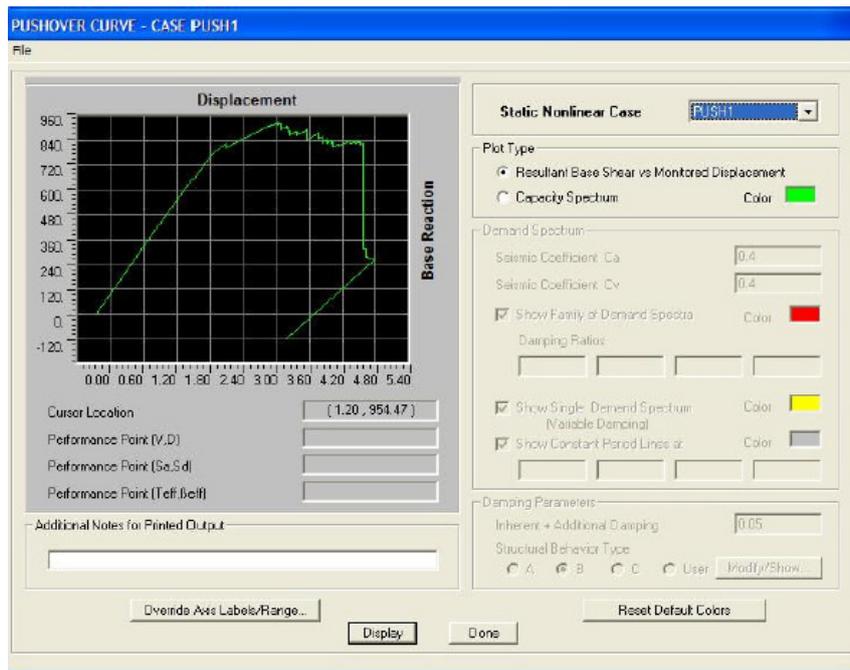
Figure 10. Pushover curve for Seismic forces in X-direction

Figure 10 shows the load-deformation curve, or *pushover* curve, and Figure 11 shows the pushover curve converted into a capacity spectrum and compared with the estimated demand using the capacity spectrum method. This figure shows the performance level where the demand and capacity spectra intersect each other, at the point called the *performance point* where it is necessary to see the condition of the structure, and whether it is fulfilling the demand or not.

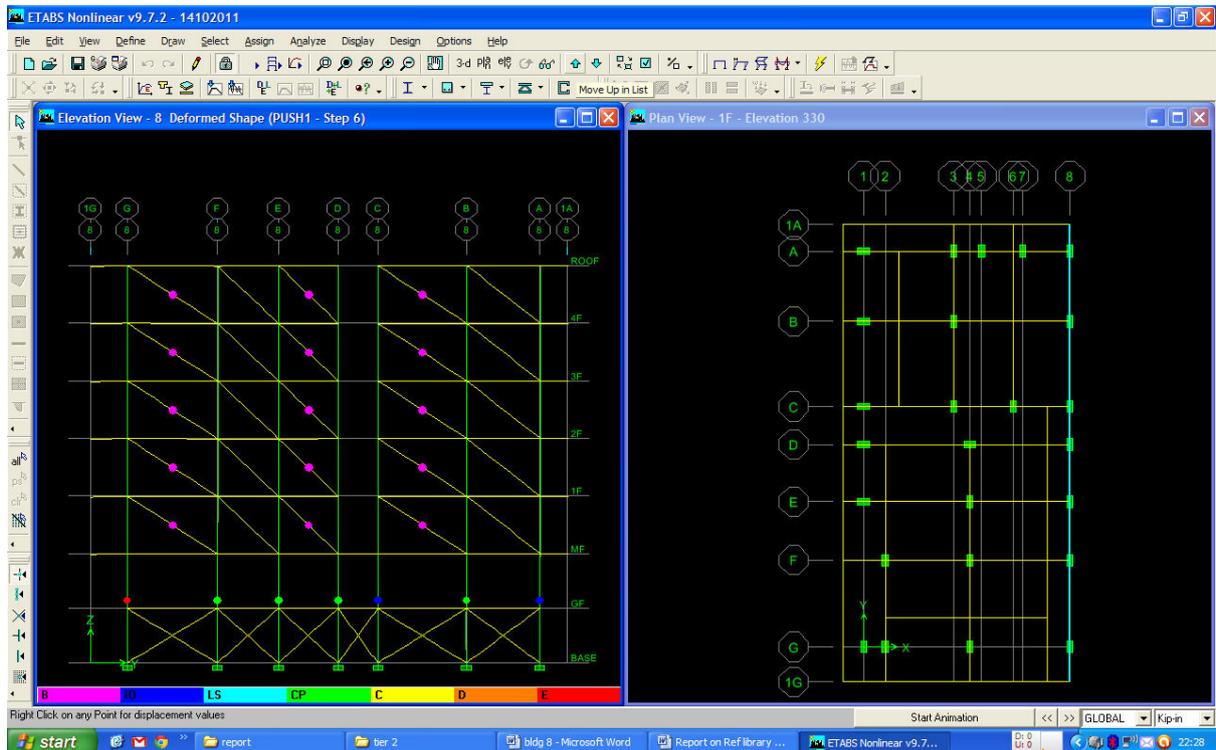
Figure 12. Hinge deformation vs. acceptance criteria

The results of the non linear analysis shown in Figure 12 and Appendix C show the state of the nonlinear hinges at the performance point. These results confirm that retrofitting is needed to achieve stability and to prevent failure at the acceptance level.

Figure 12 shows the state of the nonlinear hinges at the performance point for X-direction analysis. Note the column hinges in the weak ground storey.

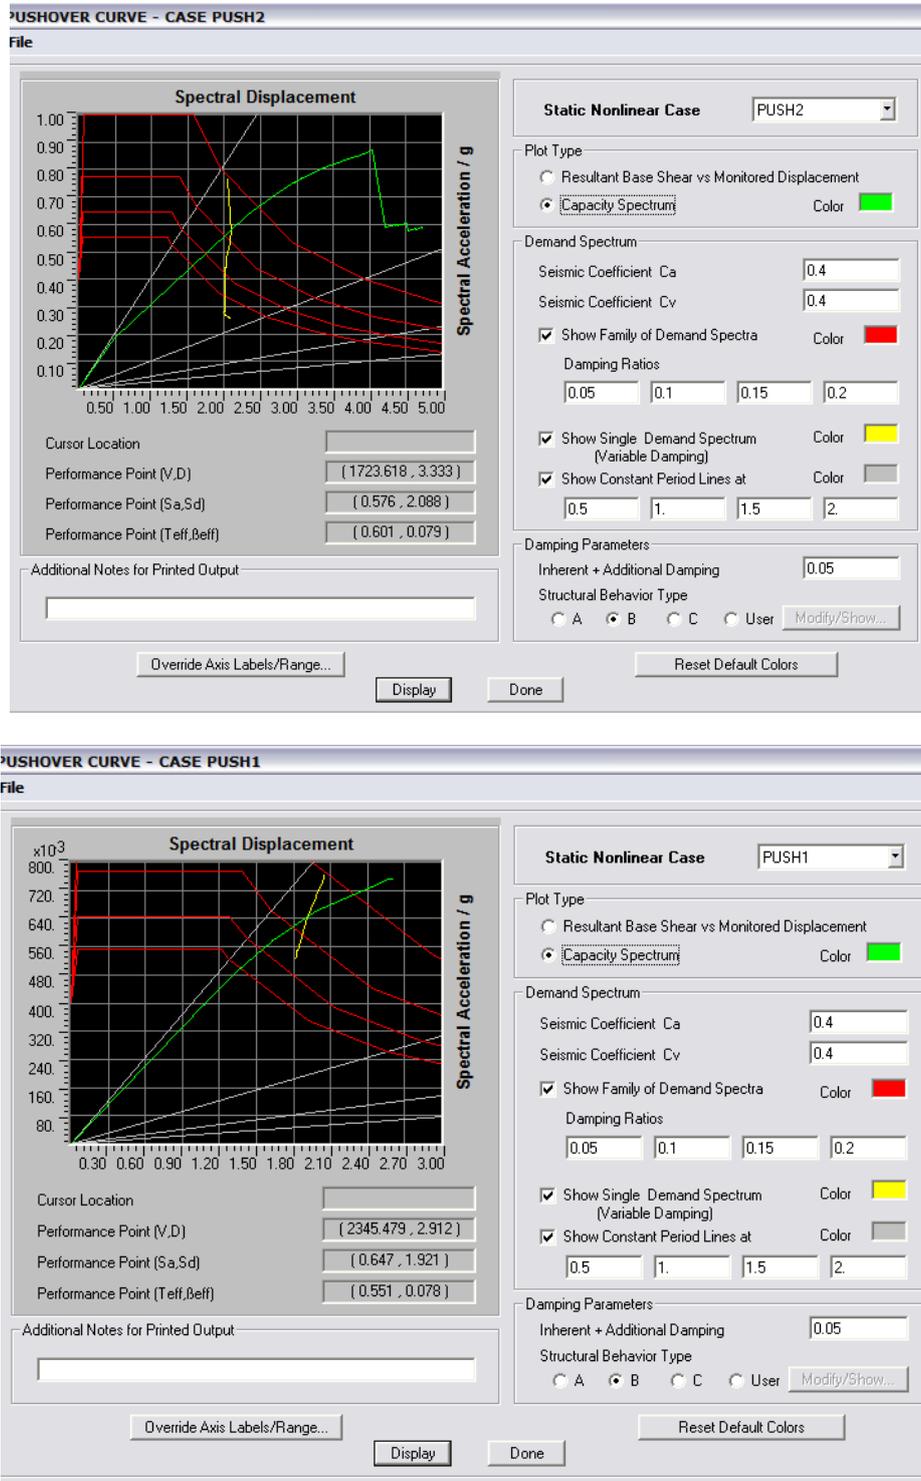
Figure 14. Performance level for the retrofitted building – Y-direction (top) X-direction (bottom)

The retrofit scheme was modeled by taking the same 3-D nonlinear model used for the existing building, but increasing the column size and adding RCC infill walls modeled with single strut members. Figure 14 shows the pushover curve and capacity curve for the retrofitted building.

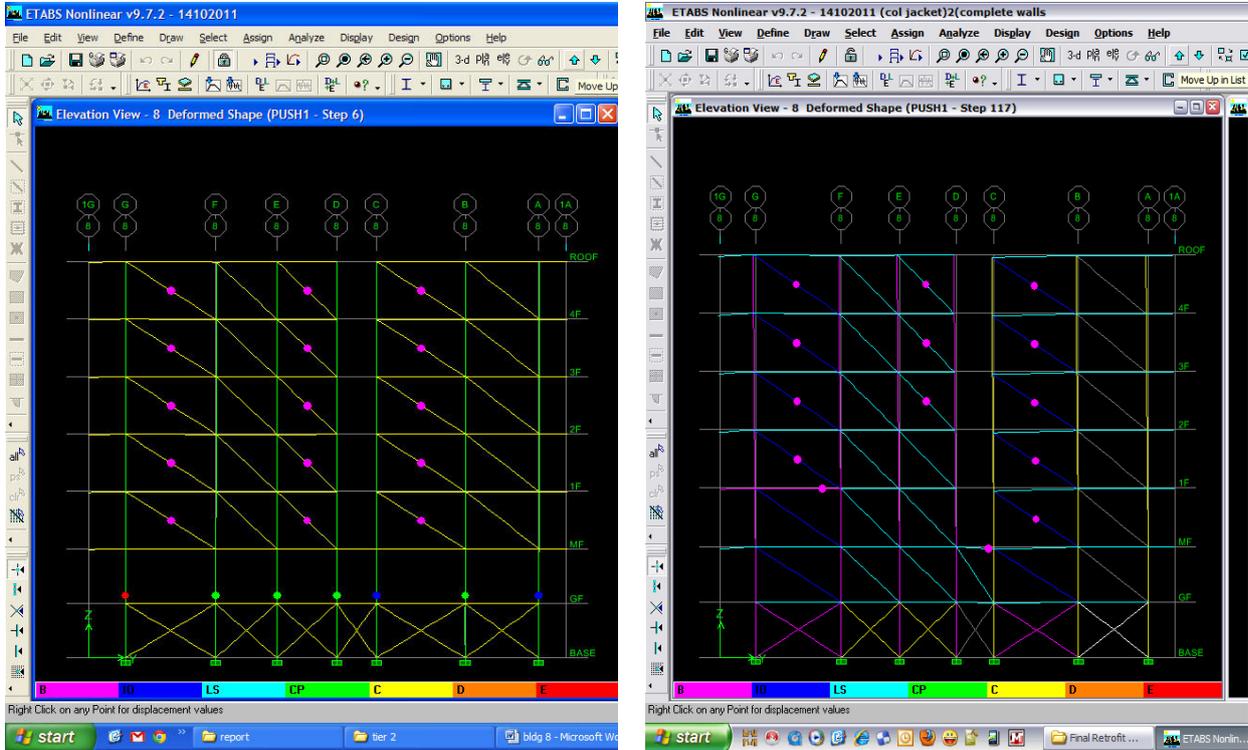
Figure 15. Hinge deformation vs. acceptance criteria (grid-8) before retrofit (left) after retrofit (right)

Figure 15 shows a comparison of the state of the building's plastic hinges for one of the frames both before and after retrofit. It is clear that the retrofit greatly improves the performance and prevents the ground storey columns from hinging. Figures showing the deformed shapes of the remaining frames and the status of the plastic hinges for the retrofitted building are given in Appendix D of this report.
