**PRELIMINARY REPORT ON
OBSERVATIONS FROM 16 APRIL
2013 IRAN EARTHQUAKE
(PAKISTAN SIDE)**

**NED University of Engineering and Technology,
Karachi, Pakistan**

INTRODUCTION

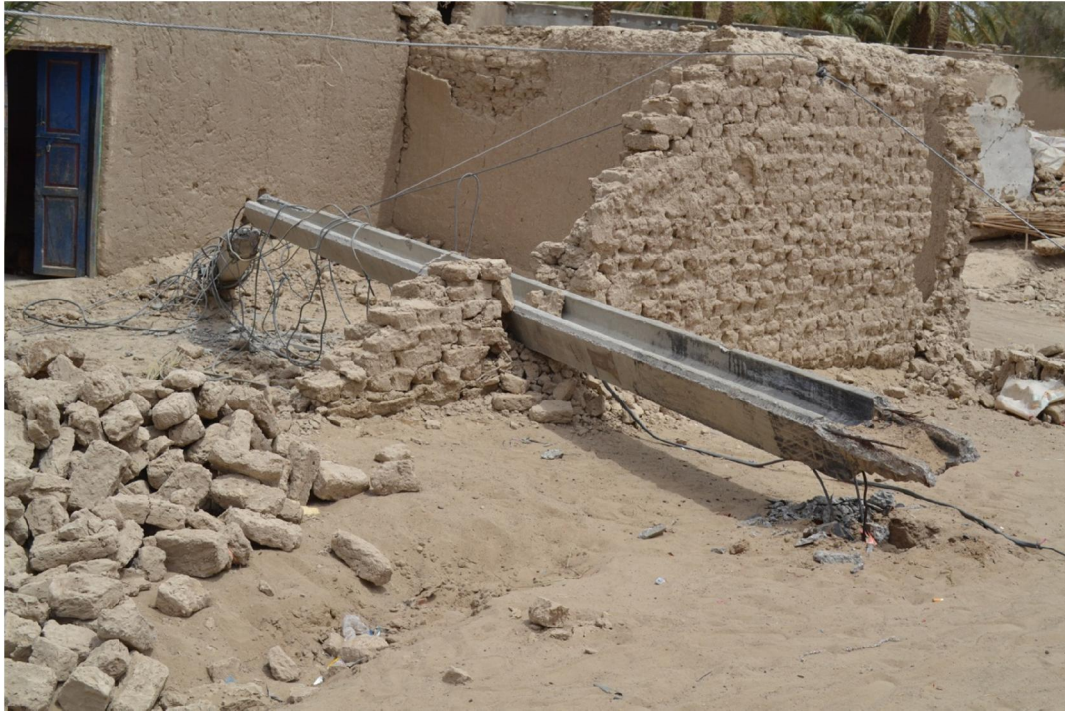
The infrastructure facilities in the area consist of electric poles and sewerage lines. Ground wells are the major source of water supply and the roads are non-existent in the region. Insignificant damage was observed to any of these infrastructure facilities in the affected areas. Except West Zawag, no damage to electric poles was observed (Fig. 2). All poles were, however, damaged in West Zawag (Fig. 4). The wells were also functional in the area. Similarly, telecommunication infrastructure was also intact and the mobile phones were functioning satisfactorily.

Fig. 4 Broken electricity poles in West Zawag

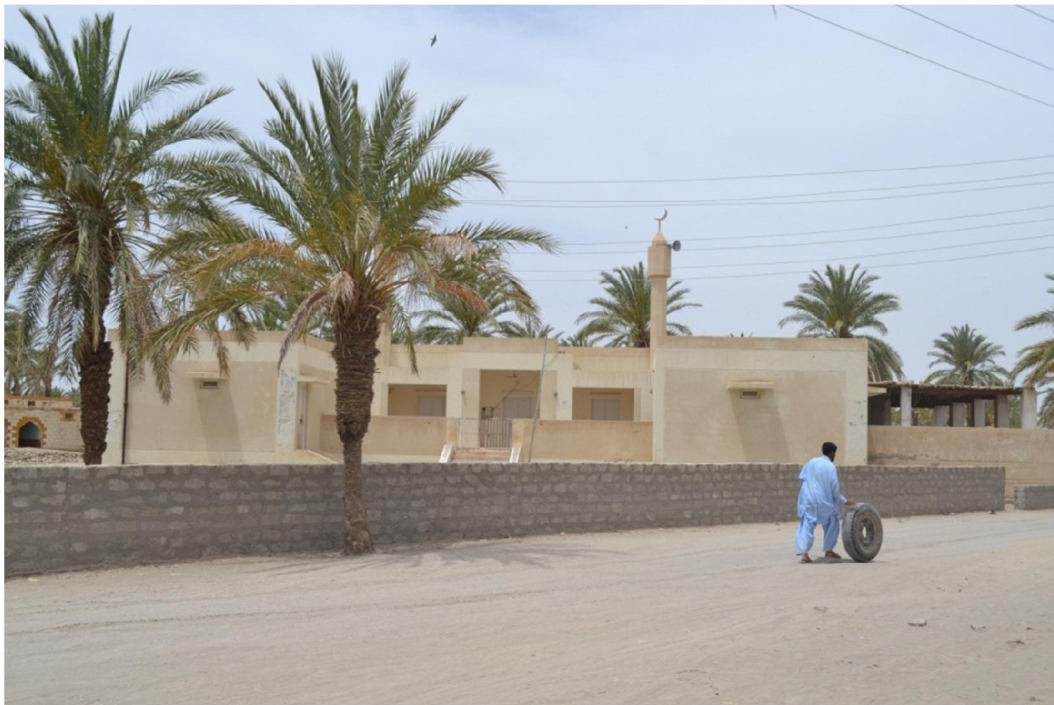
In respect of material types, RC buildings performed well and were undamaged (Fig. 5). Minor damage to block masonry houses was observed in the Mashkel city area (Fig. 6). The adobe buildings performed poorly, as can be expected and suffered huge losses (Figs. 7 and 8). According to some of the reports (these are not verified by the team) nearly 45,000 people were affected in Mashkel out of a total population of 48,000 whereas 5,470 houses were damaged.

Fig. 5 View of a RC structure of a mosque in West Zawag

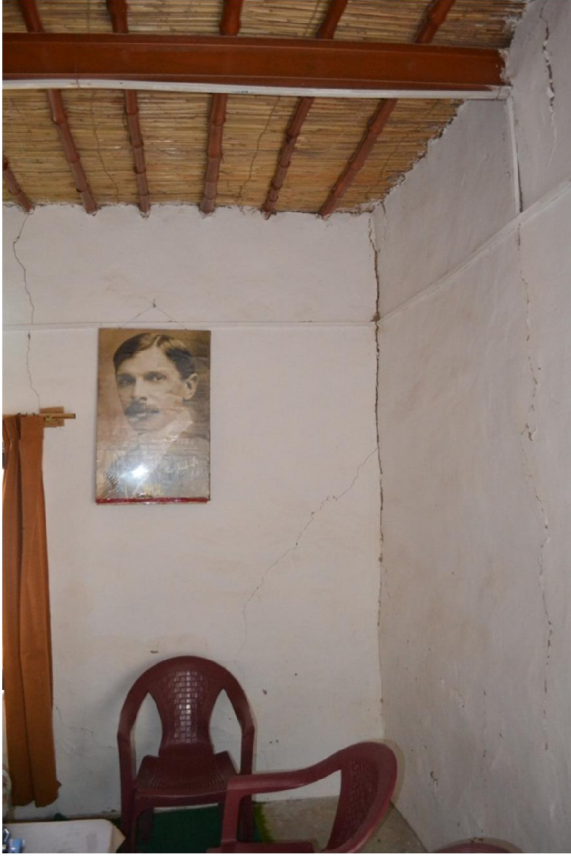
Fig. 6 Cracking in block masonry building in FC Headquarter

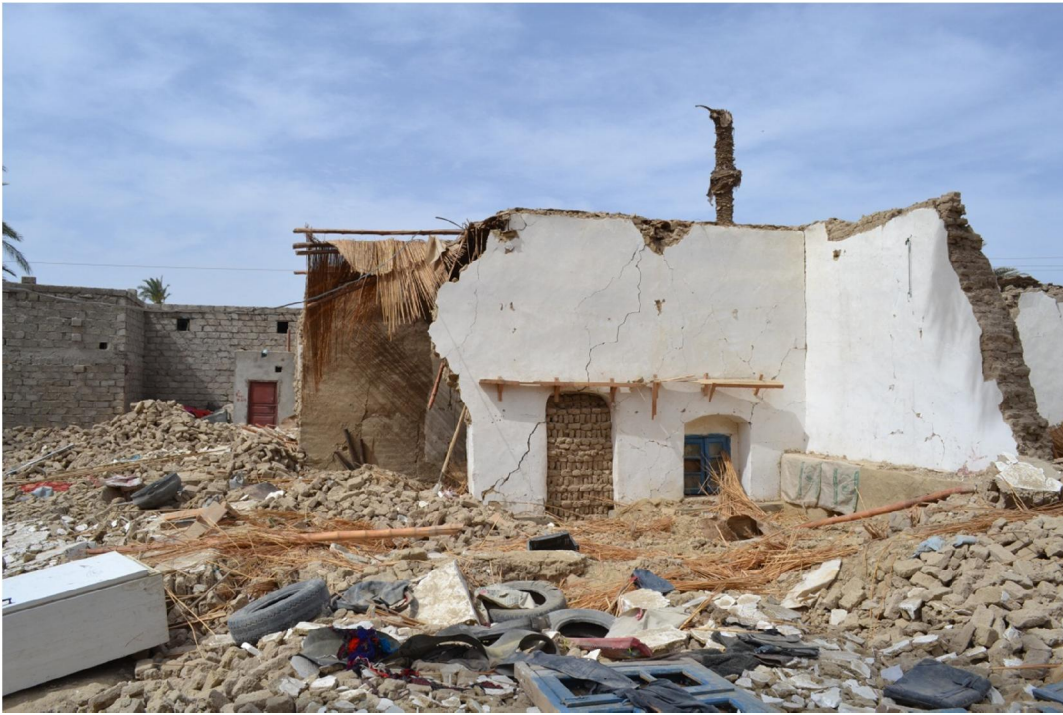
Fig. 7 Damaged adobe buildings in East Zawag

In respect of surveyed area, East and West Zawag suffered the maximum damage and most of the adobe buildings collapsed in these parts (Figs. 7 and 8). A historical adobe castle in the FC Headquarter was also heavily damaged (Fig. 9). Building damages in the kilis varied. Most of the building damages were noted in Kili Kallag. These damages include from cracking in the wall to the complete building collapse (Figs. 10 and 11). Minor damages were observed in the rest of the kilis (Fig. 12).

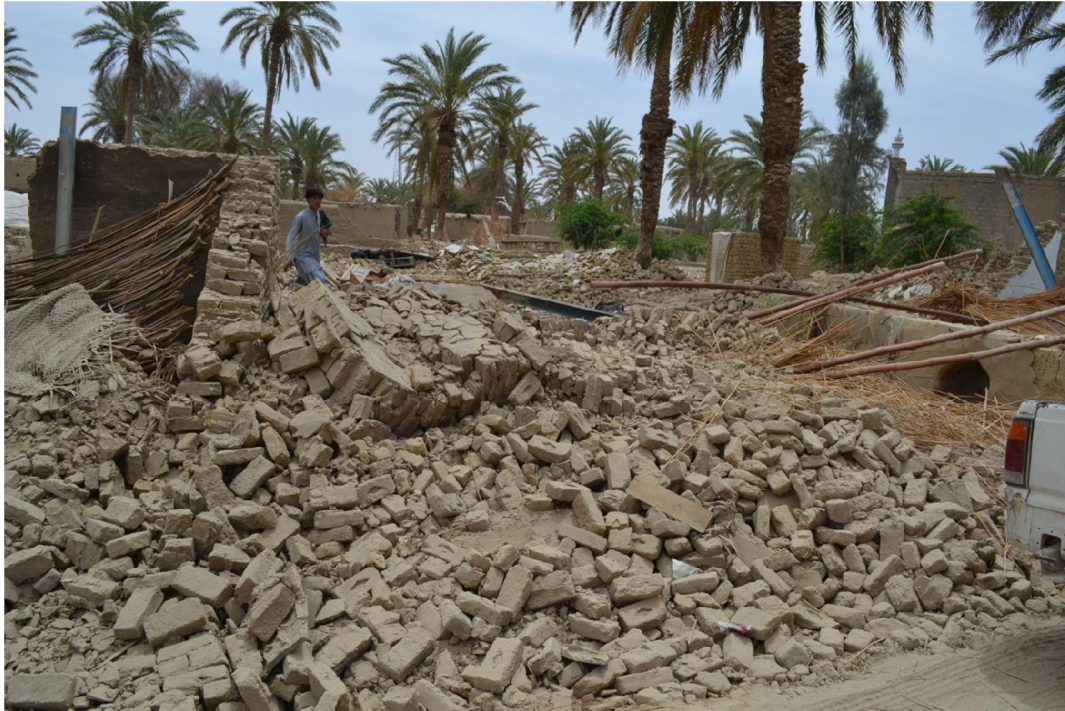
Fig. 8 View of damages in West Zawag

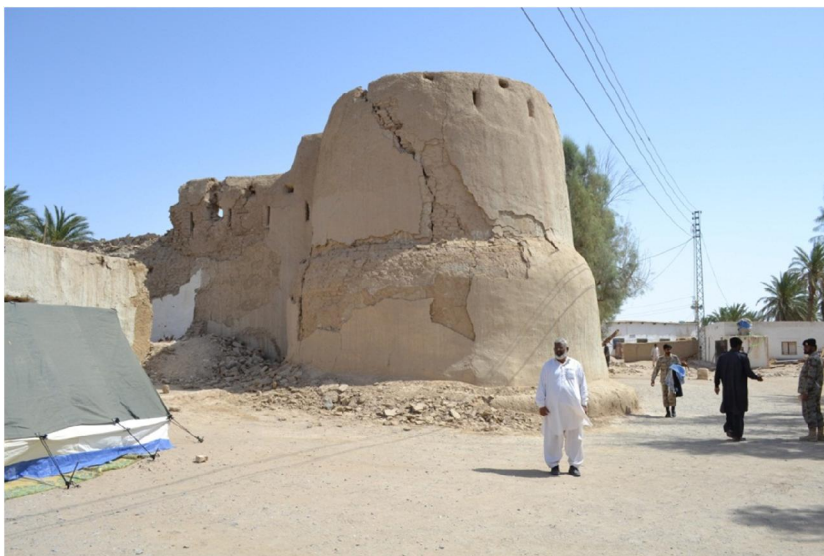
Fig. 9 View of damaged castle in FC Headquarter in Mashkel

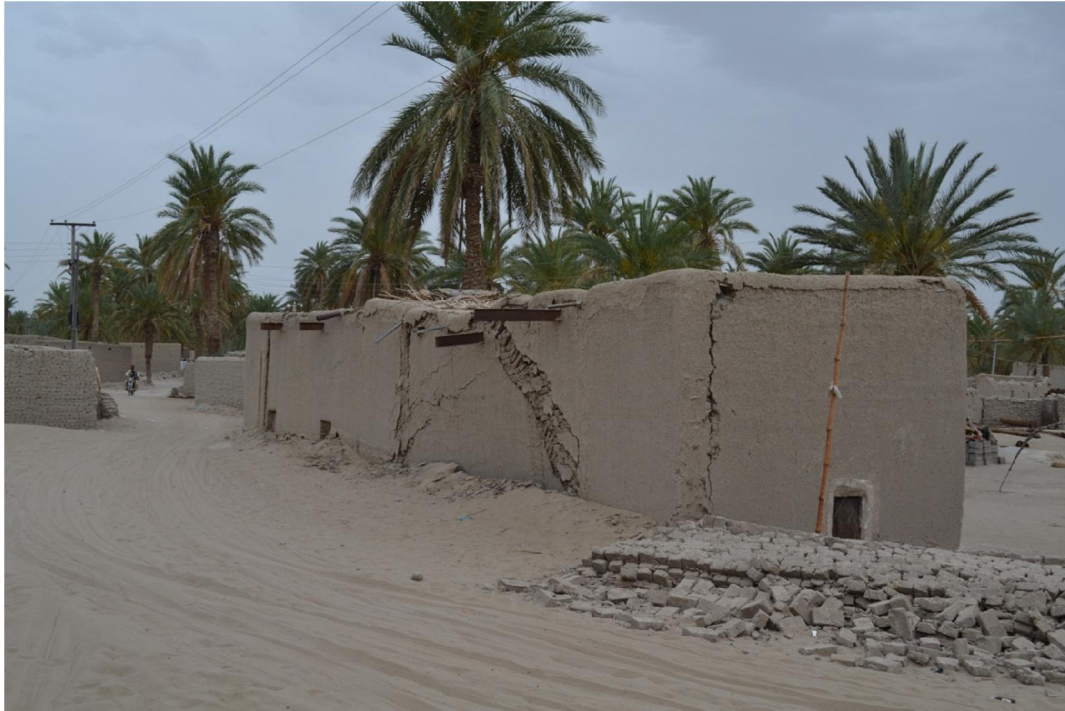
Fig. 10 Visible crack in walls in adobe buildings in Kili Kallag

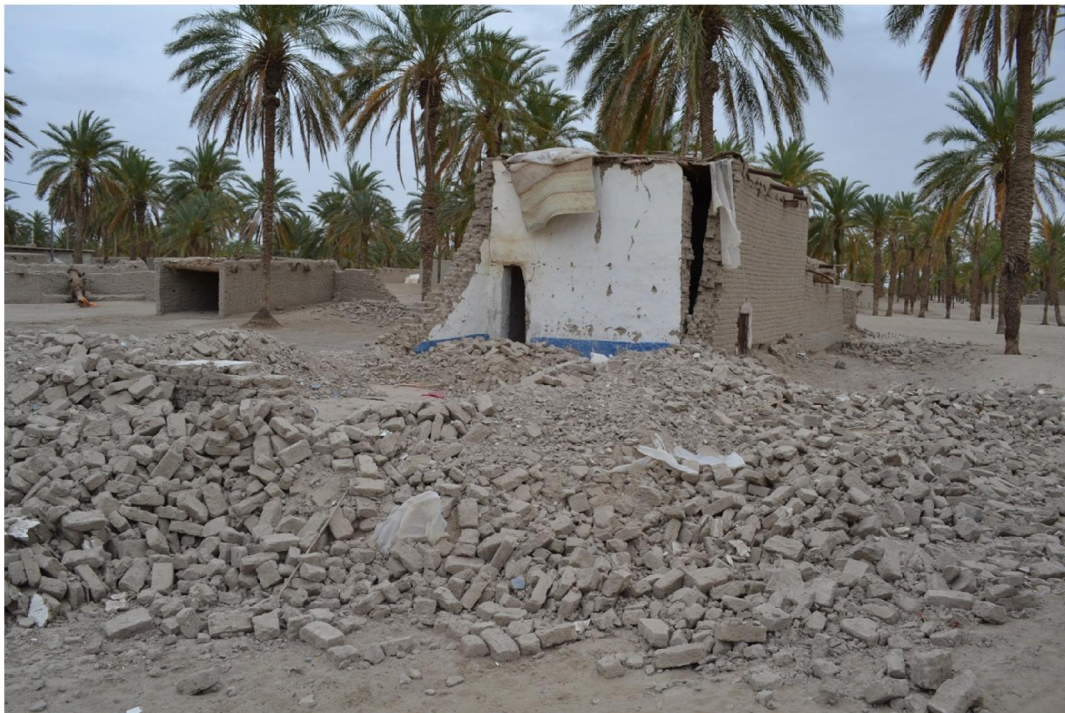
Fig. 11 Damaged adobe houses in Kili Kallag

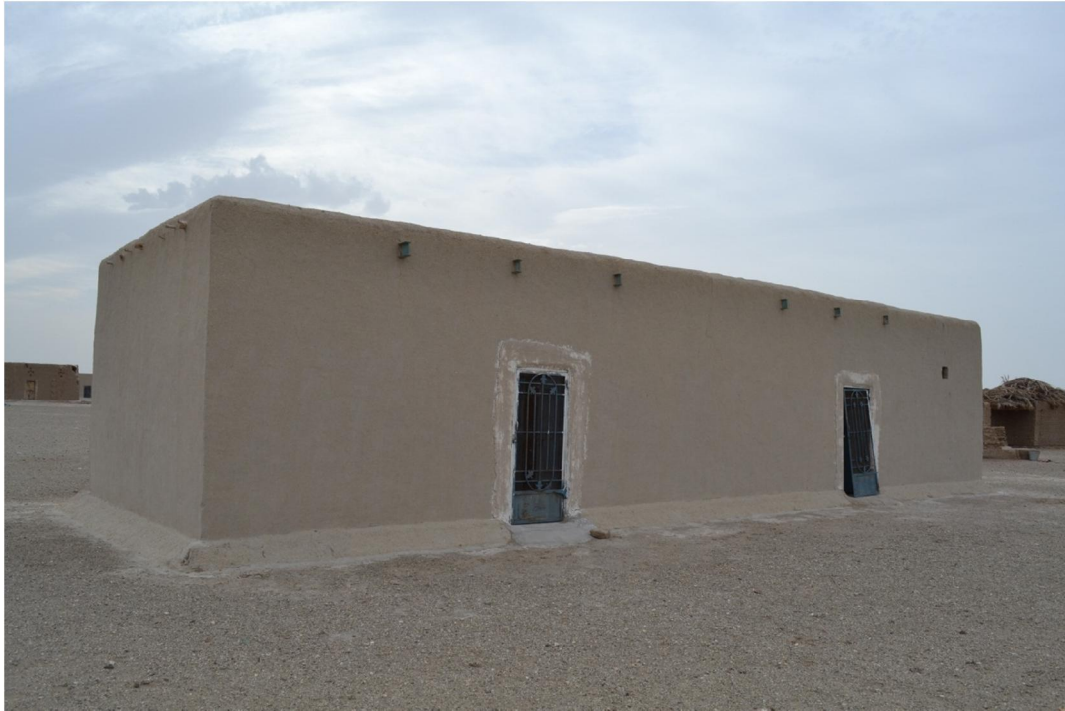
Fig. 12 An adobe house in Kili Tachap after the 16 April 2013 earthquake
