Report No. NED/EQD/SR-19/06

Preliminary Report of Reconnaissance Surveys in Mirpur Post 24 September 2019 Earthquake

November 2019

**DEPARTMENT OF EARTHQUAKE ENGINEERING
NED UNIVERSITY OF ENGINEERING AND TECHNOLOGY**

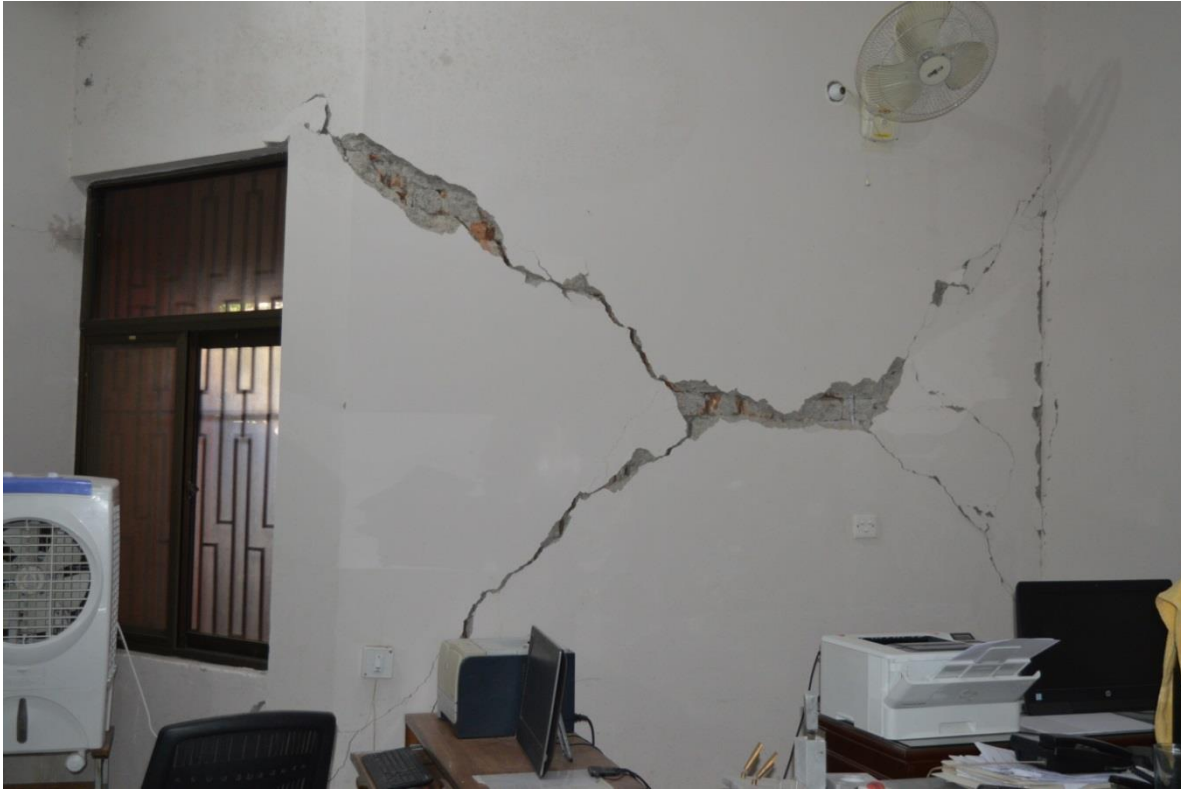
The visited buildings in MUST include Girls Hostel, Computer Systems Engineering Department building, Home Economics Department building and Admin building. Except for Home Economics Department building the structural system for the rest of all buildings comprised on reinforced concrete (RC) frame structure. The walls in these buildings are made of clay brick masonry and are non-structural members. The structural system of the Home Economics Department building comprised of load bearing unreinforced masonry (URM) walls which constructed using burnt clay bricks. The Girls Hostel and Computer Systems Engineering are generally in good shape after the 24 September earthquake where some minor cracks in the walls were observed in these buildings. Significant cracking in the walls in the Admin building was found (Fig. 4) which is usual in URM walls during seismic ground motion. Since these walls are non-structural elements, these cracks are only safety hazard for the occupants and could be repaired to make the building functional again.

Fig. 4 Cracks in walls in Admin building at MUST

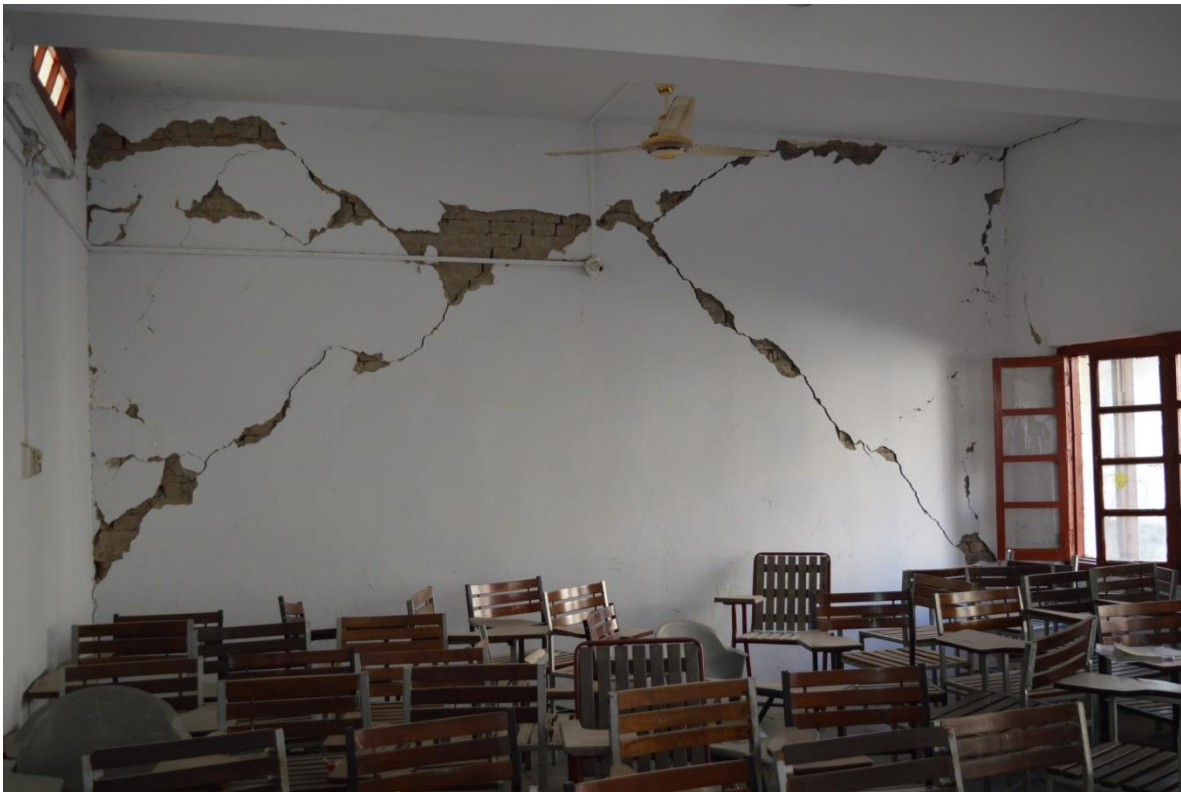
The cracks in the walls in the Home Economics Department building are similar to those observed in the Admin building (Fig. 5). The cracks were mostly in the form on diagonal cracks which were caused in the in-plane walls which are parallel to the direction of lateral seismic forces. Since the walls in the Home Economics Department building are also the structural members, these damages are a concern from the structural stability point of view. This is particularly due to the fact that these types of buildings are constructed without any engineering input in Pakistan and AJK and are classified as non-engineered construction. This building requires serious attention as repairing the cracks may not be enough to avoid any catastrophe in future. All such buildings are in urgent need of seismic retrofitting to save precious human lives during an earthquake.

Fig. 5 In-plane shear cracks in classroom in Home Economics Department building

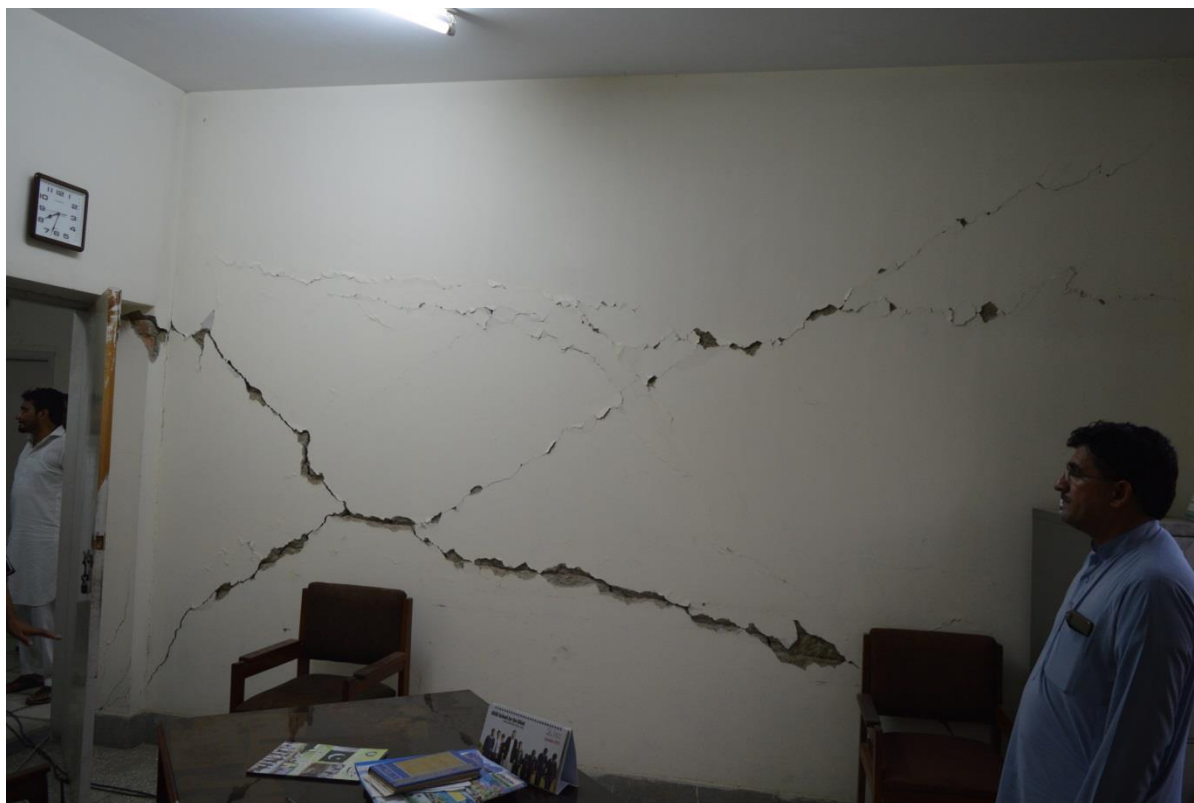
Fig. 6 Wall cracks in Radio Station building at Mirpur

The building is a two storey structure with one basement. The structural system of the building comprised of unreinforced load bearing clay brick masonry walls. It is very likely that this building is also constructed without any engineering input as the knowledge of designing masonry structures is very limited in Pakistan. This does not come as a surprise that the walls in this building also showed severe cracking due to the in-plane lateral seismic forces (Fig. 6). The cracks are very similar to those found in the Home Economics Department building at MUST which can be attributed to similar structural systems of both these buildings. This fact also requires a similar post-earthquake treatment of this building as mentioned for the Home Economics Department building above.

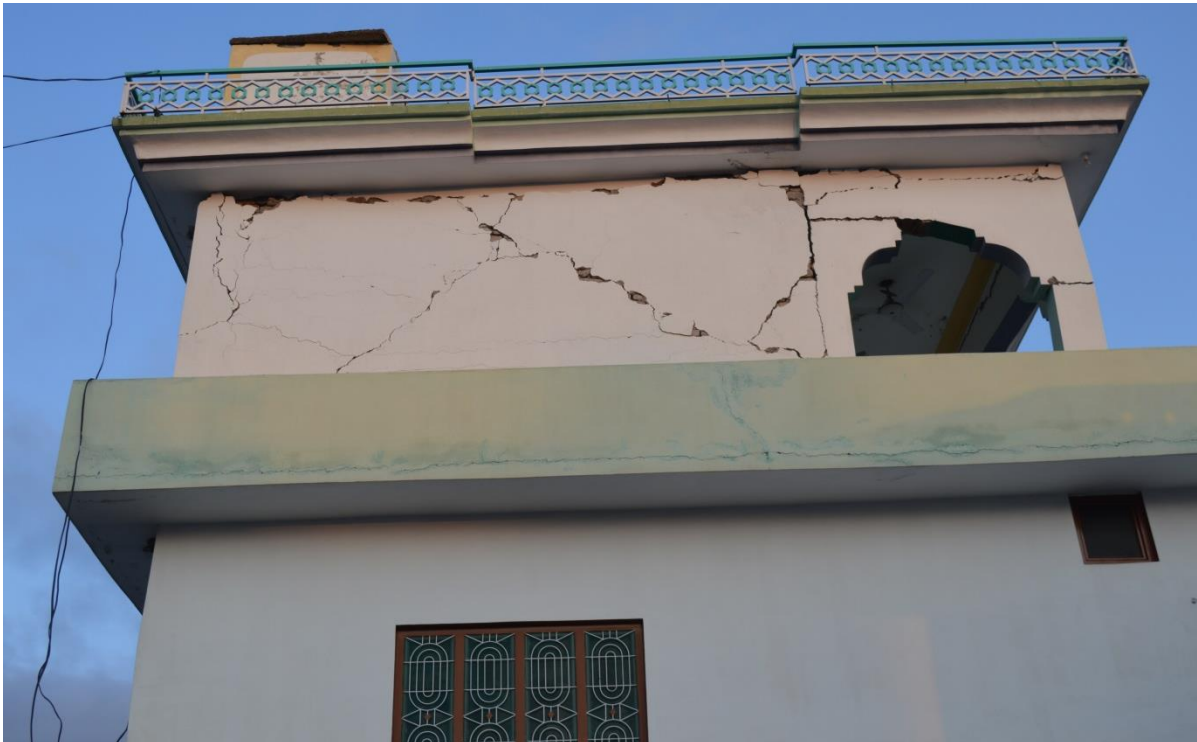
Apart from the buildings at MUST and Radio Station, URM structures are also used for private housing throughout Mirpur. These buildings vary in their quality of construction and sizes. The damages observed in these URM buildings ranged from cracking in the wall to the collapse of structure. The cracks were mostly in the form on diagonal cracks which were caused by the in-plane seismic forces (Fig. 7). In only a very few instances, the wall collapsed out-of-plane which were either short height

Fig. 7 Residential building with diagonal wall cracks

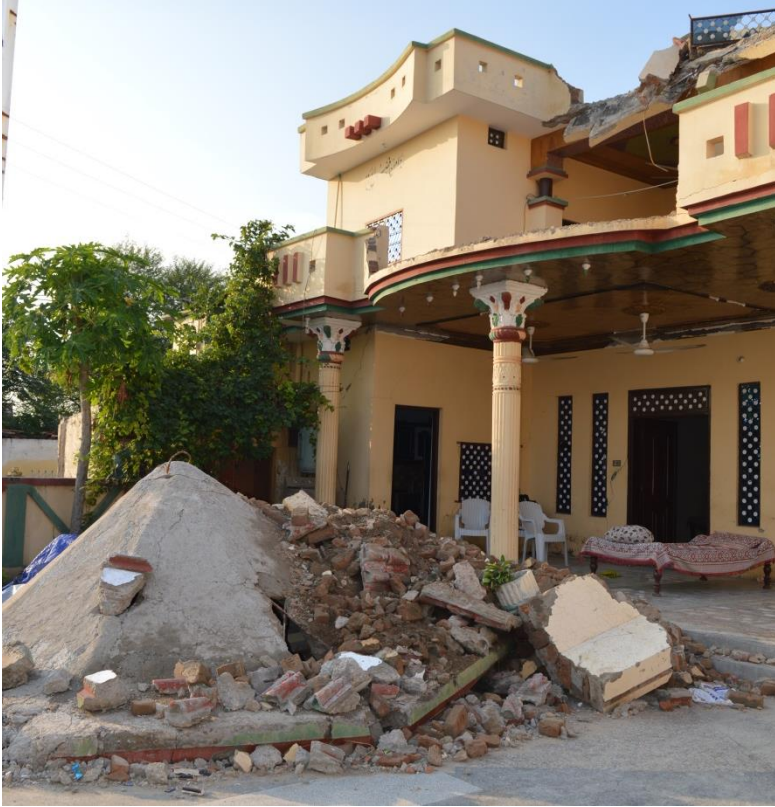
boundary or parapet walls. In some cases, the circular stair tower roof slid off the wall of the tower to fall down in the front of the house (Fig. 8). In addition, cattle shed fell down in some of the residential buildings (Fig. 9).

Fig. 8 View of fallen circular roof of stair tower

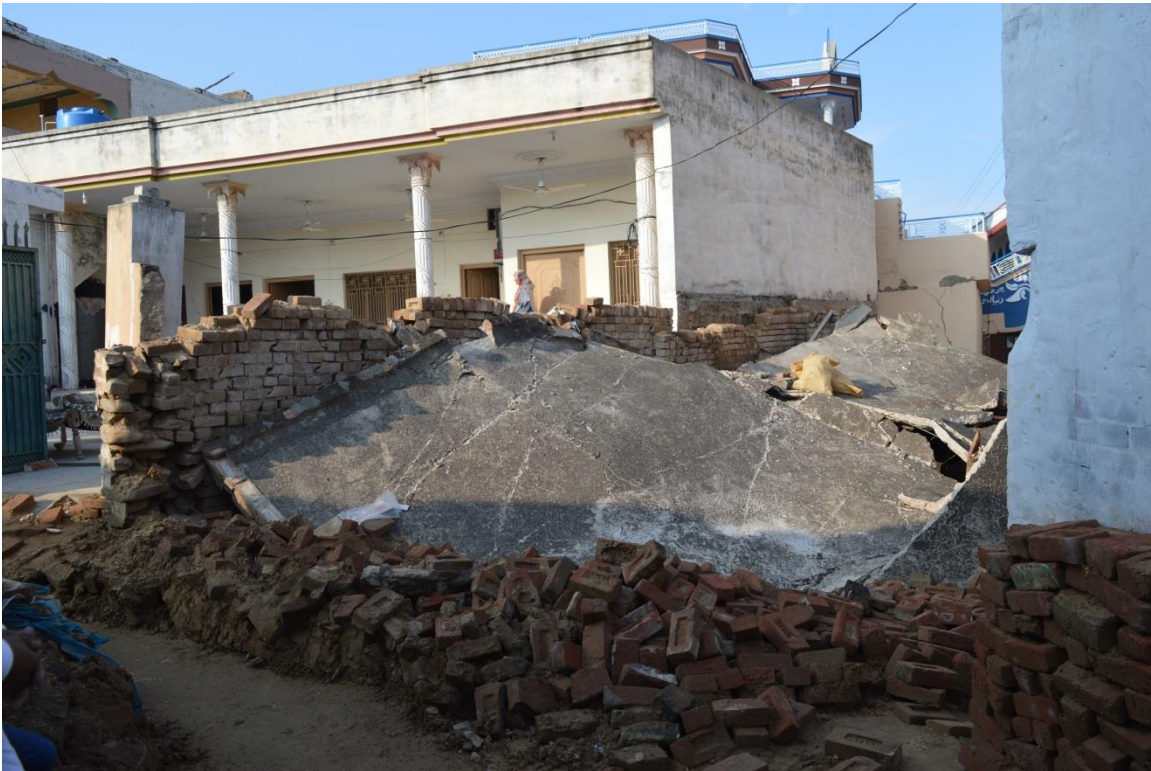
Fig. 9 Collapse of cattle shed

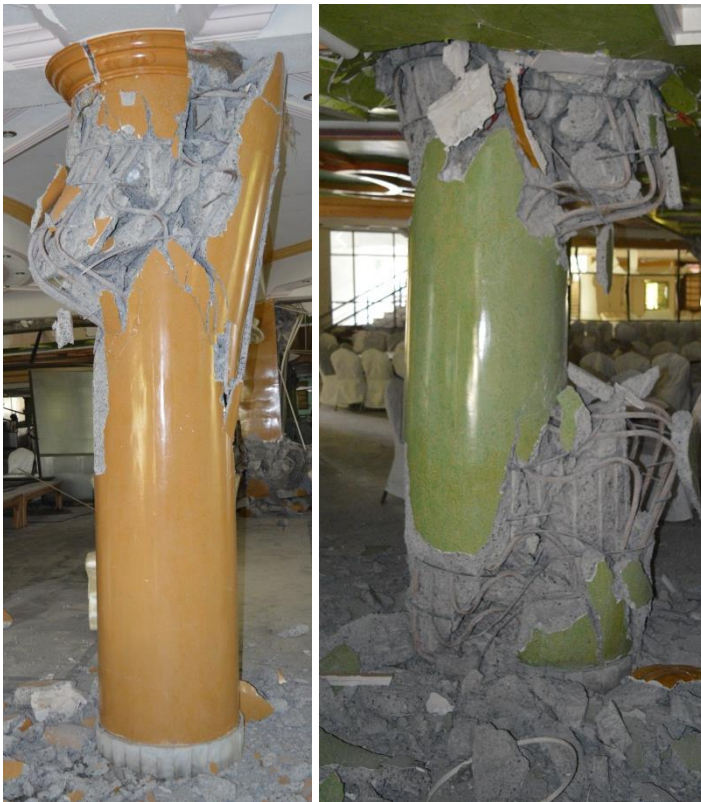
Gulshan-e-Jabeer building is a two storeyed RC frame structure building with one basement (Fig. 10). The building is nearly 10 years old. The building of Ahsan Medical Complex is a seven storey high RC building including a mezzanine (Fig. 11). The building is only one year old. Figs. 12 and 13 show few damaged columns in these aforementioned buildings. It is seen in Figs. 12 and 13 that hinging is caused in columns at the beam-column junction which was accompanied by the buckling of the longitudinal bars. The latter is a result of insufficient confinement provided to the longitudinal bars by the spiral (circular columns) or stirrups (rectangular columns). It was also noted that the hook of the stirrups in the rectangular columns were bent 90 deg in violation of the design codes followed for the design of RC buildings.

Fig. 12 Column damages in Gulshan-e-Jabeer

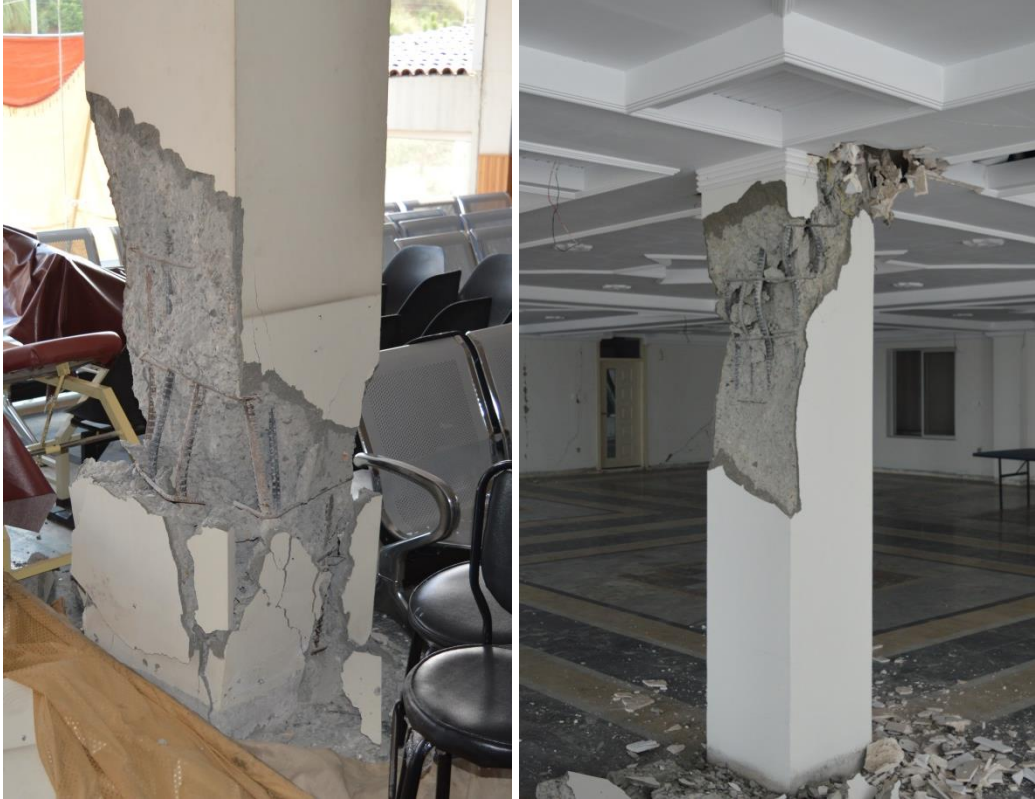
Fig. 13 Damaged columns in Ahsan Medical Complex building

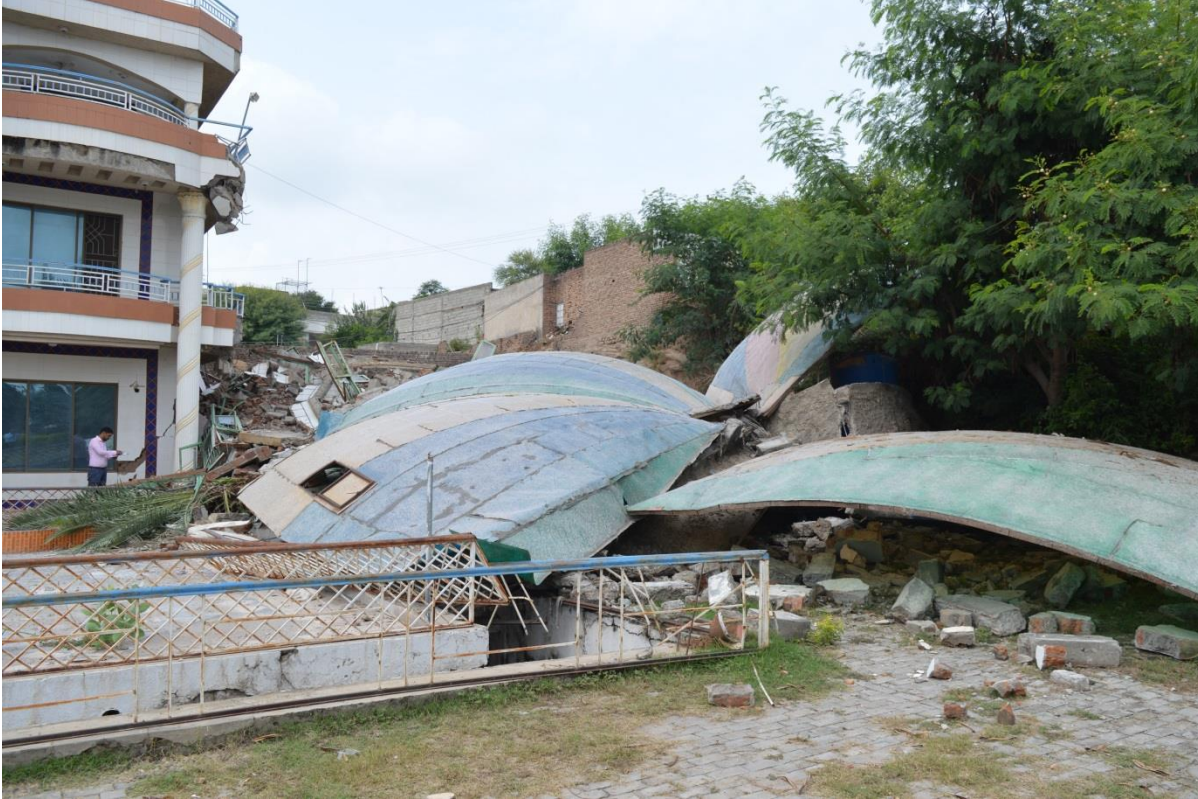
Fig. 14 shows rubbles of an RC building which was completely collapsed during to the ground shaking caused by the earthquake. The building was used as a student hostel facility by Benazir Bhutto Shaheed Medical College in the Mirpur city area. Luckily, the building was empty at the time of earthquake due to the summer holidays which avoided any human casualty.

Fig. 14 Collapsed building during 24 Sep 2019 earthquake in Mirpur

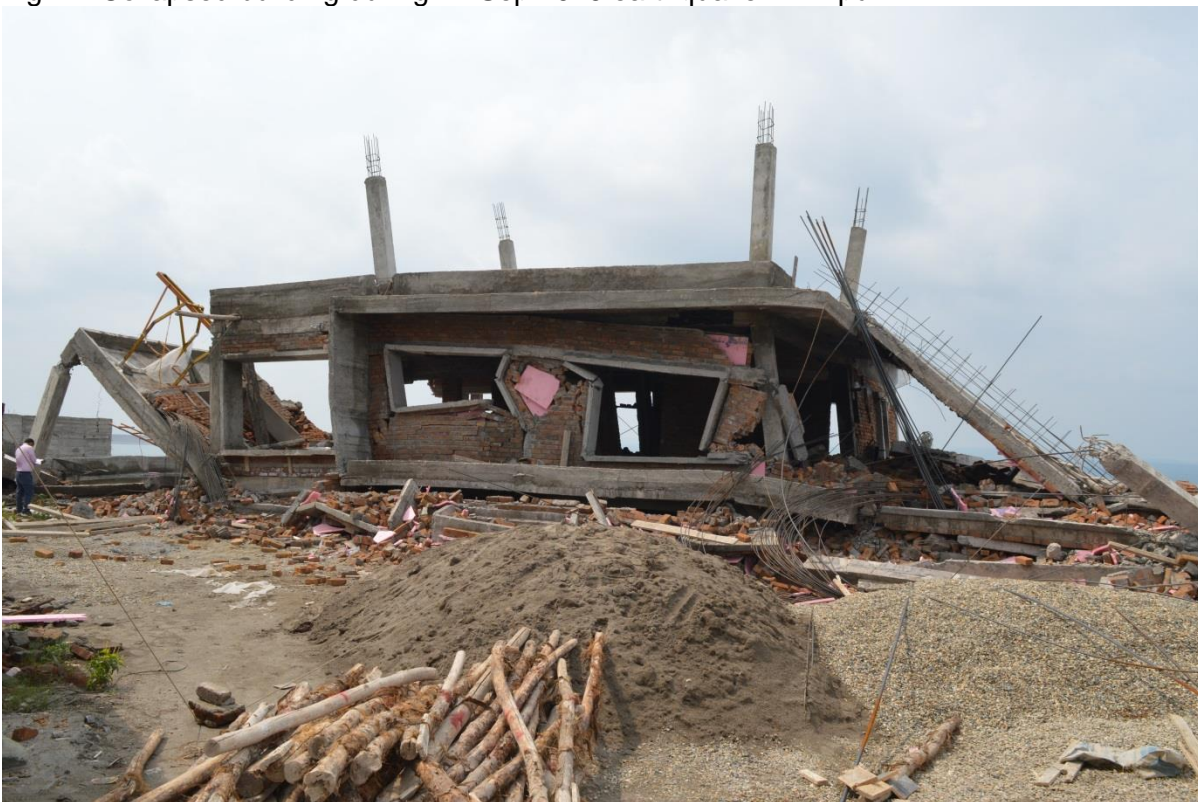
Fig. 15 shows the view of a collapsed storey of an under construction building which has six storeys including a basement. The floor plan of the building changed after fourth storey. Although the reason of collapse cannot be ascertained with certainty, a soft storey failure of the fourth storey of the building is thought to be the reason of its collapse.

Fig. 15 Collapse of a storey of an under construction building
