Tohoku Earthquake Disaster

The first issue of volume 11 of CESNED NEWS LETTER is once again an endeavor towards improving awareness of earthquake engineering in Pakistan.. Readers are encouraged to contribute in this newsletter.

CESNED is dedicating this issue to the effectiveness of March 2011 Japan Earthquake — Editor

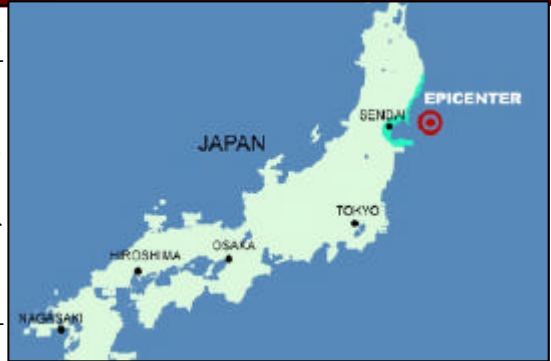
Fig 2 : A map showing the epicenter of the earthquake

On March 11 at 2:46pm JST a massive 9.0-magnitude earthquake occurred near the northeastern coast of Japan, creating extremely destructive tsunami waves which hit Japan just minutes after the earthquake, and triggering evacuations and warnings across the Pacific Ocean. The earthquake and tsunami have caused extensive and severe damage in Northeastern Japan, leaving thousands of people confirmed dead, injured or missing, and millions more affected by lack of electricity, water and transportation. The magnitude 9.0 Tohoku earthquake, which occurred near the northeast coast of Honshu, Japan, resulted from thrust faulting near the subduction zone plate boundary between the Pacific and North America plates. The March 11 earthquake was preceded by a series of large foreshocks over the previous two days, beginning on March 9th with a M 7.2 event approximately 40 km from the epicenter of the March 11 earthquake, and continuing with another three earthquakes greater than M 6 on the same day. The Japan Trench subduction zone has hosted nine events of magnitude 7 or greater since 1973. The largest of these, a M 7.8 earthquake approximately 260 km to the north of the March 11 epicenter, caused 3 fatalities and almost 700 injuries in December 1994. In June of 1978, a M 7.7 earthquake 35 km to the southwest of the March 11 epicenter caused 22 fatalities and over 400 injuries. Large offshore earthquakes have occurred in the same subduction zone in 1611, 1896 and 1933 that each produced devastating tsunami

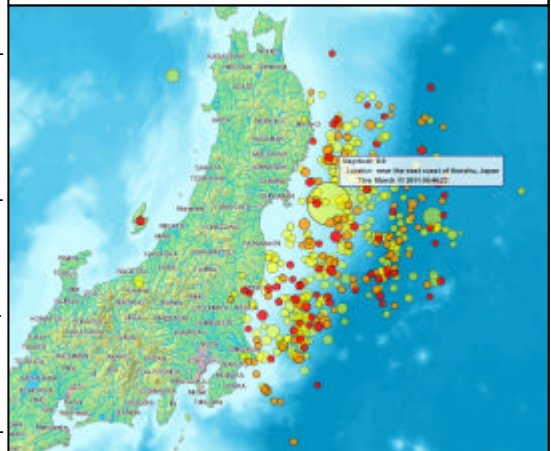
Fig 3: Map of the Tohoku earthquake and aftershocks March 11. - 14.

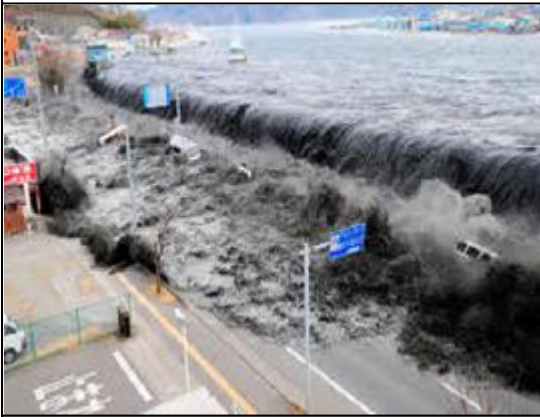
Fig 4: Tsunami wave Japan March 11, 2011

exceeding 100 km and wave heights of only a few tens of centimeters. The ruthlessness of these waves comes into play when they reach the shallow waters of the coast where the waves slow down and the water piles up into a wall of destruction tens of meters or more in height.

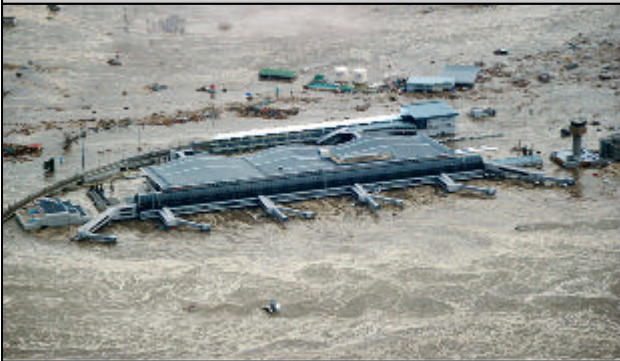
Fig 5: Sendai Airport is flooded after a tsunami following an earthquake in Sendai, northeastern Japan, March 11, 2011.

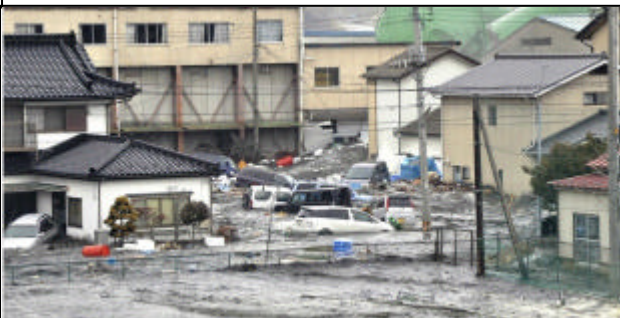
Fig 6 : In the Miyagi port city Kesenuma , which has population of 74000, the waves smashed cars up against houses

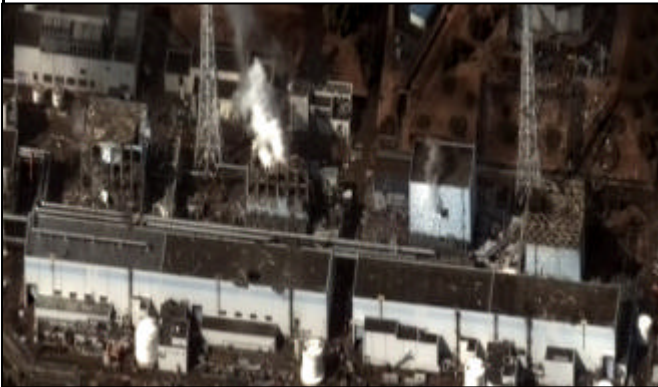
Fig 11: Satellite image on 16 March of the four damaged reactor build-

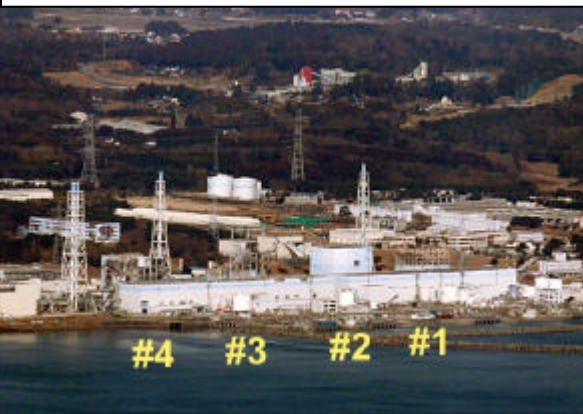
Fig 12: Fukushima Daiichi Nuclear Station showing damaged reactors #1, #3, and #4. Exterior of #2 appears intact although smoke and/or steam has streamed from hole in upper east wall. From (<http://shineyourlight-shineyourlight.blogspot.com/2011/03/japan-one-week-after->
