3-Storey Library Building in Karachi

A Case Study of Seismic Assessment and Retrofit Design

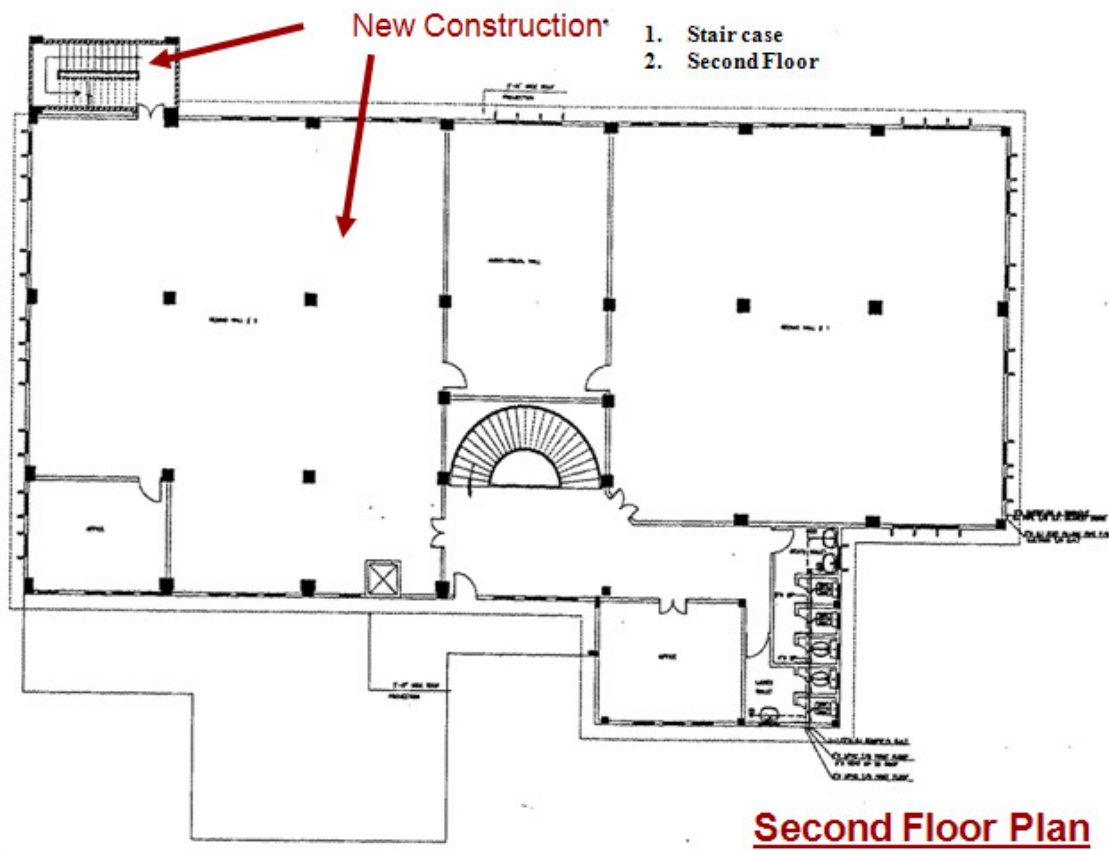
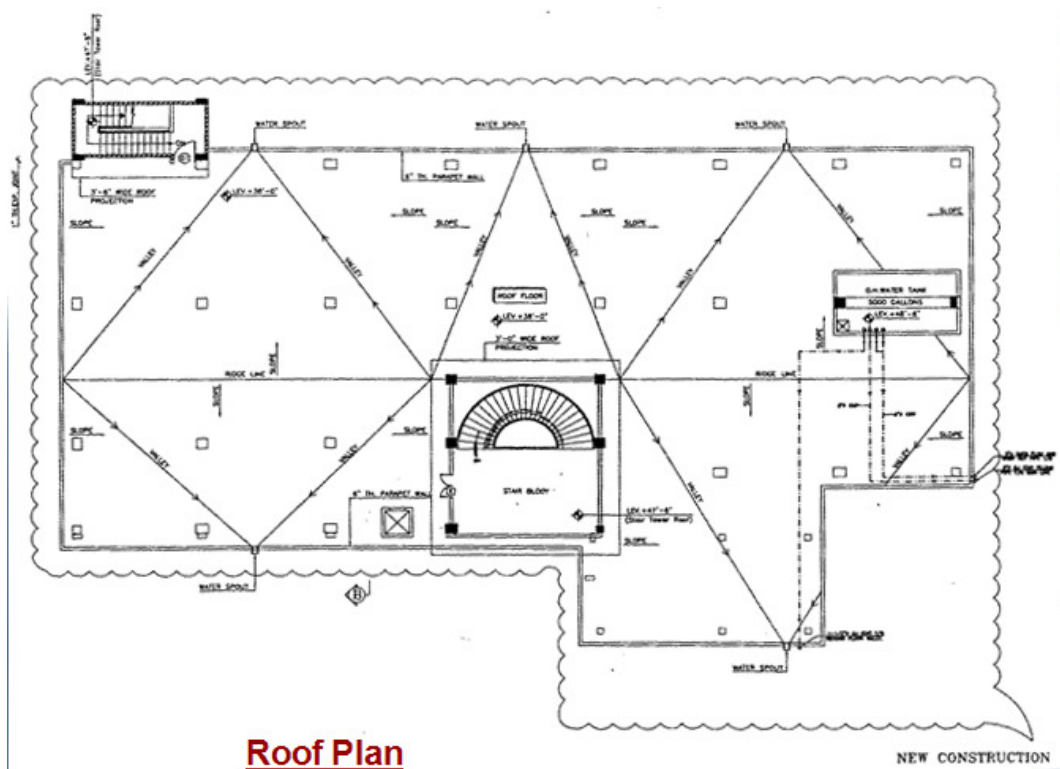
Figure 3. Architectural plans of second floor and roof

After the main building was constructed, the second storey was added, an emergency exit stair was constructed at the rear corner, and a small single storey additional block was built near the main

entrance as indicated by the black outlines in the architectural plans above. The emergency exit stair and single storey additional block are separated from the main building by a small expansion joint that was not designed to accommodate seismic deformations.

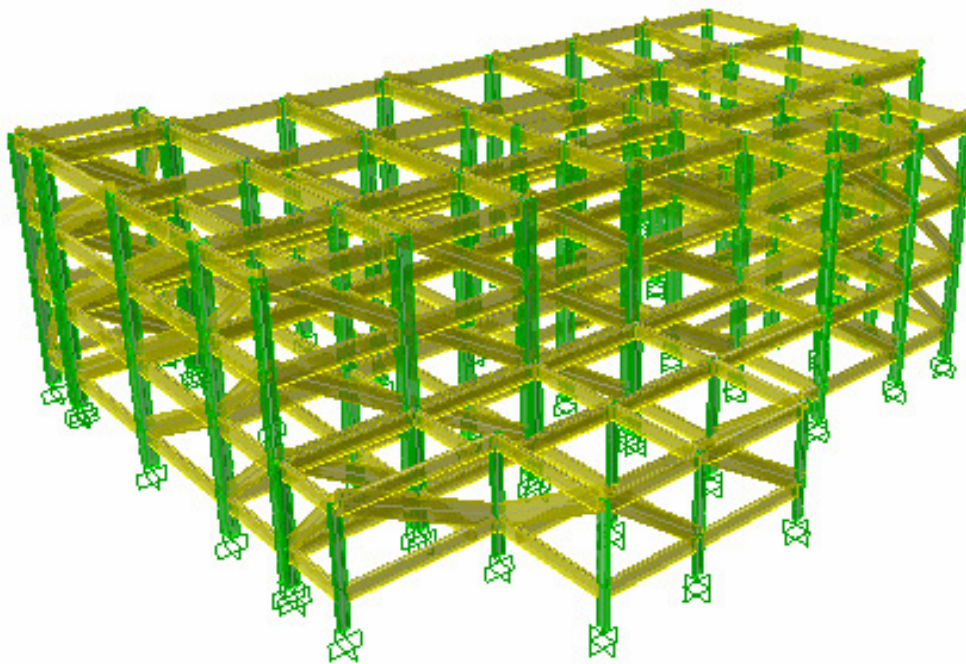
Figure 5. Rendering of linear ETABS model of the building

Figure 5 shows the 3-D model of the building generated in ETABS Nonlinear version 9.7.0. The beams and columns were modeled with linear beam-column elements, and the infill walls were modeled with single linear compression struts. The linear static analysis shows that there are a number of columns with demand/capacity ratios (DCRs) greater than one and even exceed global ductility of two, so the building is expected to respond in the nonlinear range. Please see Appendix B for linear analysis and Appendix C for non linear analysis results.

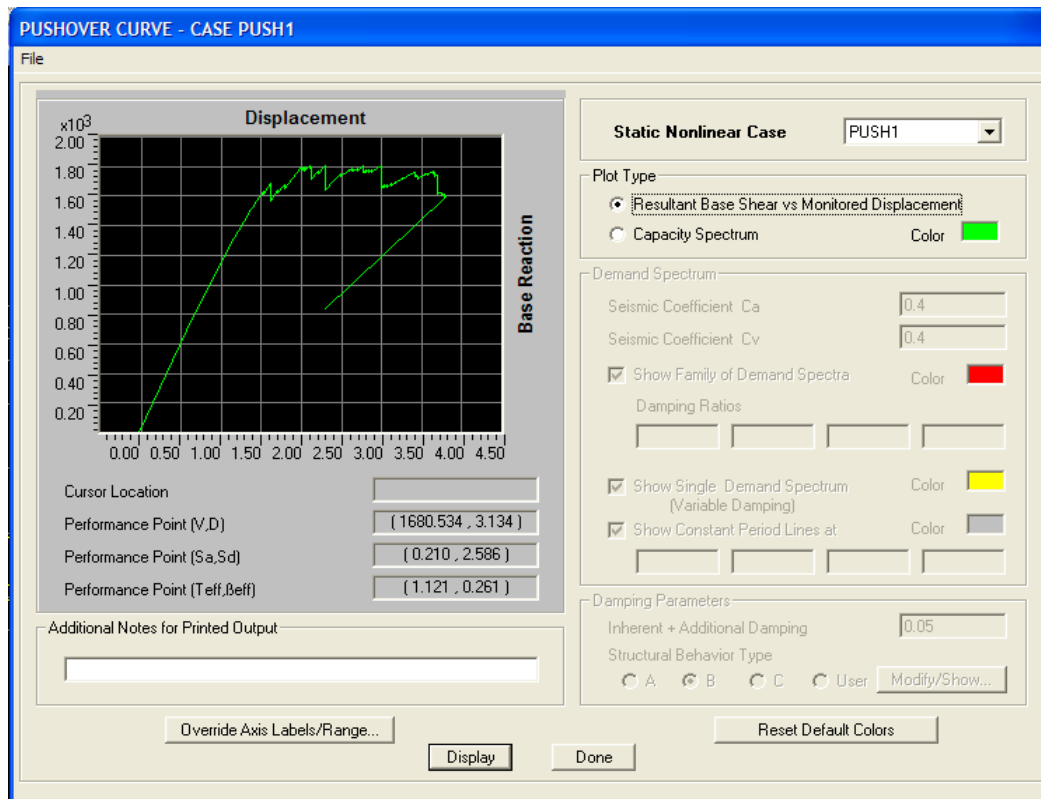
Figure 6. Pushover load-deformation curve

Figure 6 shows the pushover load-deformation curve. The curve bends and becomes jagged as the various structural members begin to yield and undergo plastic deformation. In Figure 7, the pushover curve, a measure of the building's capacity, is converted into a capacity spectrum and compared with the estimated demand using the capacity spectrum method. This figure shows the performance level where demand and capacity spectra intersect each other at that point where it is necessary to see the condition of the structure, and whether it is fulfilling the demand or not. This point is called the *performance point*.

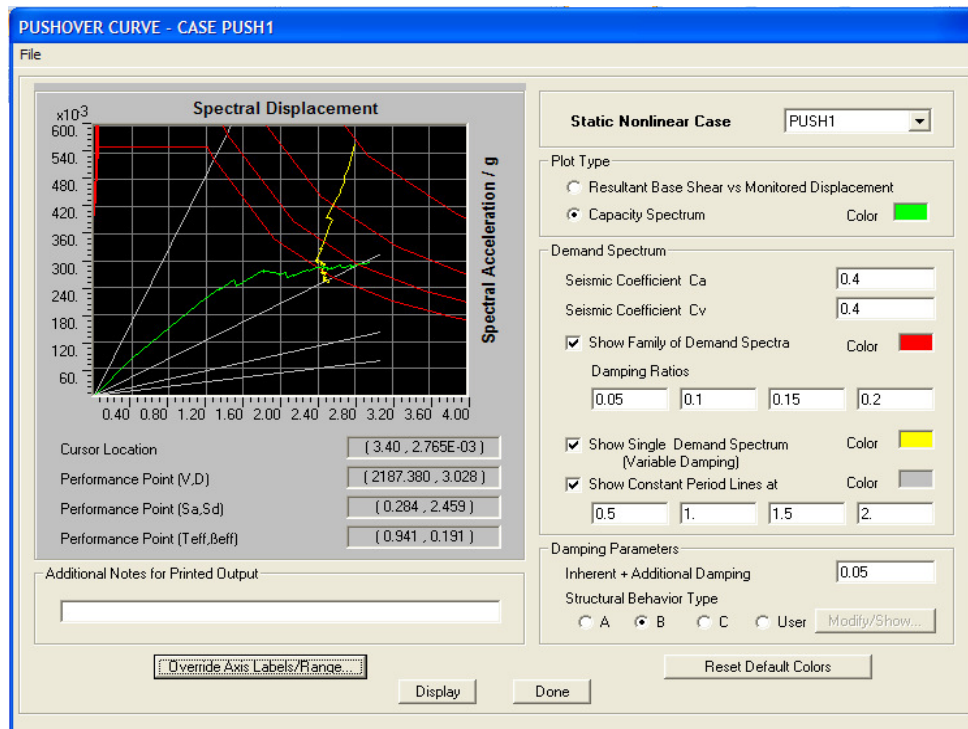
Figure 12. Performance level for retrofitted building

Figure 11 shows a comparison of pushover analysis results for the two retrofit options versus the existing building. The capacity and demand spectra for retrofit option 2 are shown in Figure 12. Retrofit option 2 provides better performance than option 1, and rectifies the column failures experienced by the existing building, as Figure 13 shows.

The case study team selected option 2, shown in Figure 10, as the recommended retrofit solution. It is simpler to construct than option 1 because it does not require construction near the toilets which would have been difficult due to the plumbing and fixtures.
