Five Storey Residential Apartment Building Near Murree

A Case Study of Seismic Assessment

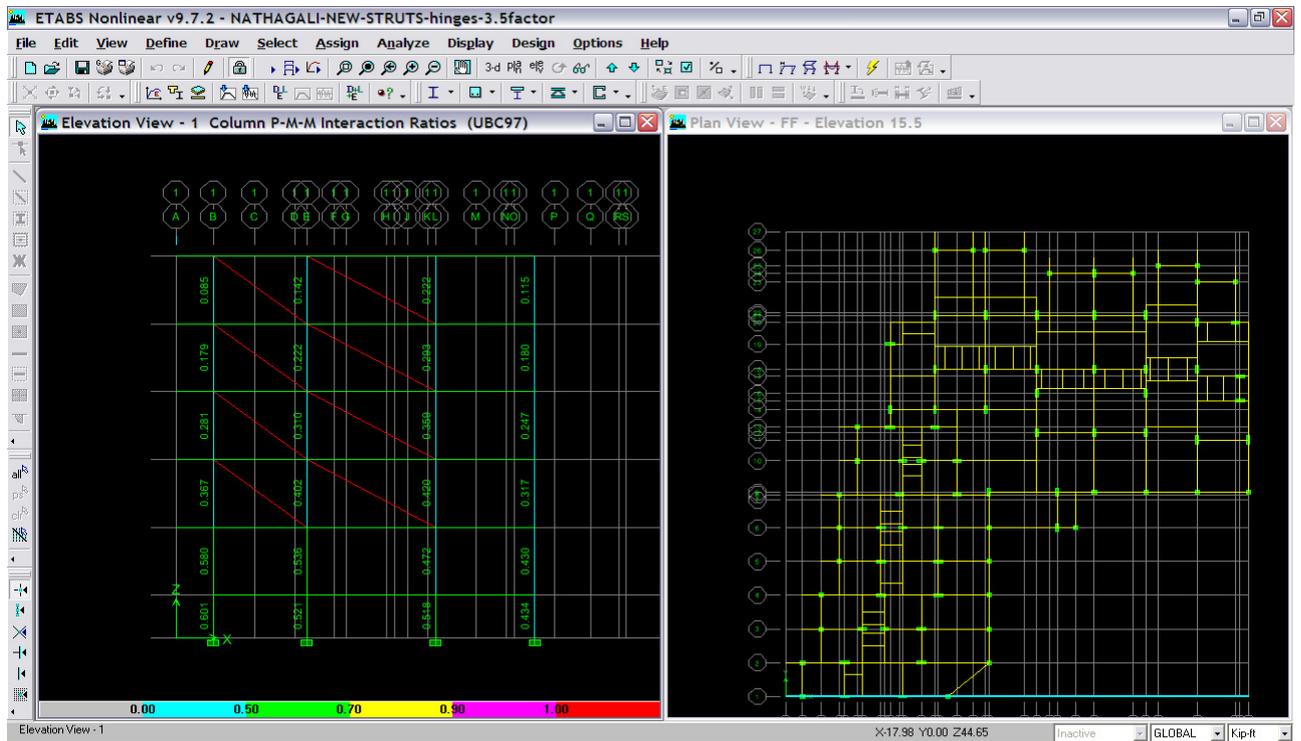
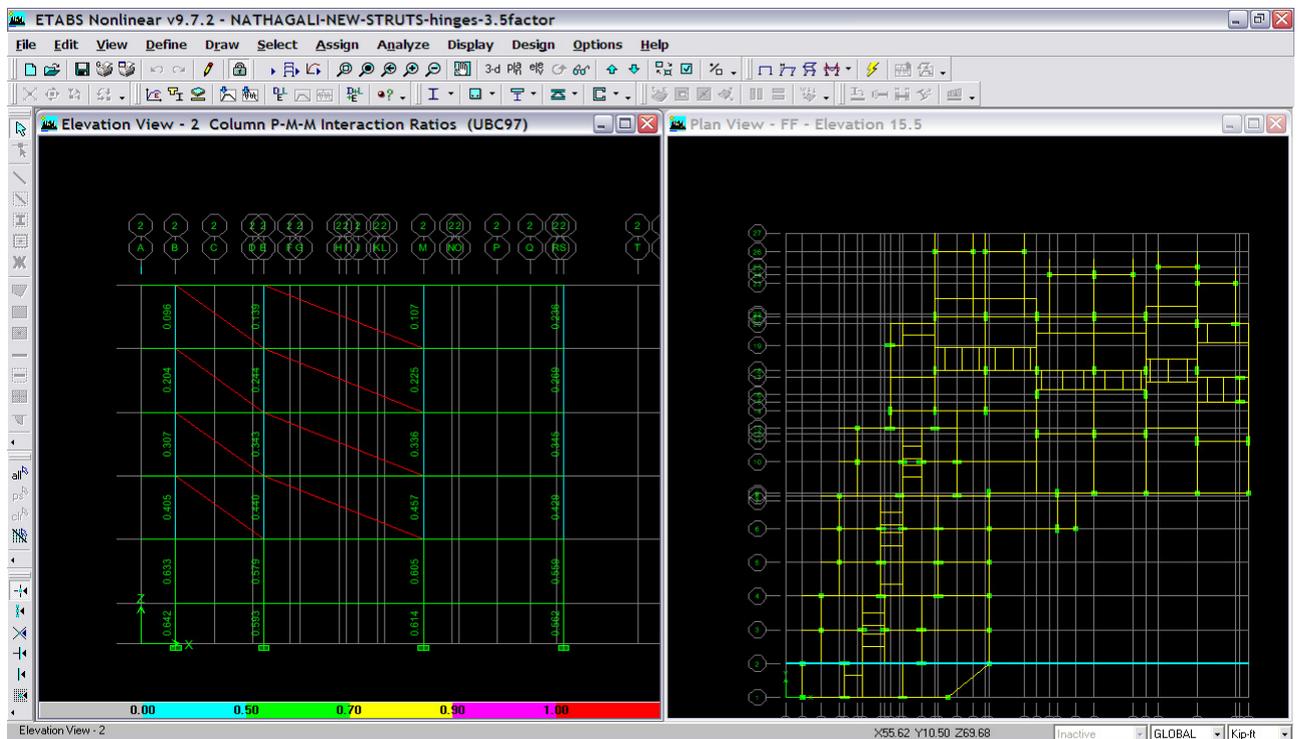
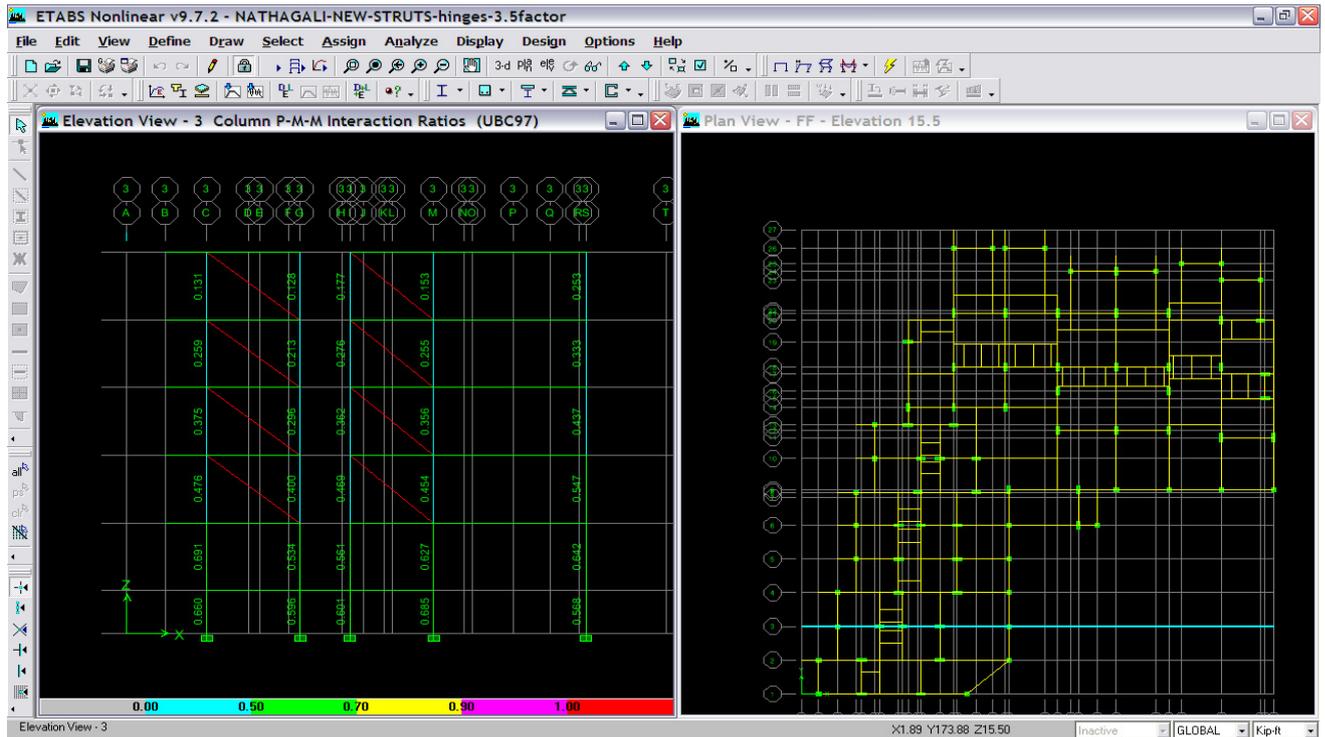
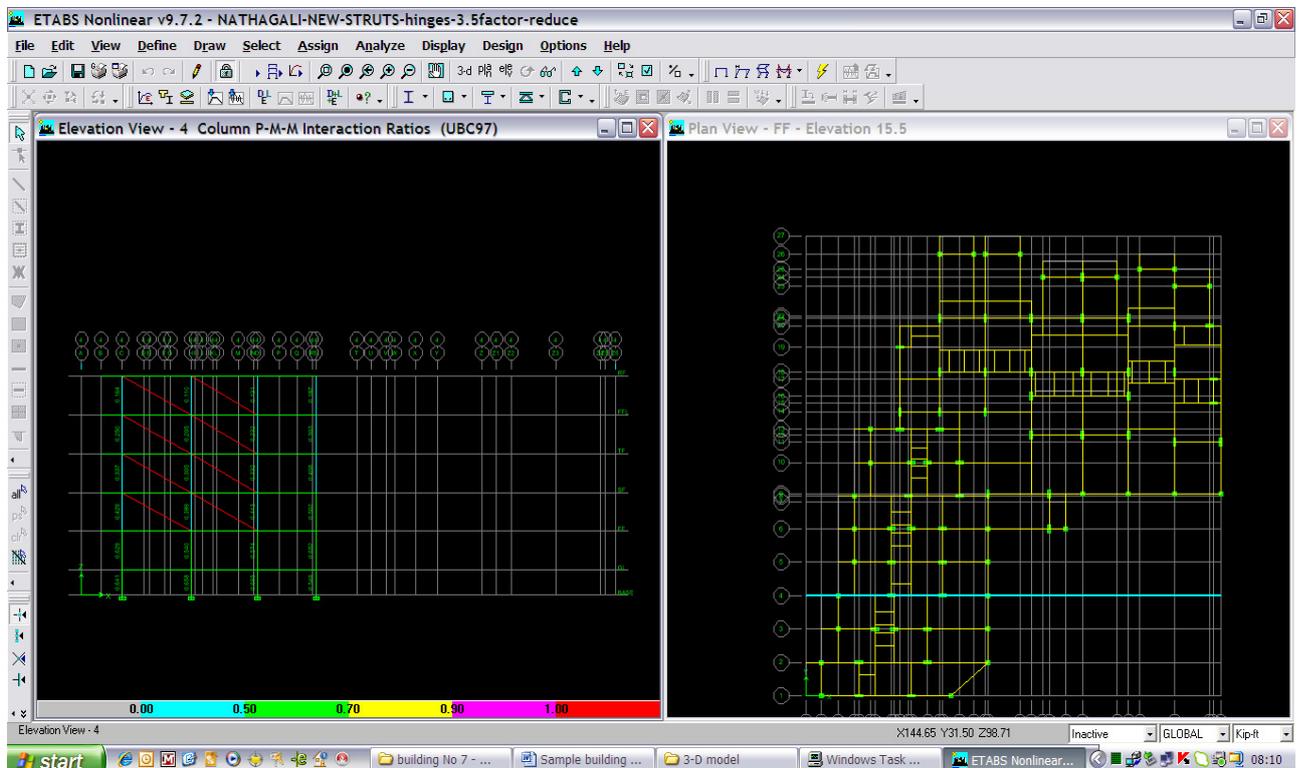
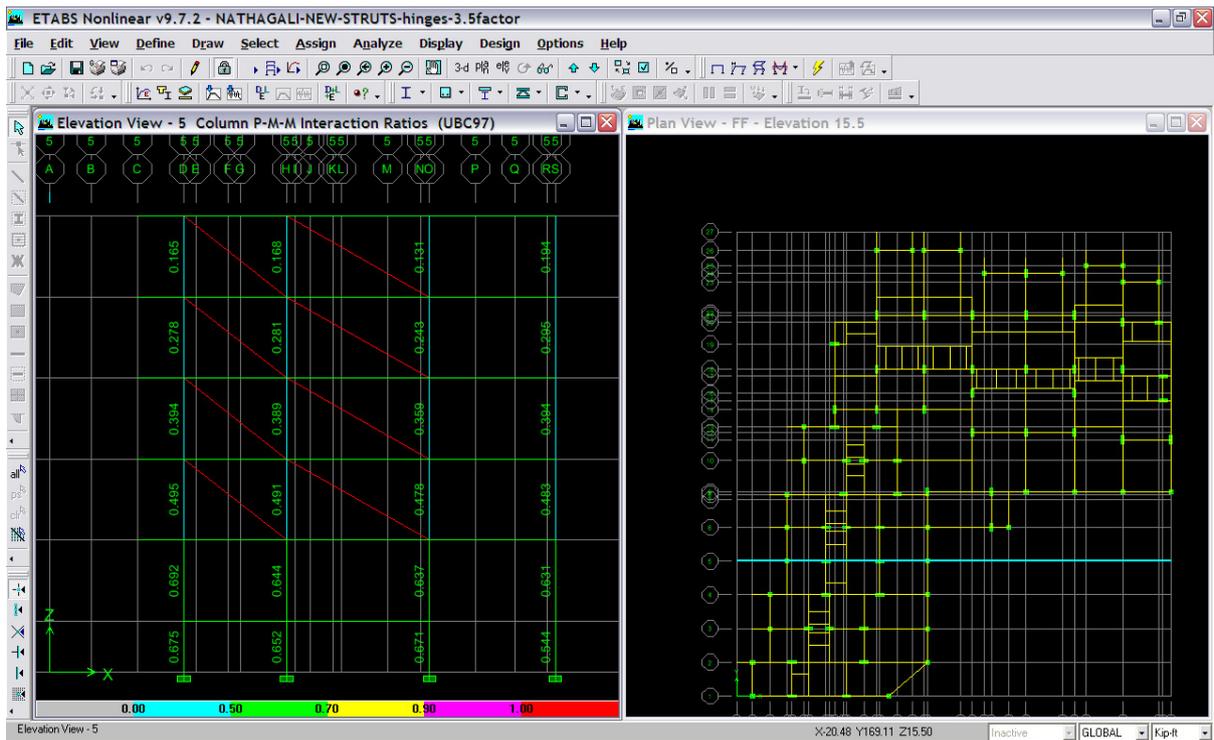
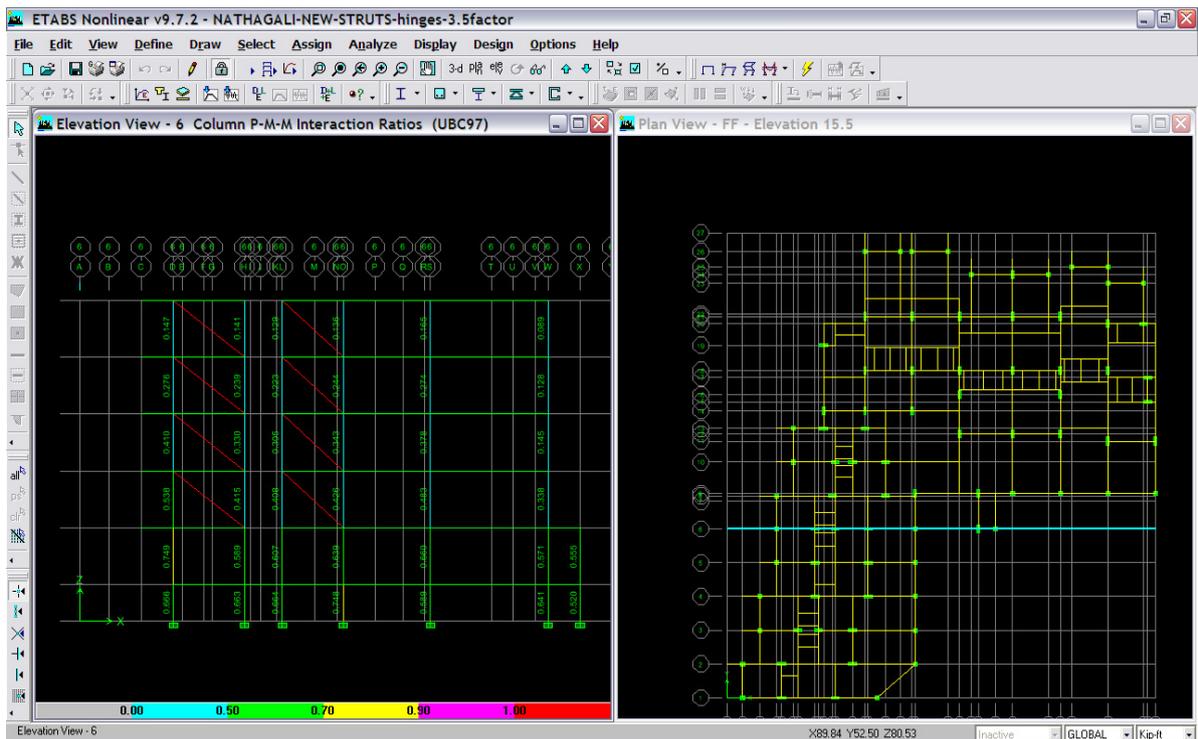
Through the results of linear static analysis, as shown in Appendix B, the building response is not expected to go into the nonlinear range, furthermore the checks for building system (mass irregularities, torsion etc.) in Tier 1 analysis which were assumed non-compliant through visual inspection, were found to be compliant after Tier 2 analysis. The building has satisfactorily passed the Tier 2 analysis. Hence there is no need to perform nonlinear static analysis.

- Two beams fail in combined shear and torsion check; however no retrofitting may be needed because the nearby beams are able to support and prevent collapse of the slab. Also, beam retrofits could be invasive and therefore costly, especially in a residential building like this.
