# Five Storey Mixed Use Building in Karachi

## A Case Study of Seismic Assessment and Retrofit Design

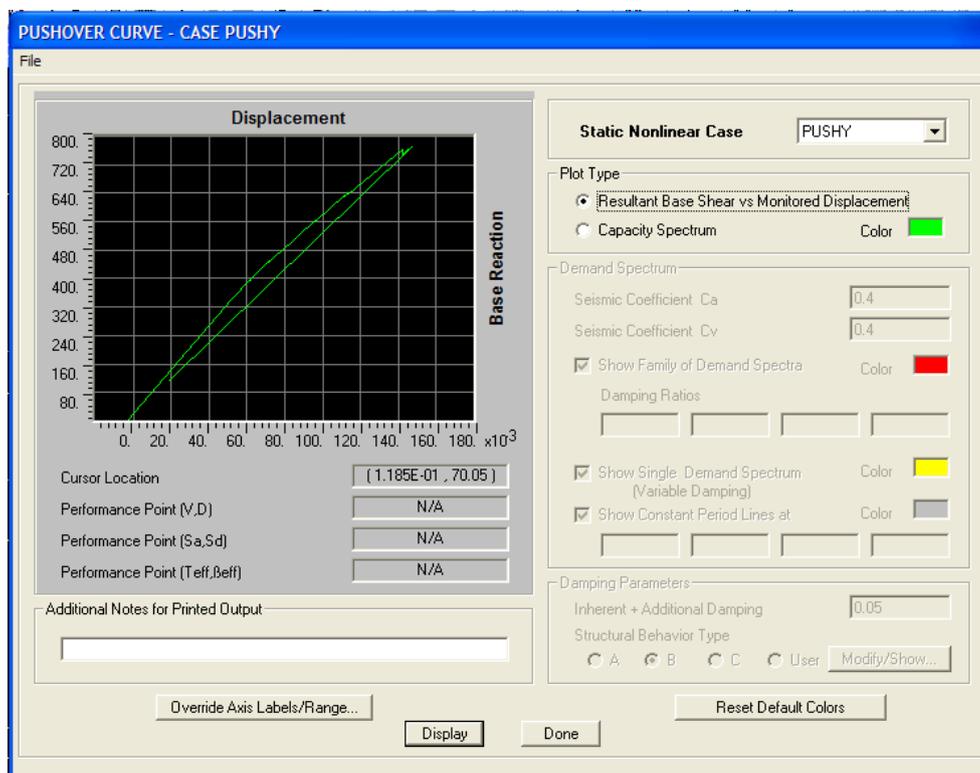
Figure 6. Pushover curve for Y-direction

Figure 6 shows the load-deformation curve in the Y-direction analysis and Figure 7 shows the performance level where the demand and capacity spectra intersect each other, at the point called the *performance point* where it is necessary to see the condition of the structure, and whether it is fulfilling the demand or not.

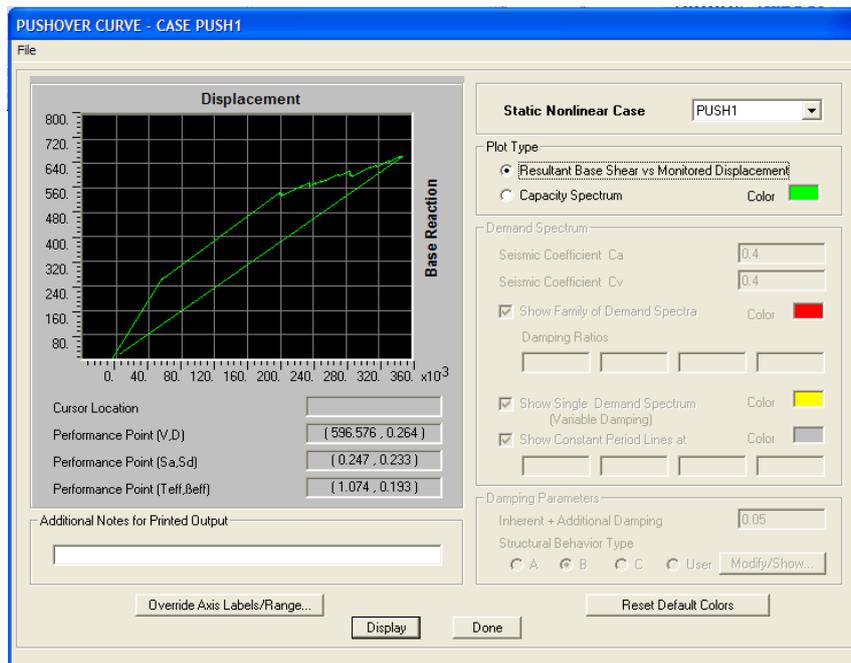
Figure 9. Pushover curve for X-direction

Figure 9 shows the load-deformation curve in the X-direction analysis and Figure 10 shows the capacity spectrum and the performance point.

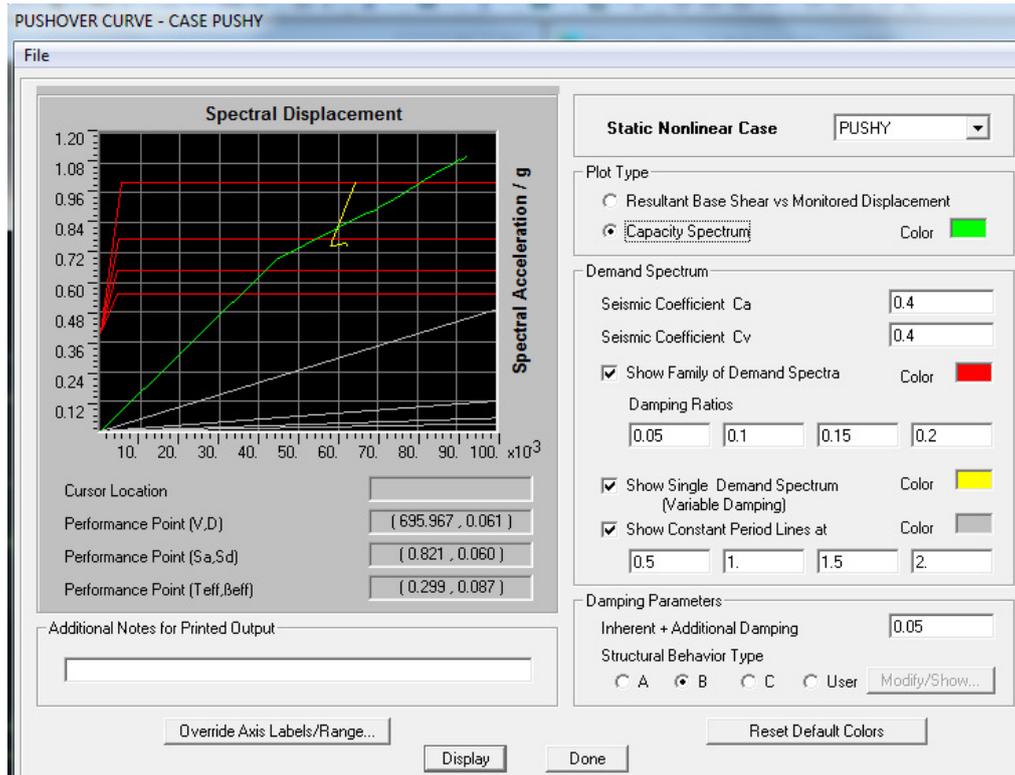
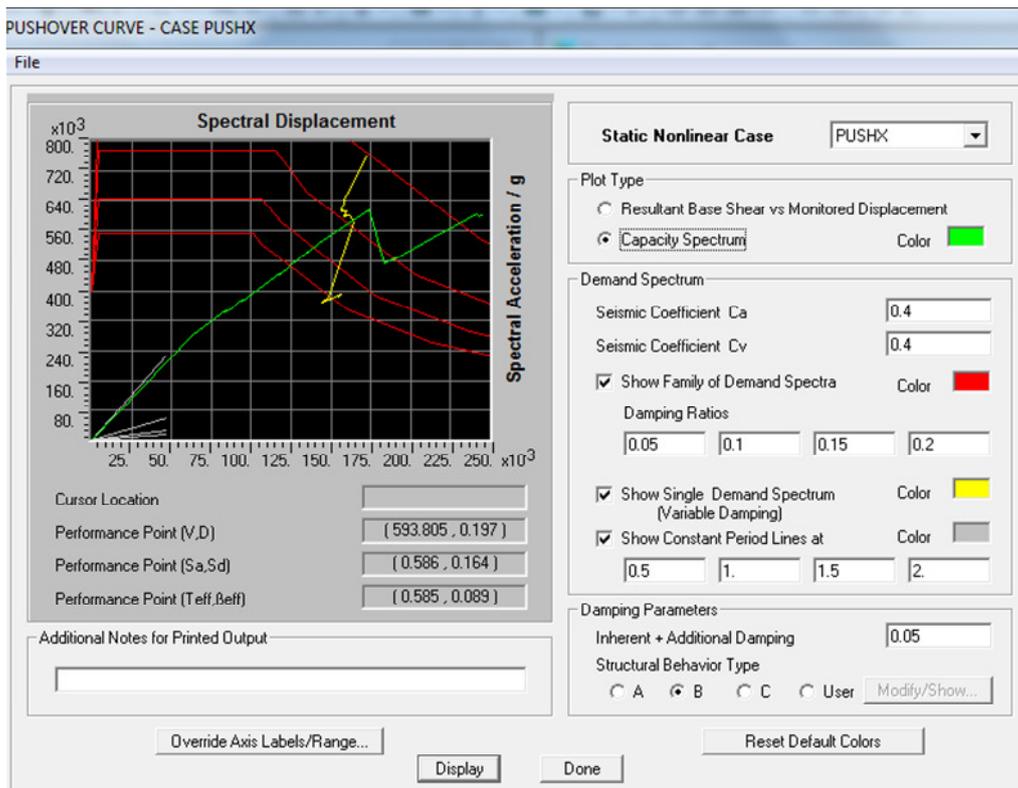
Figure 13. Performance level for the retrofitted building – Y-direction (top) X-direction (bottom)

Figure 13 through Figure 15 compare pushover analysis results for the retrofitted building model with those of the existing building. As shown, the retrofit eliminates the column failures and prevents a weak storey mechanism from forming at the ground storey. Please see Appendix C for additional nonlinear analysis results.

For retrofitting, a technical advisor suggested that the team consider increasing the sizes of the periphery columns from 8" to 16", increase the size of the beam on grid-E that frames into the lift core, and to add RCC shear walls to replace ordinary masonry infill walls to form spines. The beam on grid-E is a primary connection in the X-direction between the lift core and the building's RCC frame structure, so increasing the strength of this beam improves performance. Therefore, in addition to RCC shear walls the width of the beam was increased and new rectangular columns are introduced at the outer periphery of the building, as shown in Figure 12. Due to weakness in the ground storey two new walls were added in only that storey.
