10-Storey Office Building in Karachi

A Case Study of Seismic Assessment

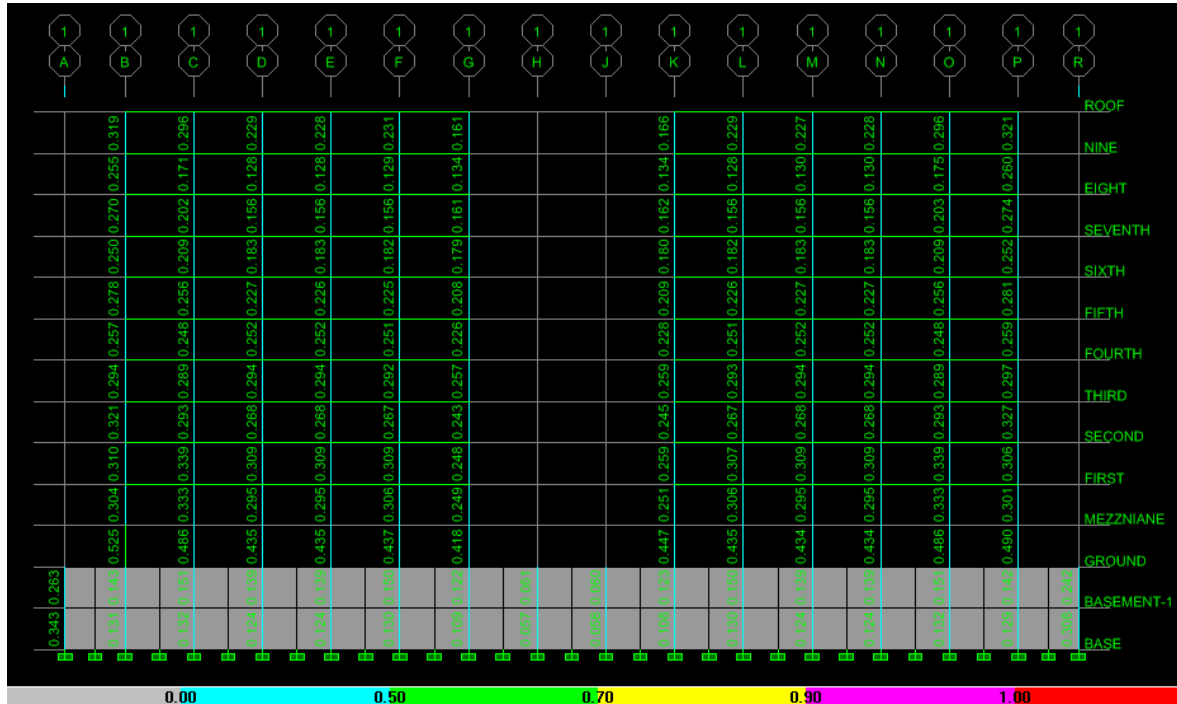
Demand/Capacity Ratios for columns at Grid-1

The damage to columns having $1 < \text{DCR} < 2$ will just be cosmetic and not affect the structural stability since there seems to be sufficient strength/stiffness in other bays to resist the seismic forces. But, some thought should be given to whether the column damage would be acceptable to building occupants. If it would not be acceptable, then some retrofit measures could be considered.
