Stone Masonry School in Abbottabad

A Case Study of Seismic Assessment and Retrofit

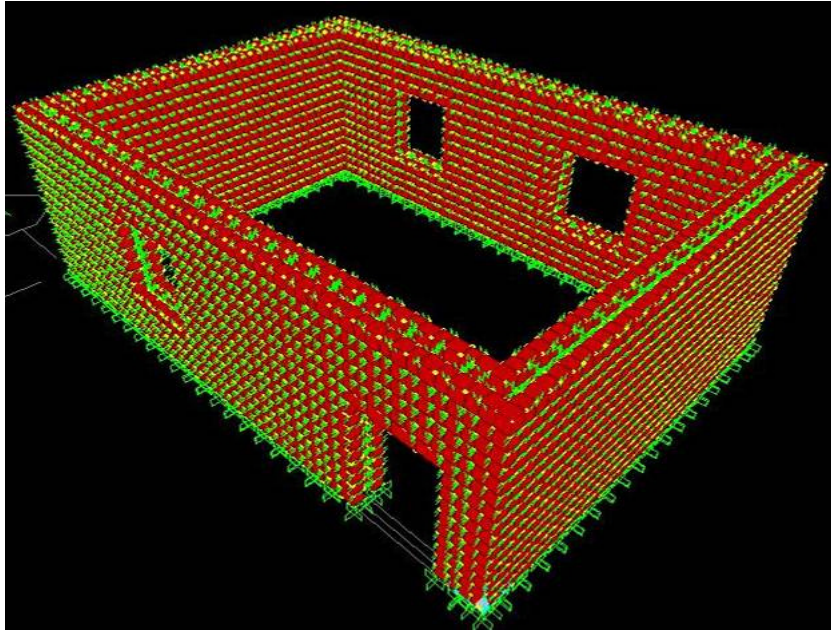
Figure 7. 3-D model of the masonry school structure

Two 3-D finite element models of the school were created in SAP2000; the model of the existing building is shown in Figure 7. A brick-by-brick modelling approach was employed and the stone masonry blocks were modelled as three dimensional linear solid brick elements which were connected to each other by the nonlinear spring elements representing the mortar joints as shown in Figure 8. Only a single room was modelled in view of the computation time required to analyse the structure. Roof trusses were excluded in the 3-D model and as a result, no diaphragm action was considered. However, as mentioned previously the roof trusses and CGI sheets are not well connected to the walls and do not provide diaphragm action.

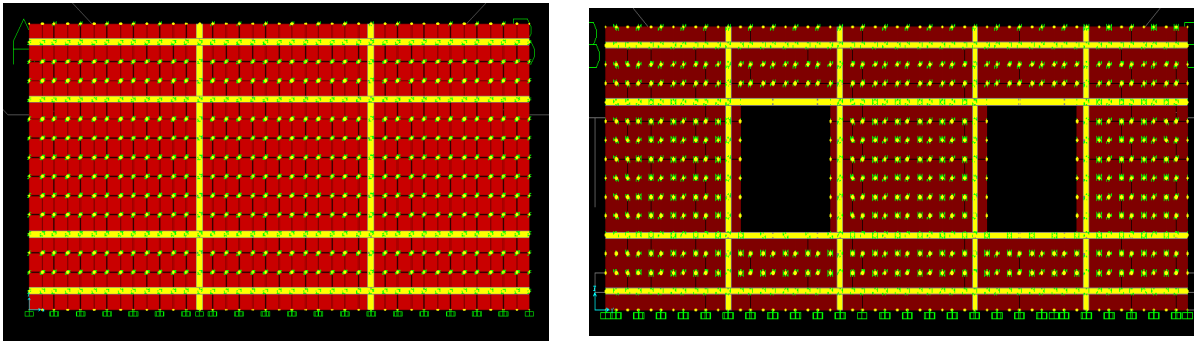
Figure 13. View of 3-D modelled walls with metal strips – short direction wall (left) long direction wall (right)

The retrofitted model was based on the retrofitting design as mentioned above. However, Ferrocement plaster was not modelled in the created 3-D retrofit model shown in Figure 13.
