# Four Storey Office Building in Muzaffarabad

A Case Study of Seismic Assessment and Retrofit Design

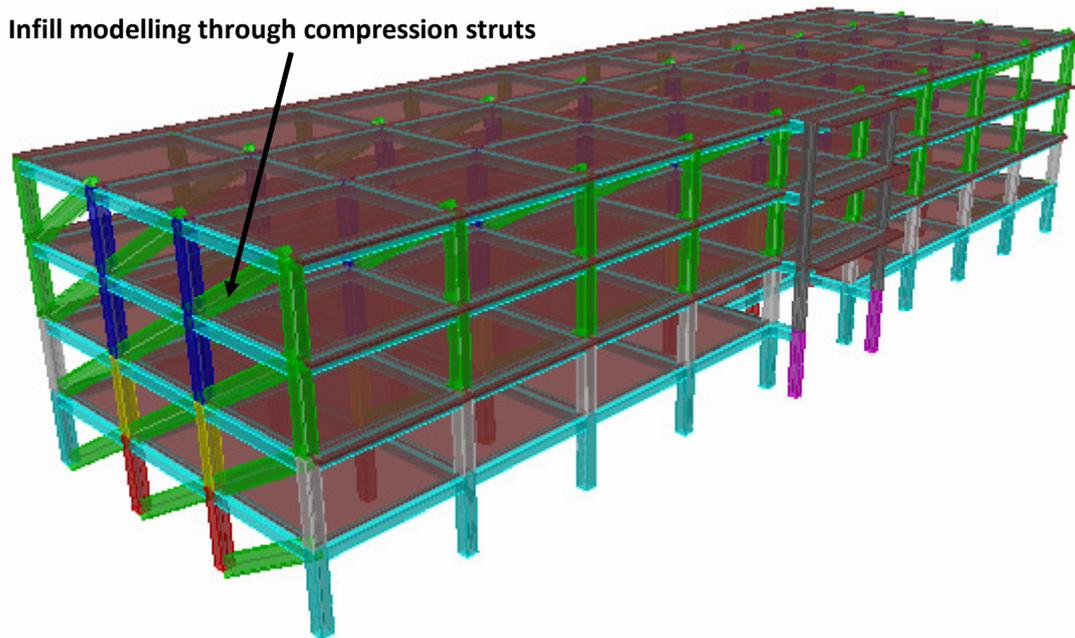
Figure 11. Rendering of linear ETABS model of the building

A 3-D model of the building was developed in ETABS Nonlinear version 9.7.0, using the modeling parameters shown in Table 2. The model is shown in Figure 11. The beams and columns were modeled with linear beam-column elements, and the infill walls were modeled with single linear compression struts. The team then performed a linear static analysis. This analysis shows that there are no columns with demand/capacity ratios (DCRs) greater than one, so the building is not expected to respond in the nonlinear range, except for a small number of captive columns that need retrofit measures to resolve the captive condition. Please see Appendix B for linear analysis results.
