6-Storey Mixed Use Building in Karachi

A Case Study of Seismic Assessment and Retrofit Design

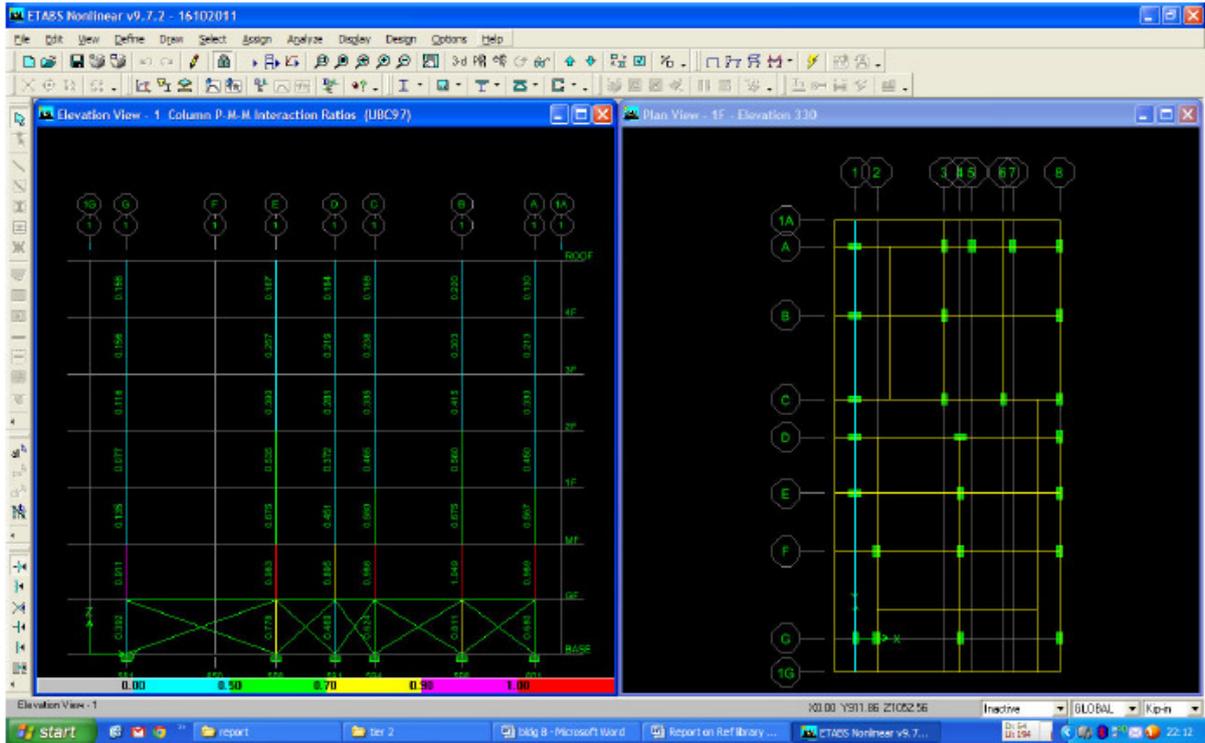
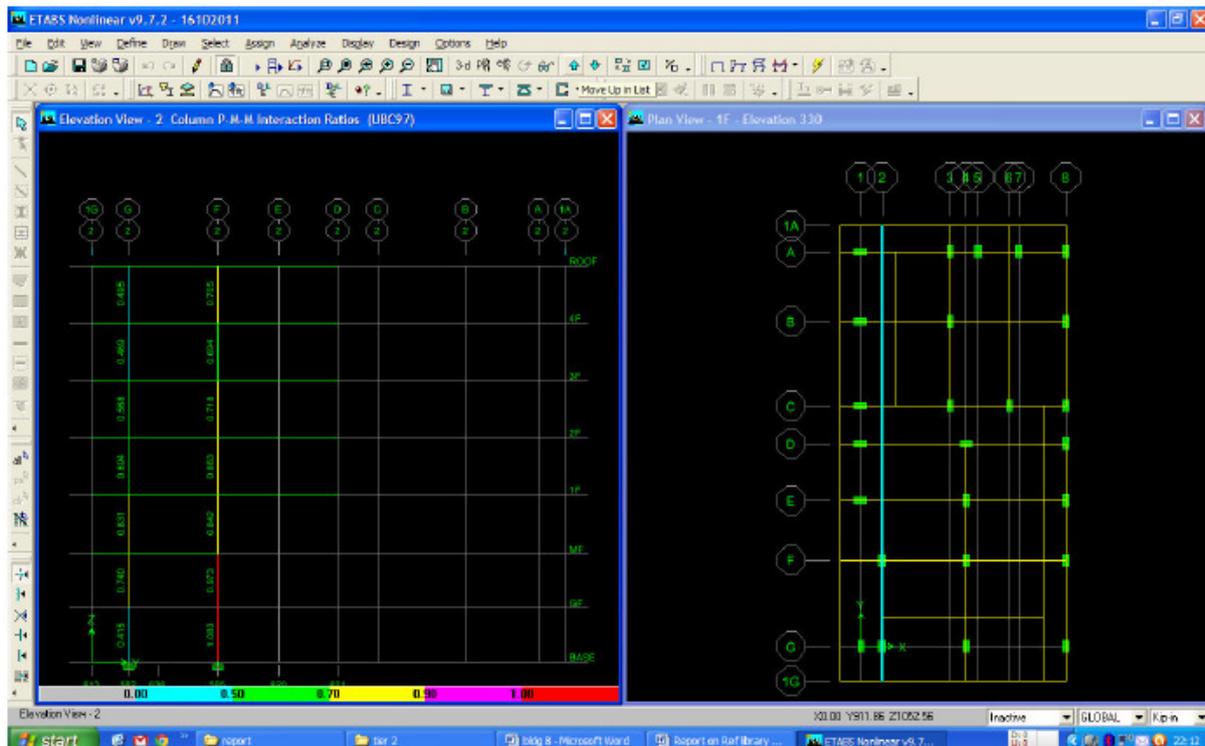
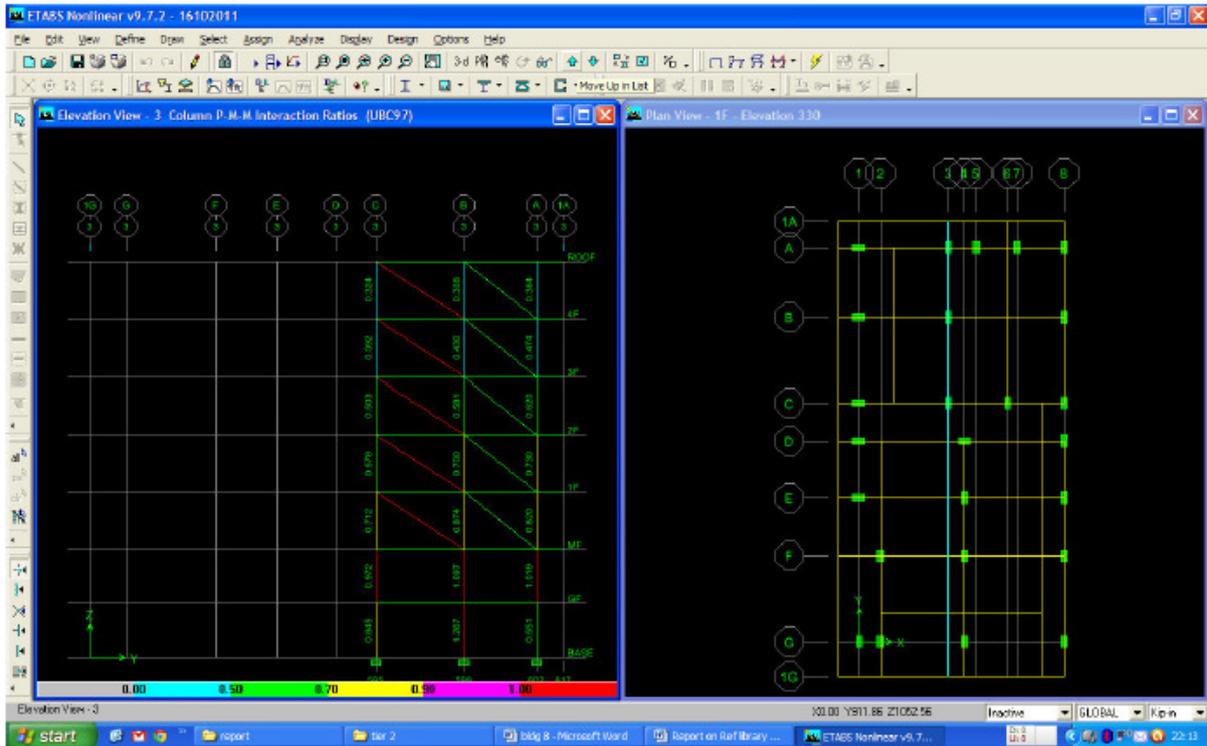
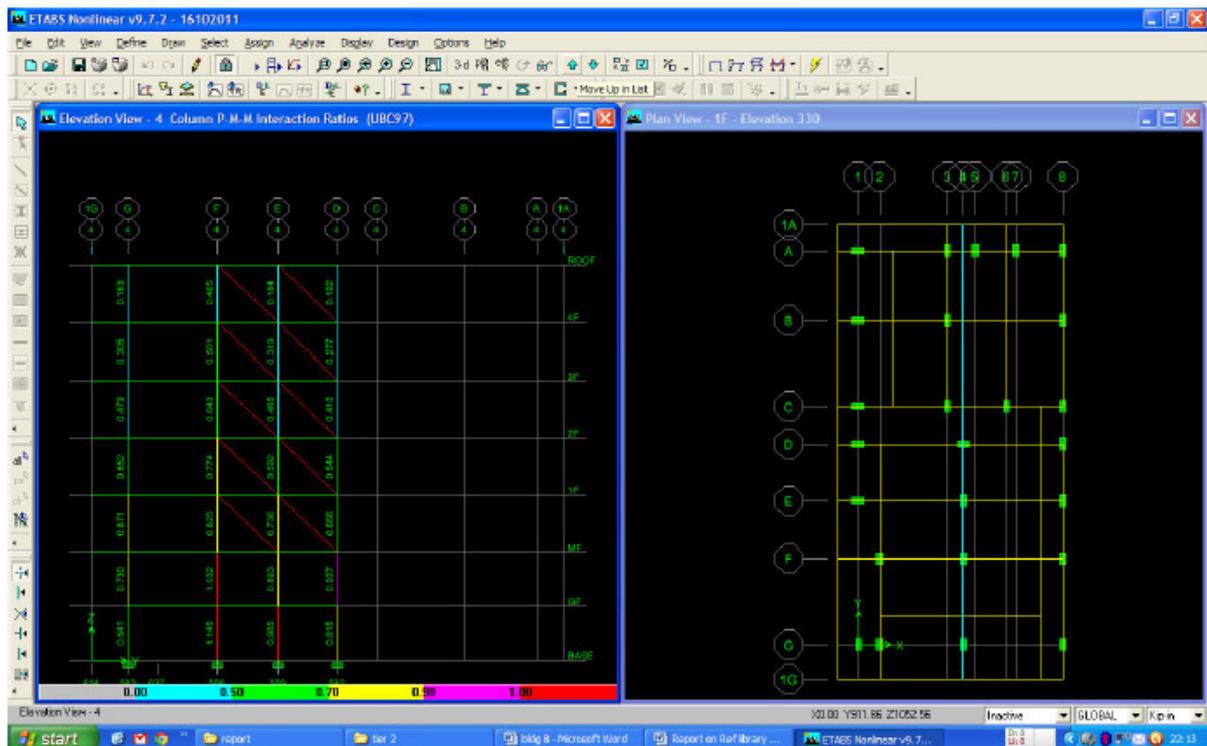
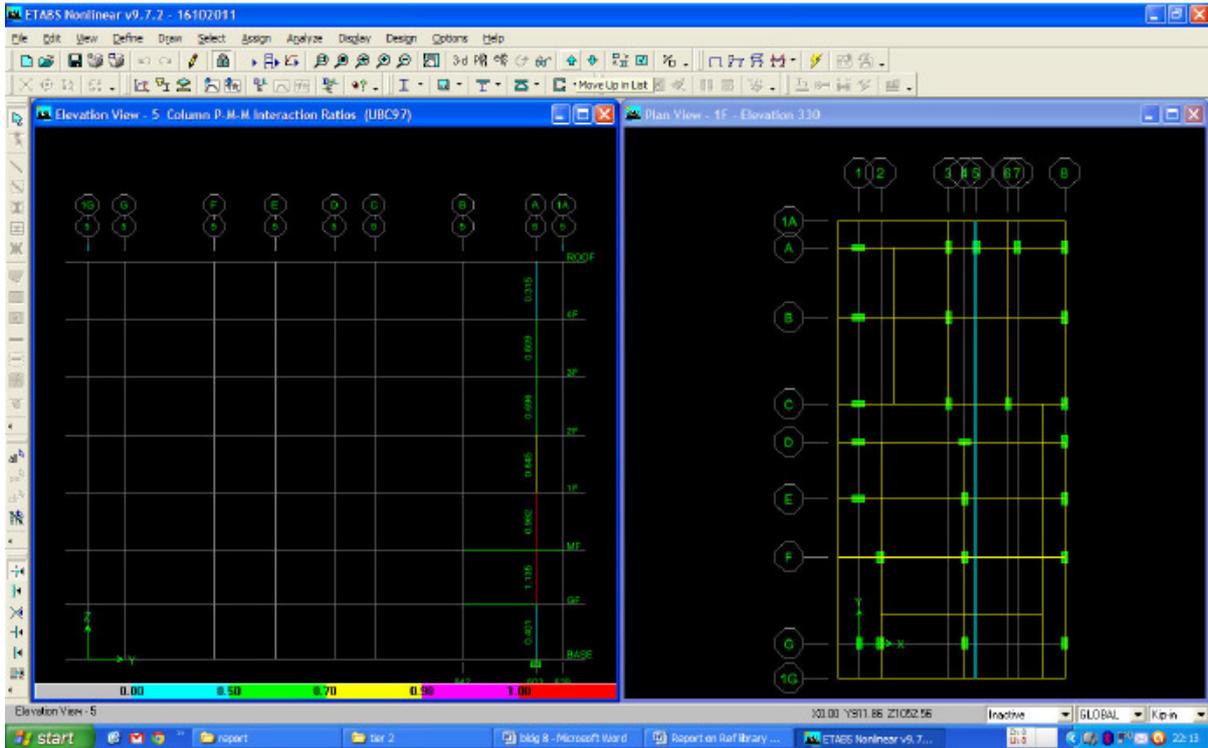
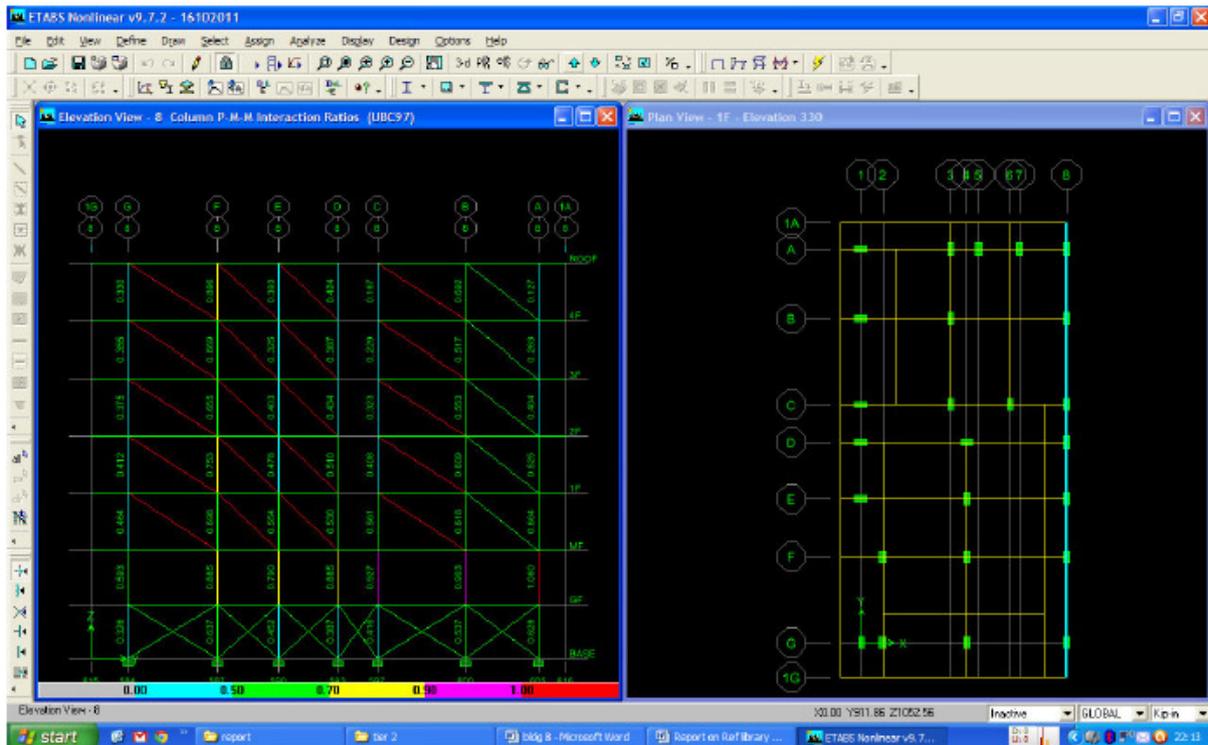
Appendix B: Linear Analysis (Tier 2) Results

As some columns were failing under gravity loads and many columns had $DCR > 1$, the team decided to jacket the columns first and replace the ordinary masonry infill walls with new RCC shear walls. However, due to architectural limitations, shear walls could only be provided at certain locations. The team investigated several possibilities before finalizing the locations shown in Figure 13 along with the columns to be jacketed. The highlighted column sizes are increased to 18" x 30" and two different thicknesses of RCC walls are provided. Walls 9" thick go from base up to roof level and walls 12" thick between grid B and C only go from base to first floor.

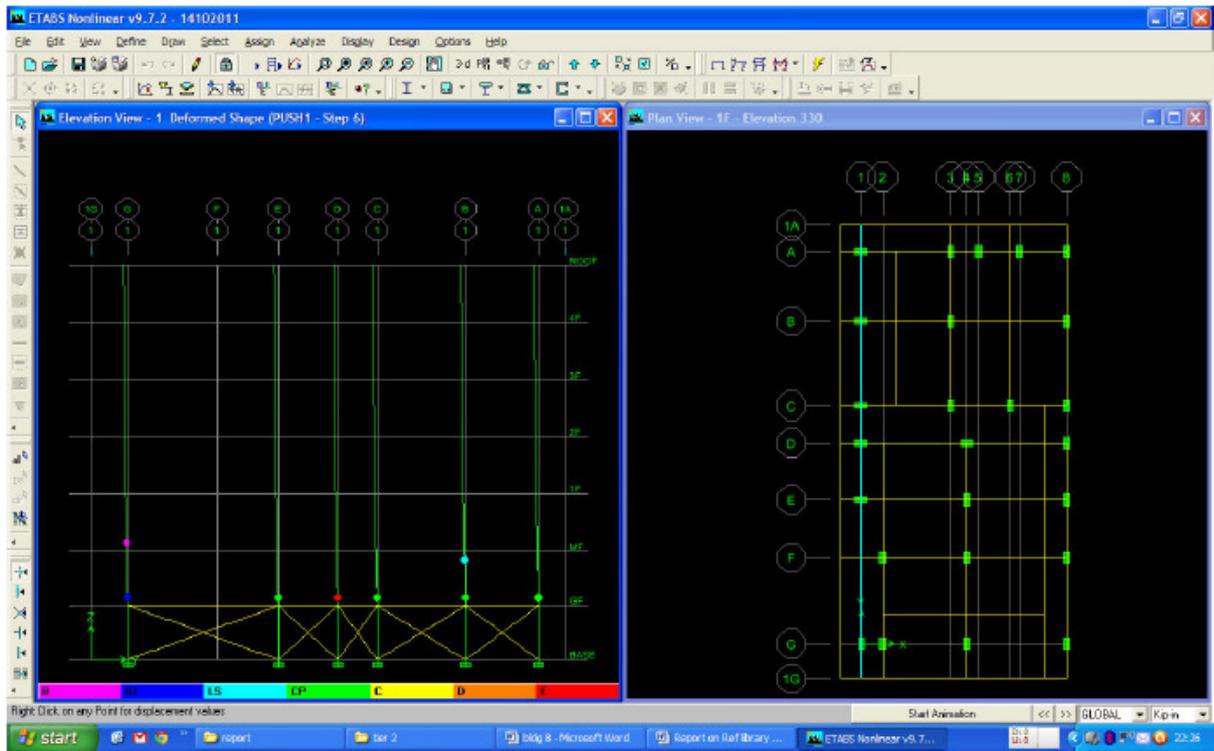
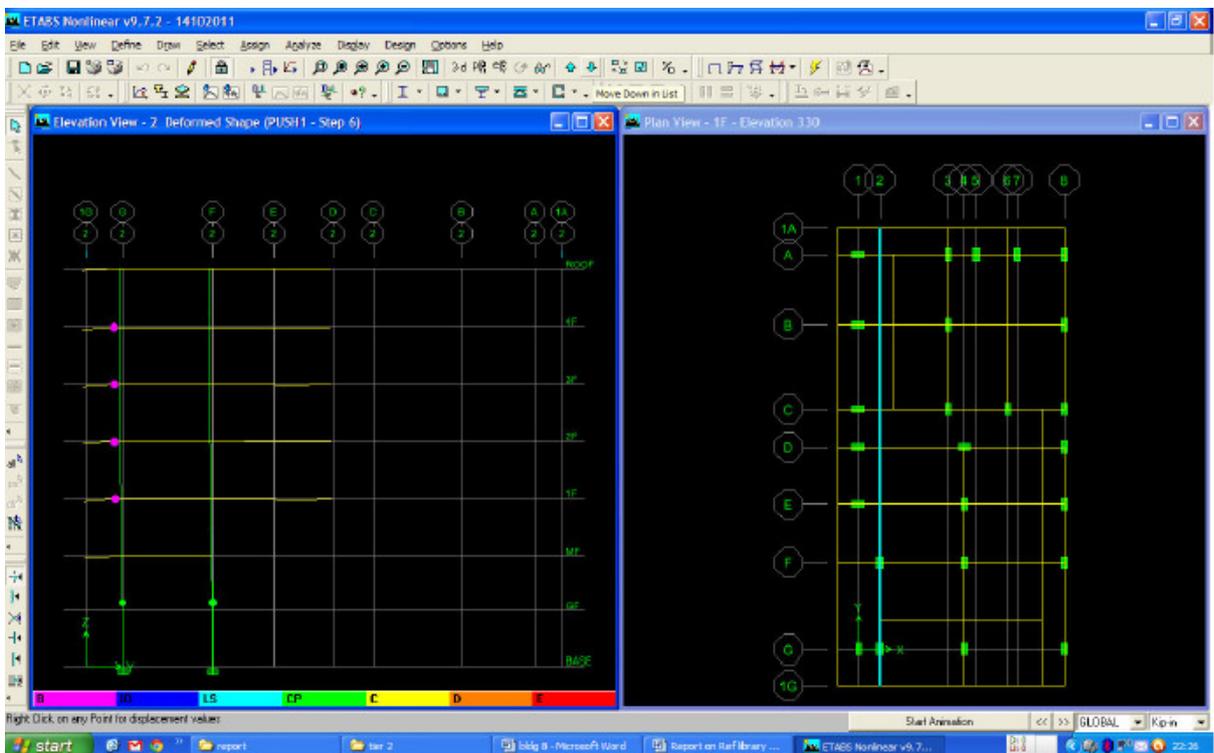
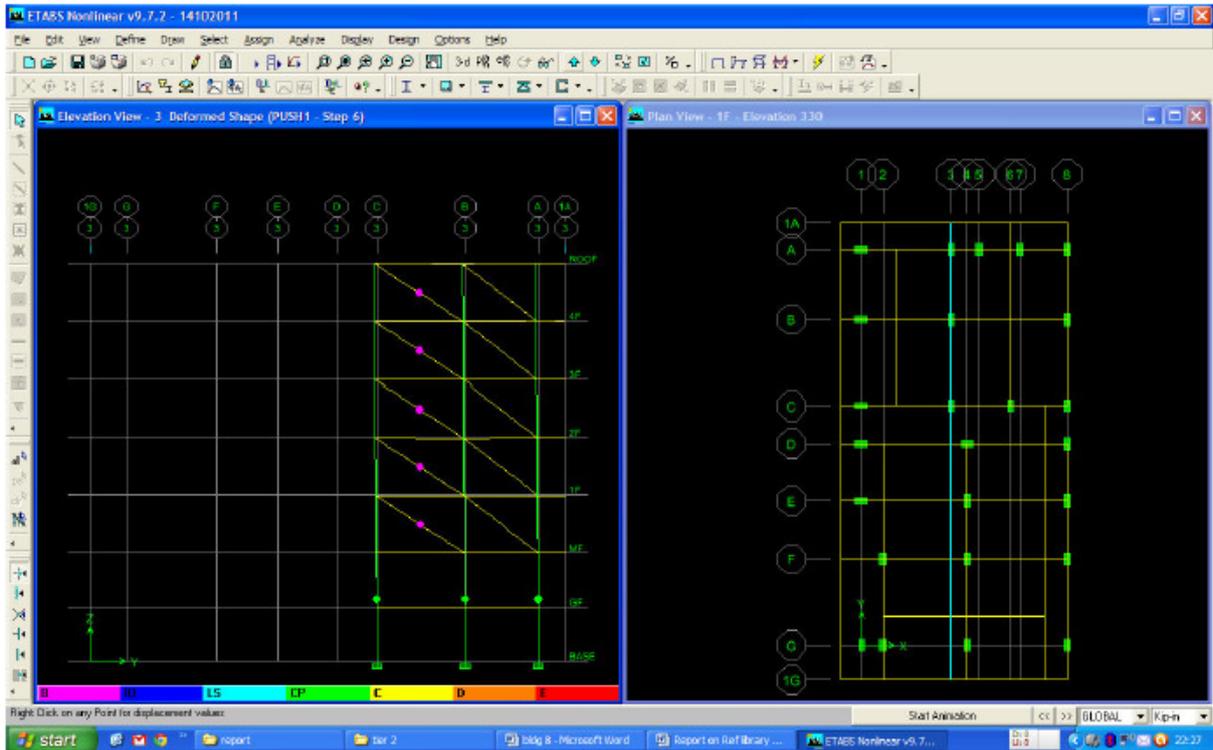
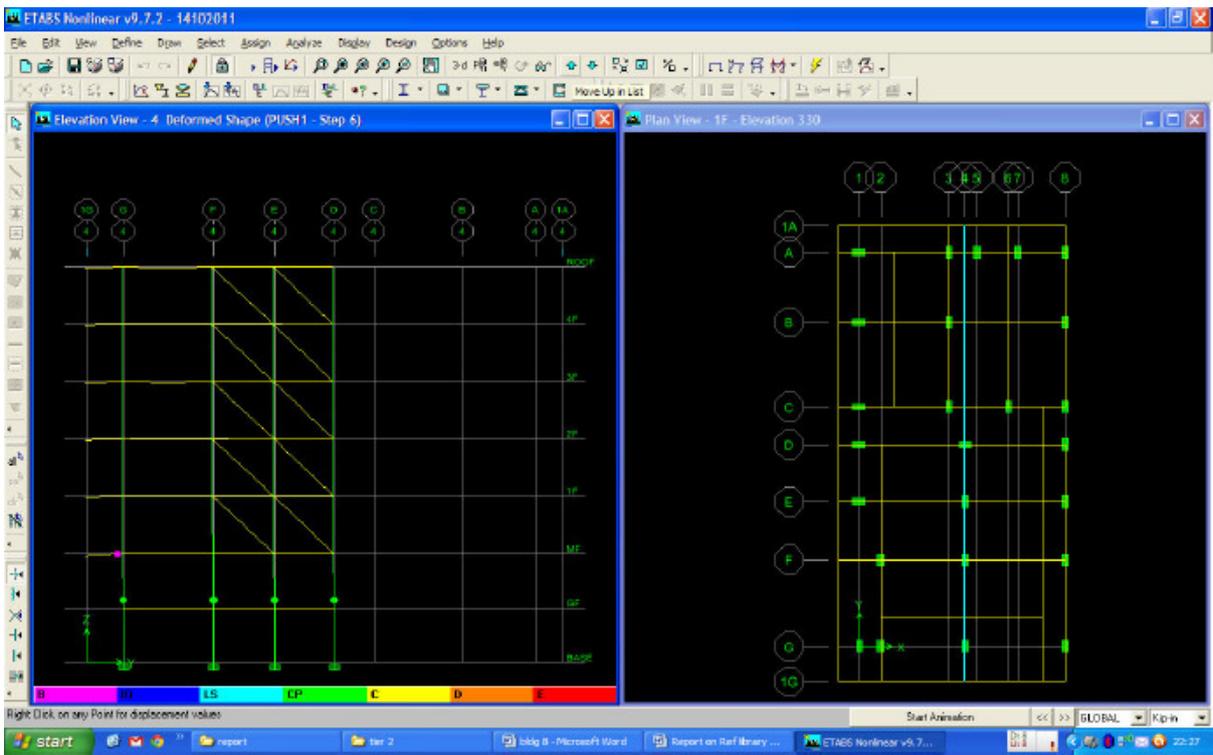
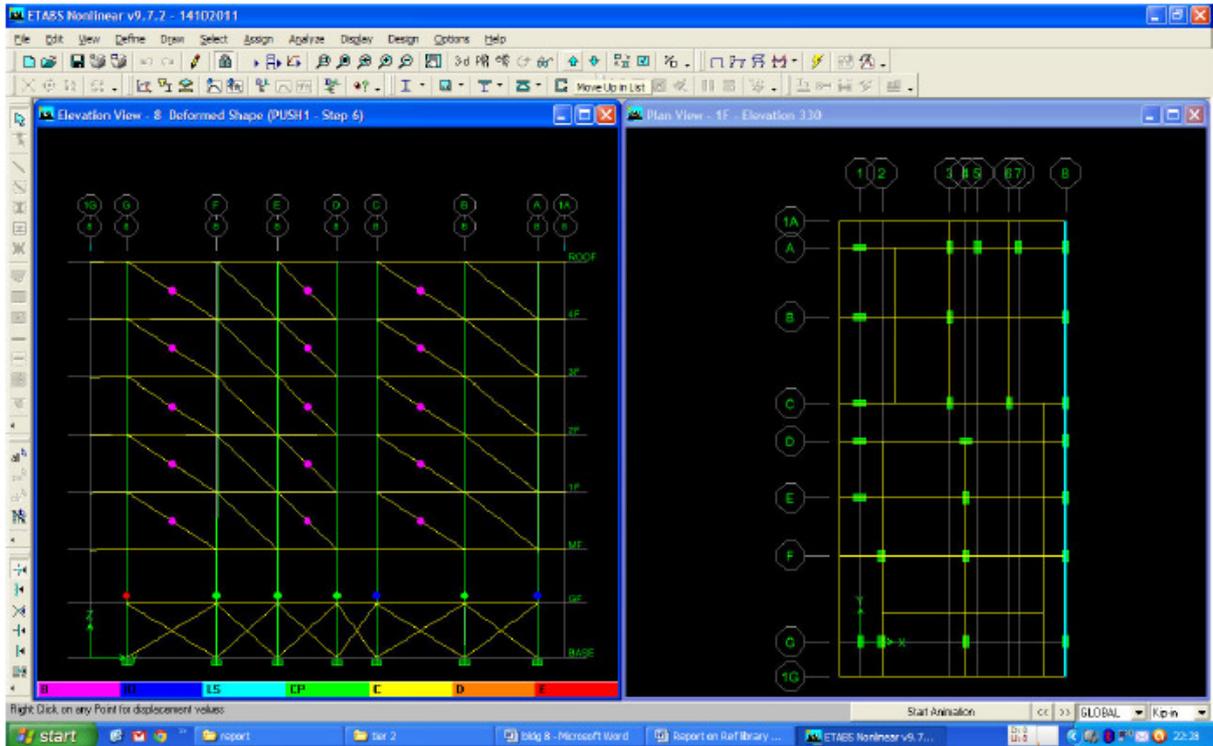
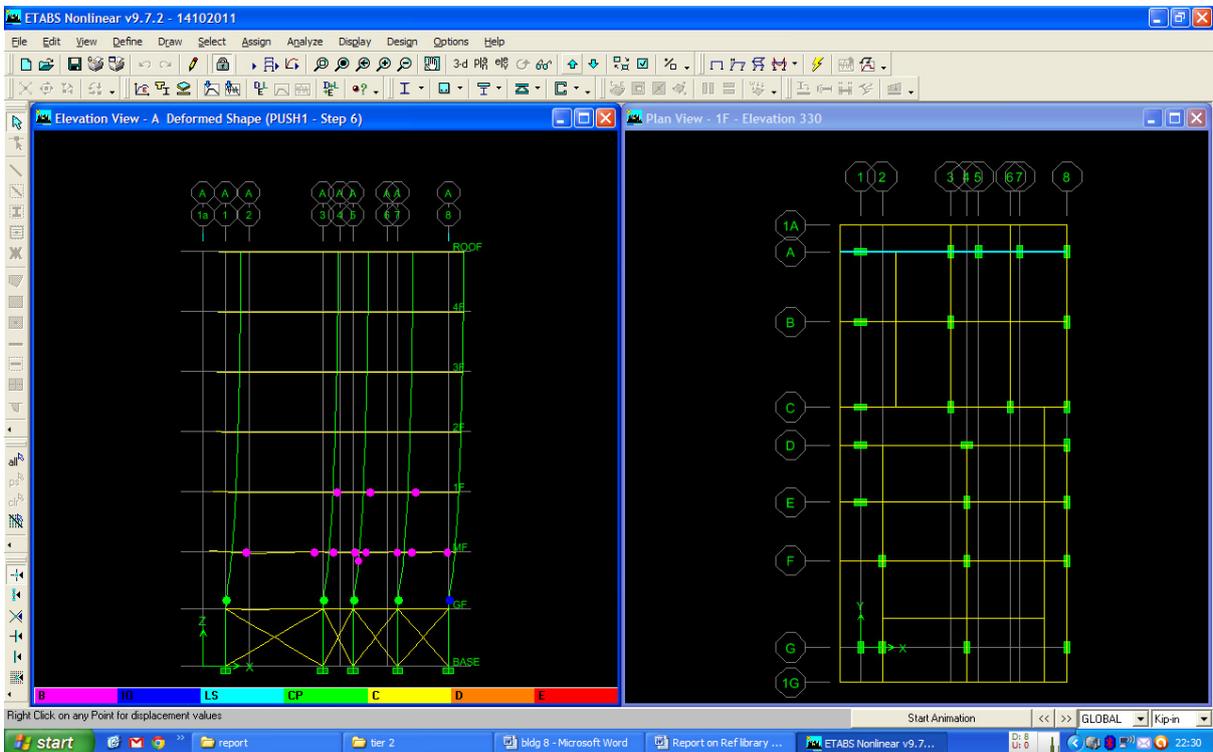
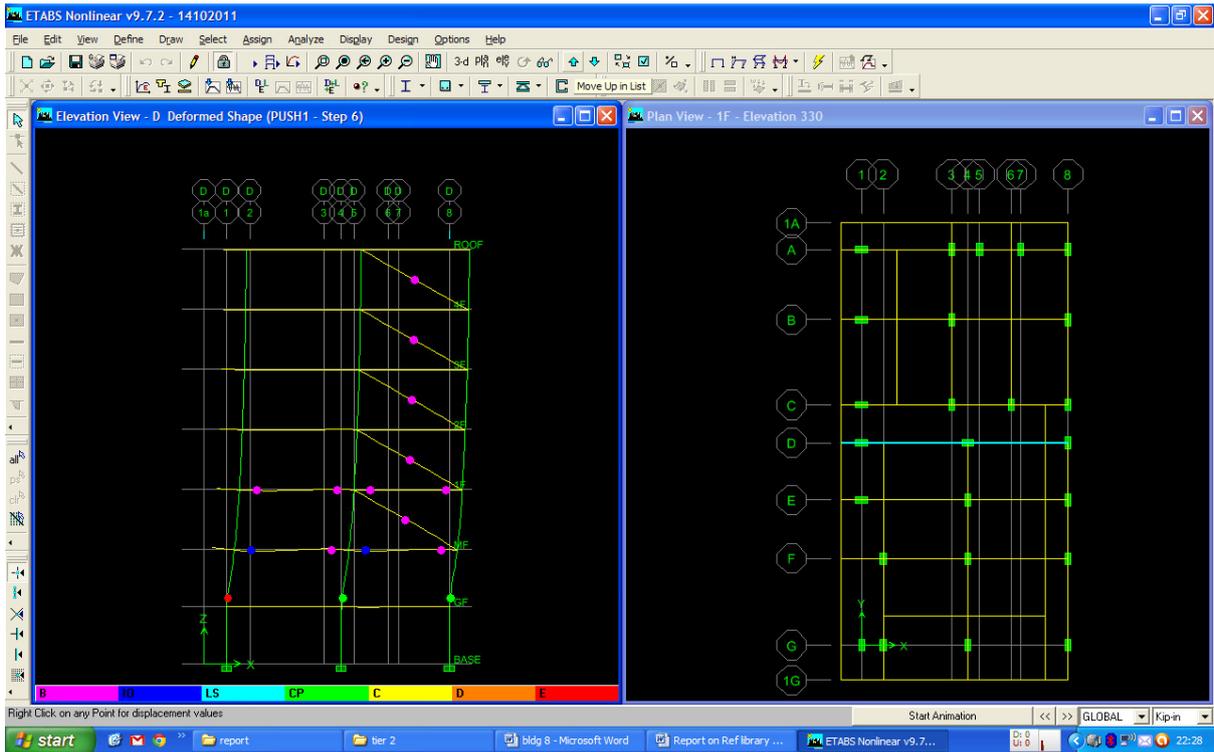
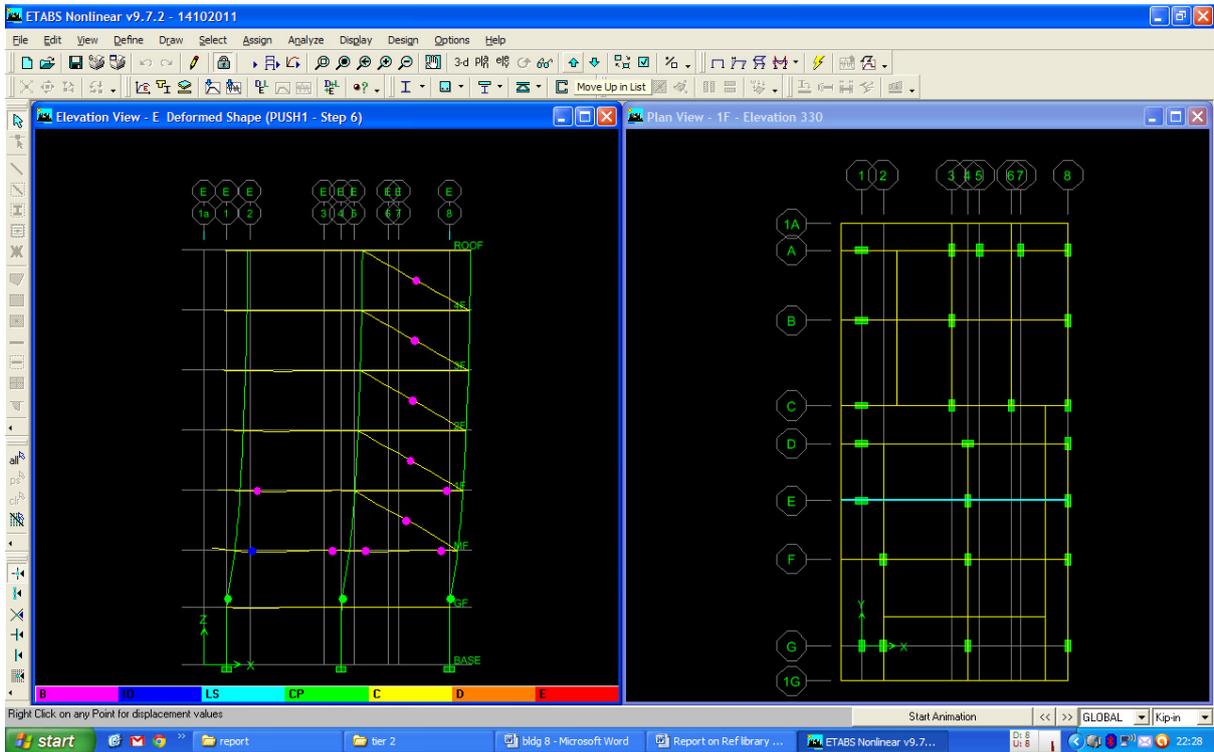
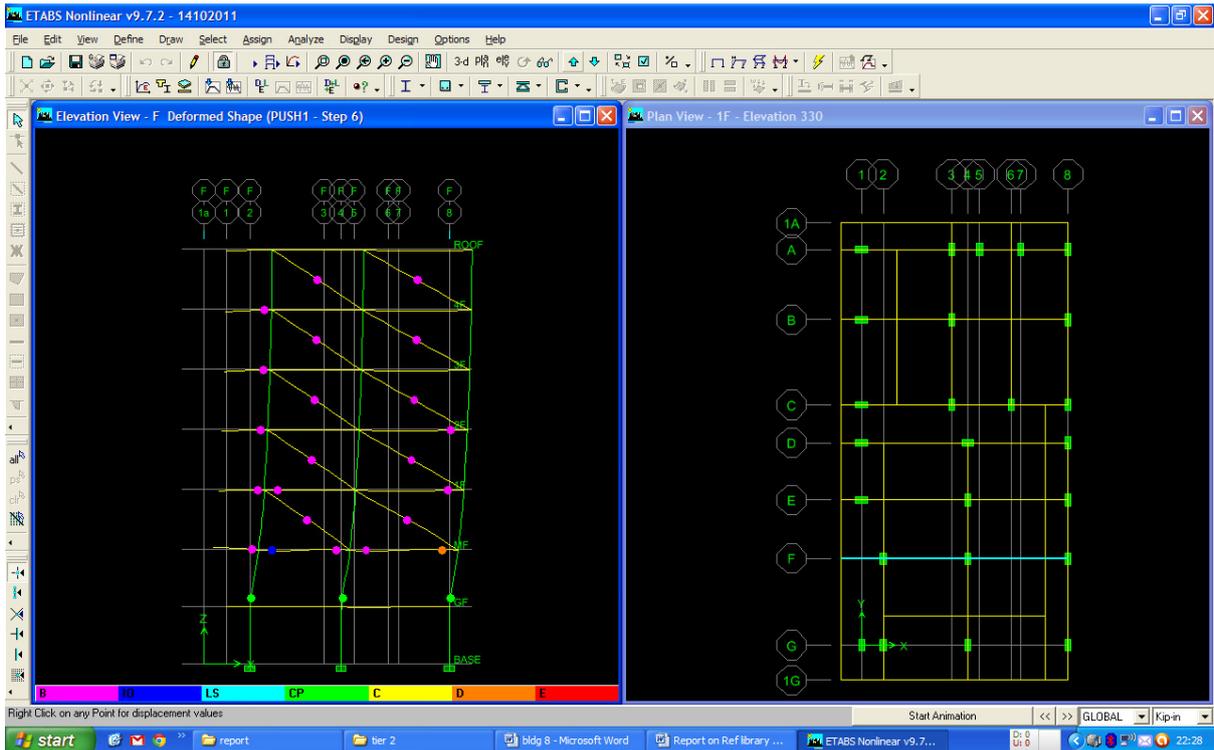
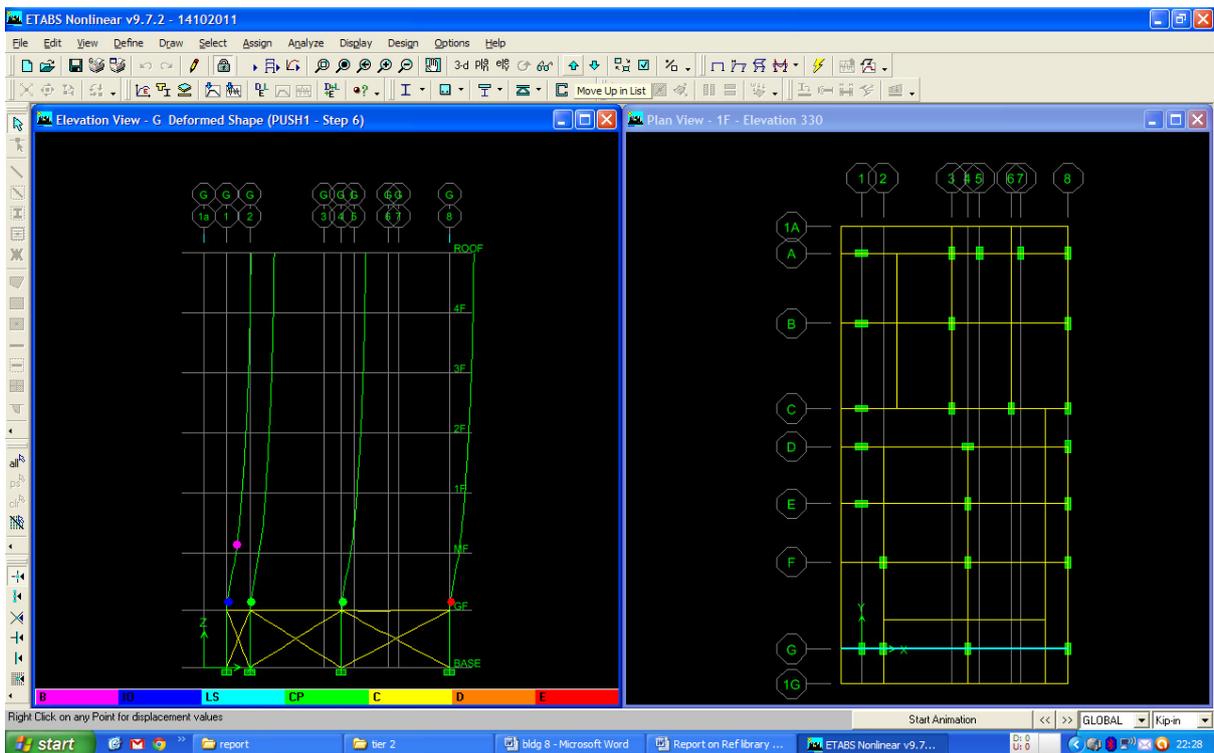
Appendix C: Non Linear Analysis (Tier 3) Results Before Retrofit

The results of the non linear analysis shown in Figure 12 and Appendix C show the state of the nonlinear hinges at the performance point. These results confirm that retrofitting is needed to achieve stability and to prevent failure at the acceptance level.
