Report No. NED/EQD/SR-19/06

Preliminary Report of Reconnaissance Surveys in Mirpur Post 24 September 2019 Earthquake

November 2019

**DEPARTMENT OF EARTHQUAKE ENGINEERING
NED UNIVERSITY OF ENGINEERING AND TECHNOLOGY**

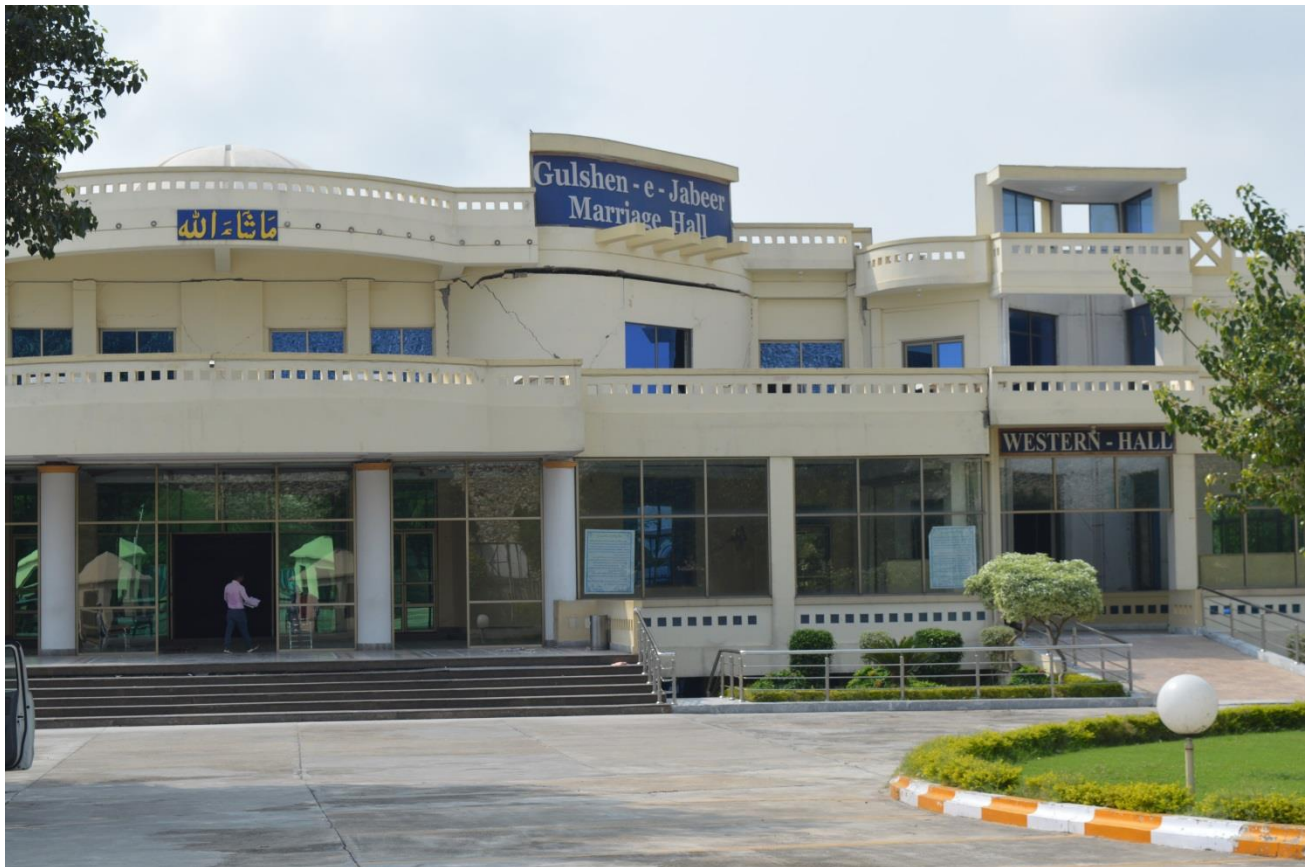
Fig. 10 View of Gulshan-e-Jabeer building

Gulshan-e-Jabeer building is a two storeyed RC frame structure building with one basement (Fig. 10). The building is nearly 10 years old. The building of Ahsan Medical Complex is a seven storey high RC building including a mezzanine (Fig. 11). The building is only one year old. Figs. 12 and 13 show few damaged columns in these aforementioned buildings. It is seen in Figs. 12 and 13 that hinging is caused in columns at the beam-column junction which was accompanied by the buckling of the longitudinal bars. The latter is a result of insufficient confinement provided to the longitudinal bars by the spiral (circular columns) or stirrups (rectangular columns). It was also noted that the hook of the stirrups in the rectangular columns were bent 90 deg in violation of the design codes followed for the design of RC buildings.
