# Earthquakes Cause Damages in Pakistan, Iran, Japan and Morocco

# Aspects of Mitigation

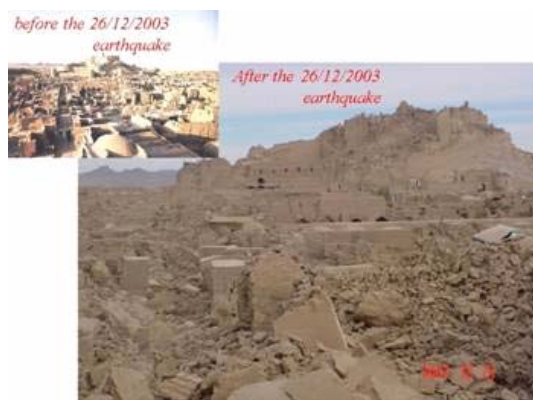
**Fig 2.** The historic site of Arg-e-Bam before and after earthquake (Source: International Institute of Earthquake Engineering and Seismology, Iran)

An earthquake measuring 6.6 on the Richter scale struck southeastern Iran's Kerman Province on December 26, 2003. The epicenter of the earthquake was near the city of Bam which is 180 km southeast of the provincial capital of Kerman and 975 km southeast of Tehran. Fig.2 shows the view of Arg-e-Bam before and after earthquake on February 26. The earthquake brought a
